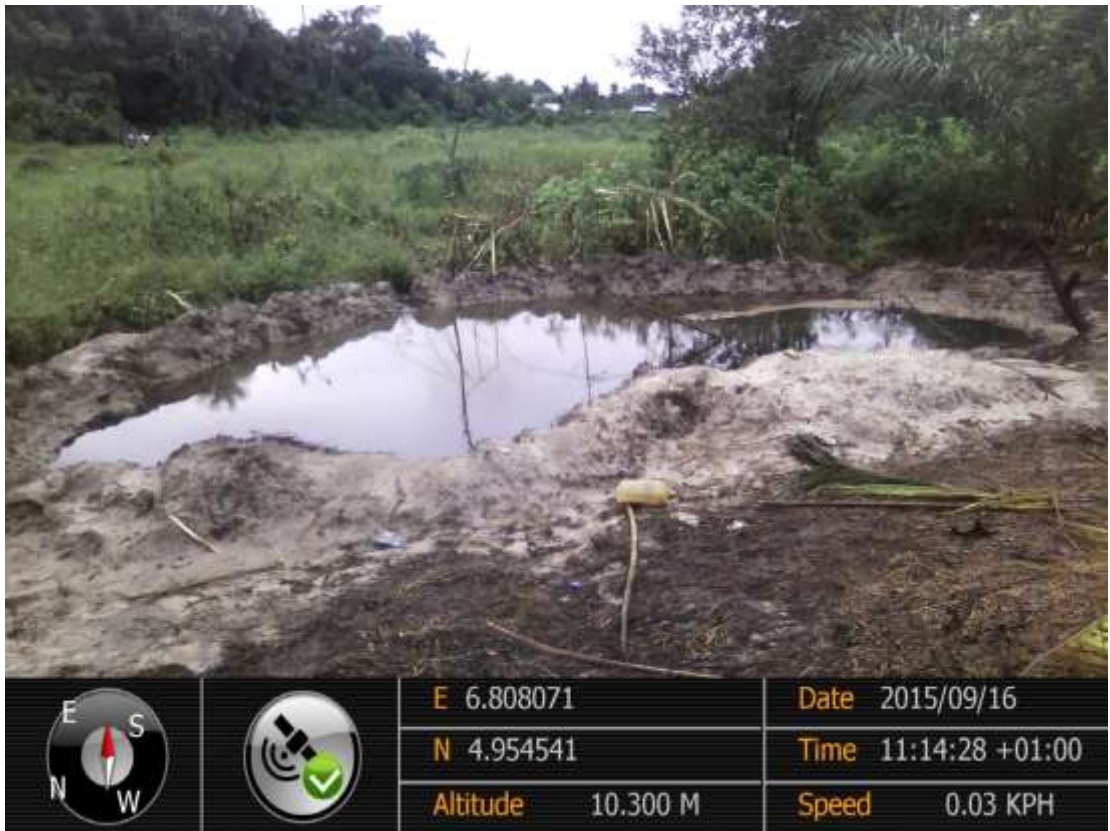
**Overview:** Part of spill impact on 20" Rumuekpe-Nkpoku Pipeline Right of Way at Omukpobu. Picture was taken during Joint Investigation of 16<sup>th</sup> September 2015.

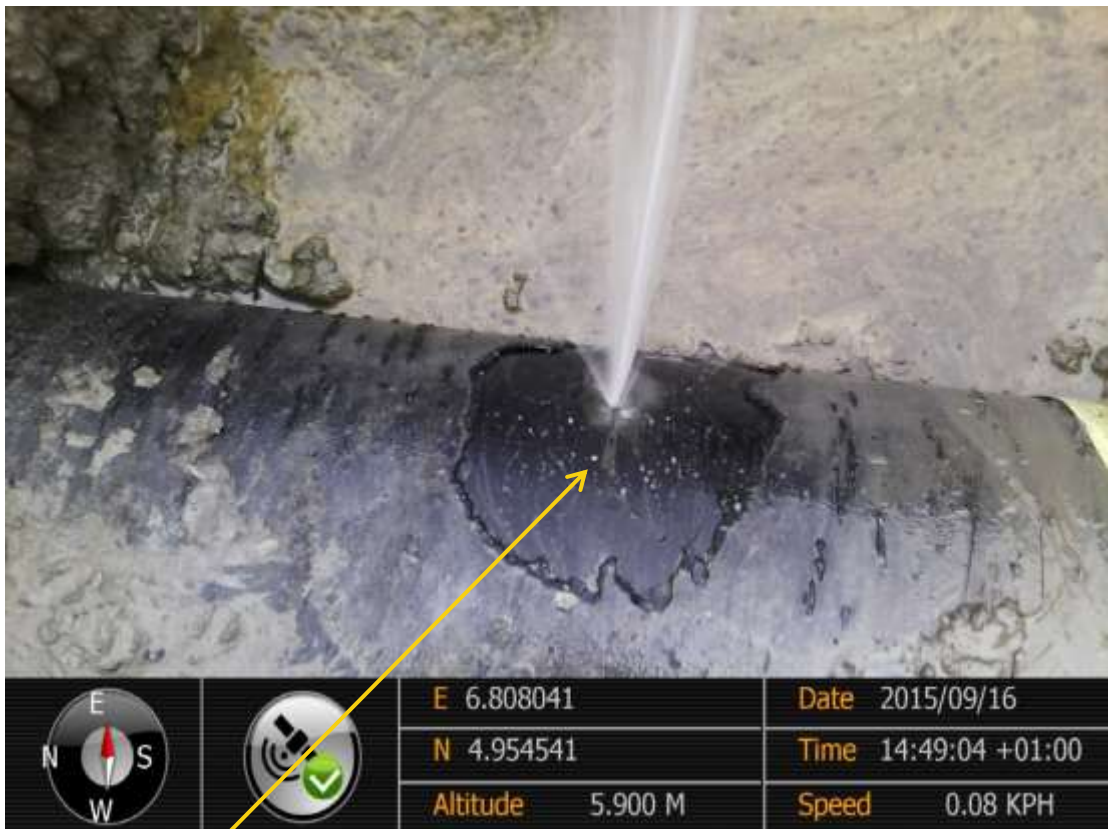
**Close-up:** Hacksaw cut on 20" Rumuekpe-Nkpoku Pipeline at Omukpobu. Picture was taken during Joint Investigation of 16<sup>th</sup> September 2015.
