JOINT INVESTIGATION REPORT

INCIDENT NO: 1492780 JIV report S/N:

1. Spill incident Number: 1492780 2. Type of incident* OIL SPILL
3. Name of Location 20" KOLOCRAEK - KUMUEKPE TRANS NIGER PIPELINE
4. Name of nearest community ODAU 5. State: KINERS 6. LGA ABUA/ODUAL
7. Type of Production facility/Installation OIL PIPELINE
8. Asset owner/District THE SHELL PETROLEUM DEVELOPMENT COMPANY OF NIG LTD

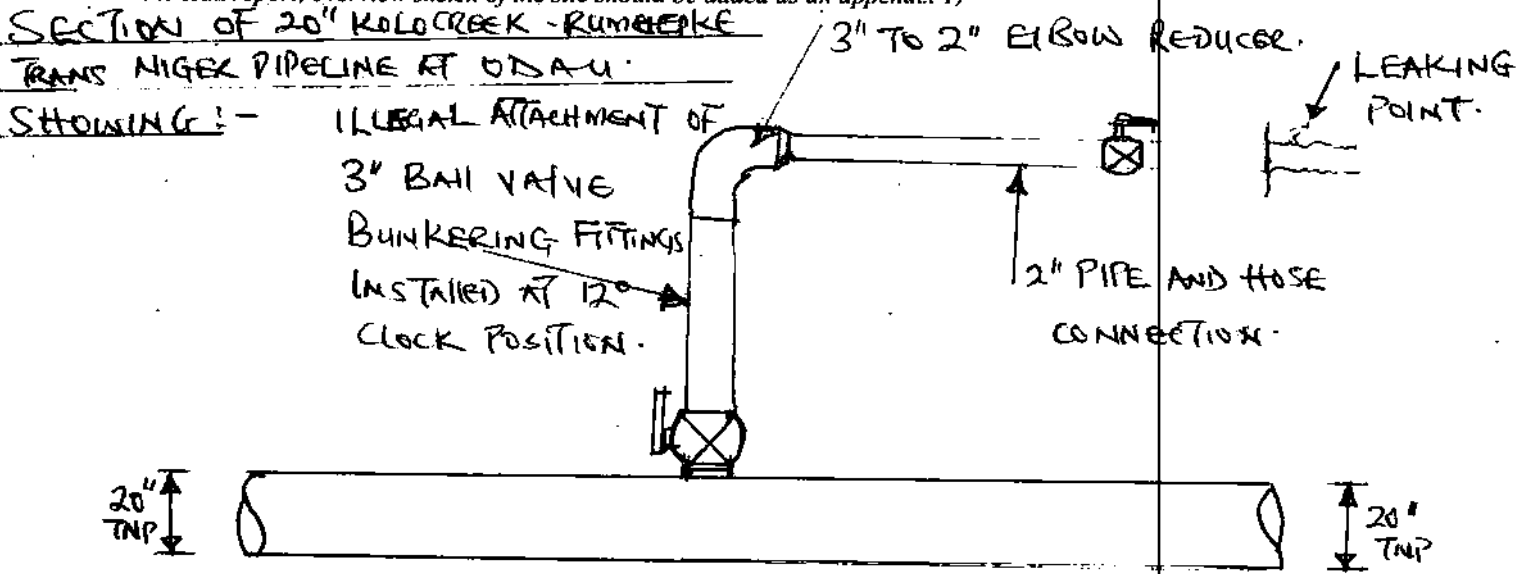
E. GRAPHIC DESCRIPTION OF LEAK POINT (while detail report of the leak point should be contained in the leak report, overview sketch of the site should be added as an appendix 1)

Additional observations around the spill point: THE JOINT INVESTIGATION TEAM (JIT) OBSERVED NO VISIBLE IMPACT AROUND THE SUSPECTED INCIDENT POINT. ON EXCAVATION A PIPE AND HOSE WAS FOUND ATTACHED TO THE LINE BY UNKNOWN PERSON(S). THE ATTACHED PIPE EXTENDED BEYOND SPDC RIGHT OF WAY TO THE BUSH. THE JIT OBSERVED SOME OIL IMPACT AROUND THE POINT THAT THE UNKNOWN PERSON(S) CONNECTED FLEXIBLE HOSE TO THE 2" ILLEGAL ATTACHMENT.

TEMPORARY REPAIR BY SCREW
CAPPING WAS DONE.

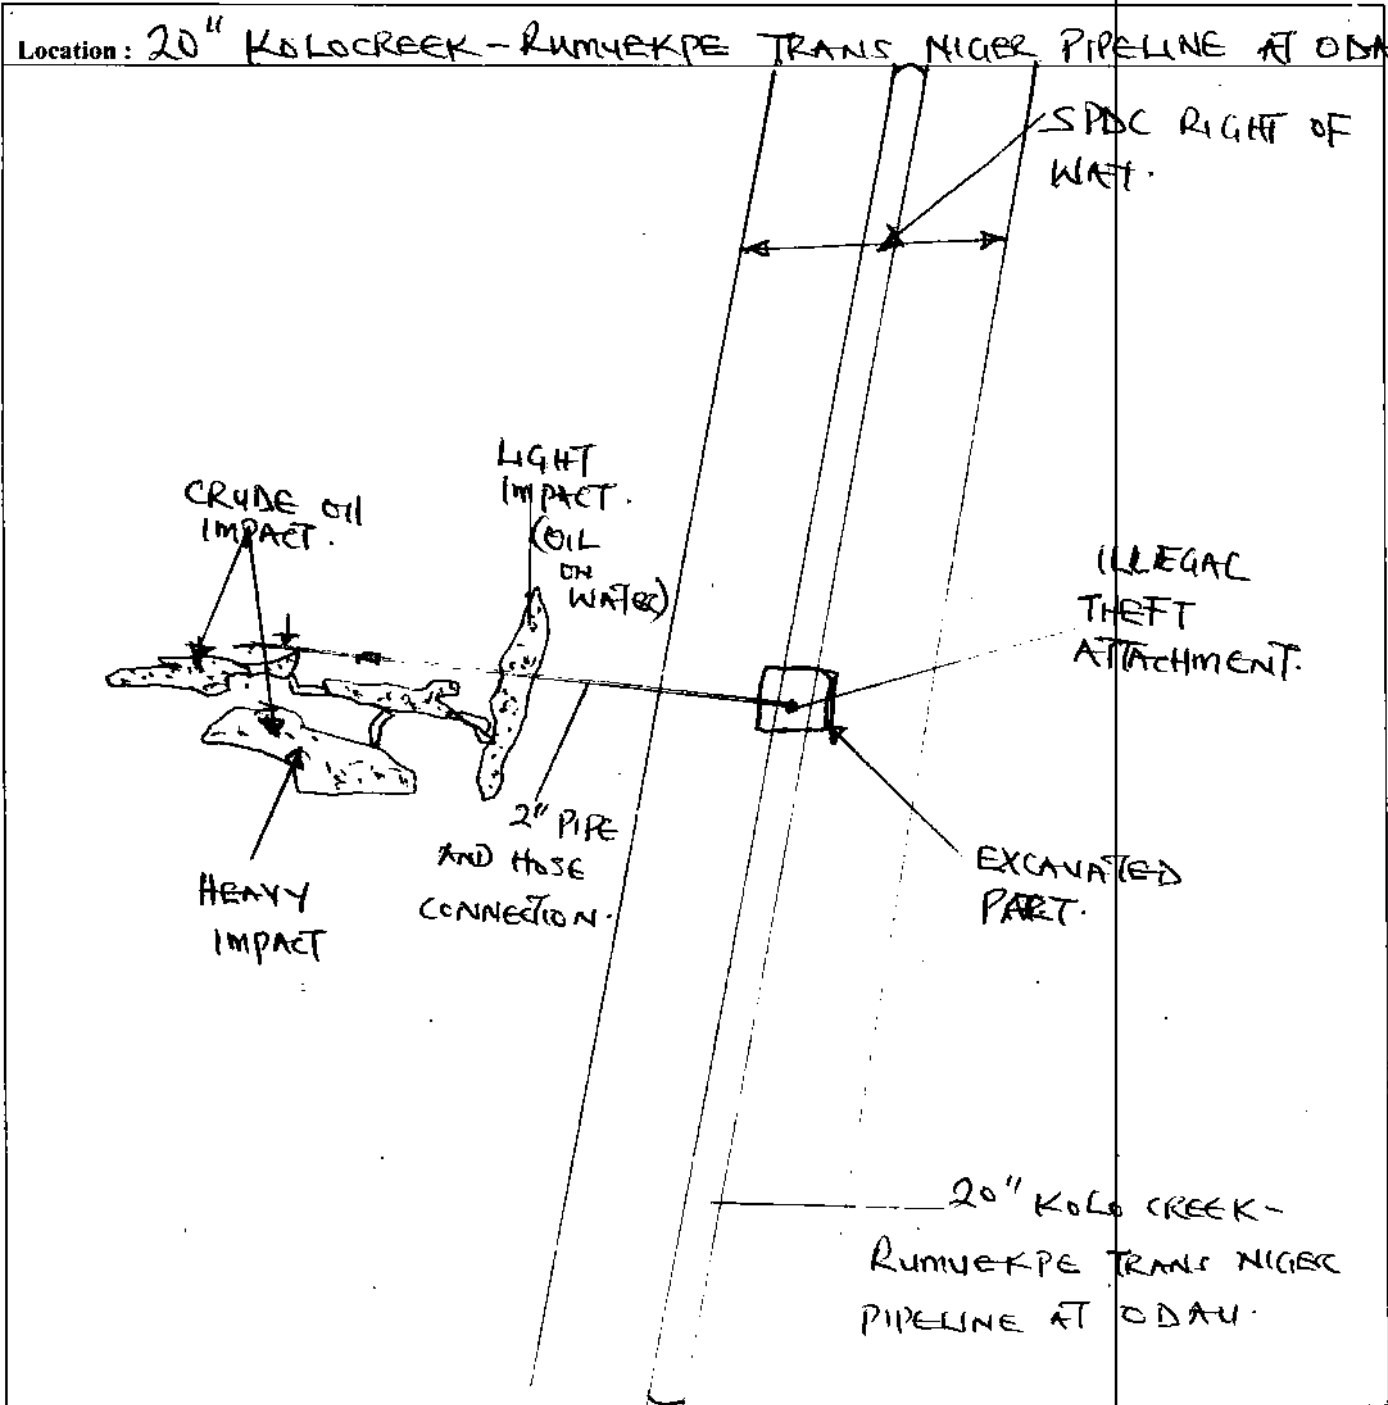
f. Appendix 1: Overview sketch of the site

Location: 20" KOLOCREEK - RUMUEKPE TRANS NIGER PIPELINE AT ODAU.
