# JOINT INVESTIGATION REPORT

INCIDENT NO: 1577647 JIV report S/N: Nº. 0000362

1. Spill incident Number: 1577647 2. Type of incident\* OIL SPILL  
3. Name of Location 20 INCH OPUKUSHI BRASS CREEK PIPELINE  
4. Name of nearest community TAMOGBENE 5. State: BAYELSA 6. LGA EKEREMOR  
7. Type of Production facility/Installation OIL PIPELINE  
8. Asset owner/District THE SHELL PETROLEUM DEVELOPMENT COMPANY OF NIGERIA LIMITED / SWAMP WEST.

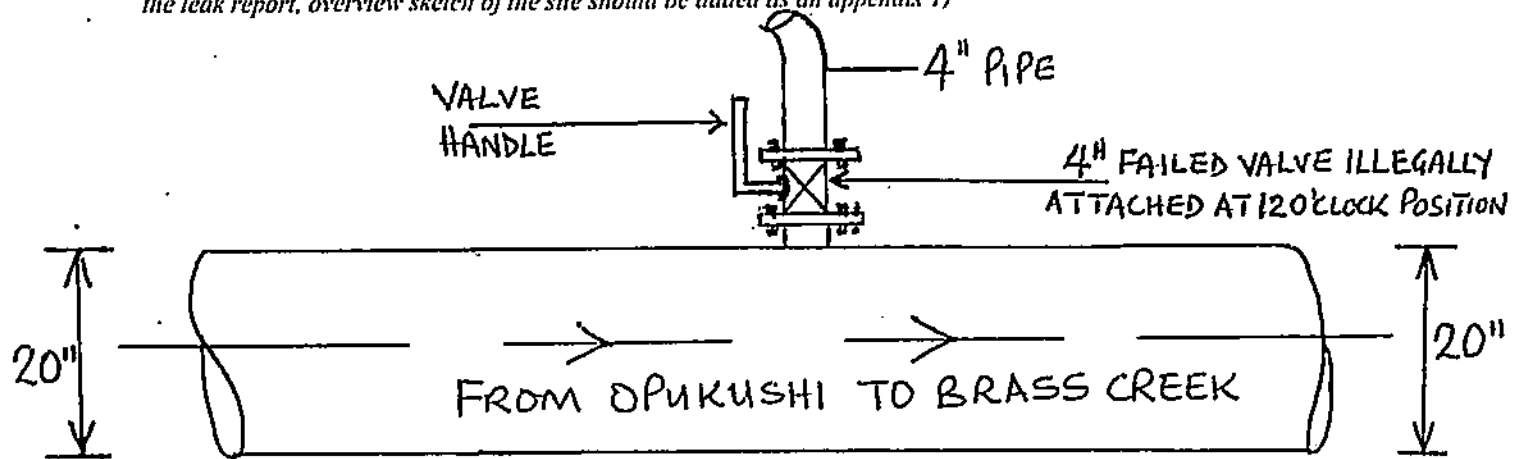
**E. GRAPHIC DESCRIPTION OF LEAK POINT** (while detail report of the leak point should be contained in the leak report, overview sketch of the site should be added as an appendix 1)

Additional observations around the spill point: UPON EXCAVATION OF THE INCIDENT POINT, THE JOINT INVESTIGATION TEAM OBSERVED A FAILED 4 INCH VALVE ILLEGALLY ATTACHED TO THE 20 INCH OPUKUSHI - BRASS CREEK PIPELINE AT 12 O'CLOCK POSITION. LEAK AT THE INCIDENT POINT HAD STOPPED AS AT SECOND DAY OF INVESTIGATION.

| <input checked="" type="checkbox"/> Failed Weld-on illegal hot tap valve | <input type="checkbox"/> Failed Clamp, | <input type="checkbox"/> Missing Pipeline/Flowline |
| <input checked="" type="checkbox"/> Crude oil theft (illegal bunkering) point, | <input type="checkbox"/> Saver-pit over flow | <input type="checkbox"/> Third party tampering with Clamp |

20 INCH OPUKUSHI-BRASS CREEK PIPELINE AT TAMOGBENE
