# JOINT INVESTIGATION REPORT

INCIDENT NO: 1563611 JIV report S/N: Nº 0000123

1. Spill incident Number: 1563611 2. Type of incident\* OIL SPILL  
3. Name of Location UBIE WELL 5 L/S FLOWLINE  
4. Name of nearest community IDU-EKPEYE 5. State: RIVERS 6. LGA AHOADA-WEST  
7. Type of Production facility/Installation OIL FLOWLINE  
8. Asset owner/District THE SHELL PETROLEUM DEVELOPMENT COMPANY OF NIGERIA LIMITED / LAND 2

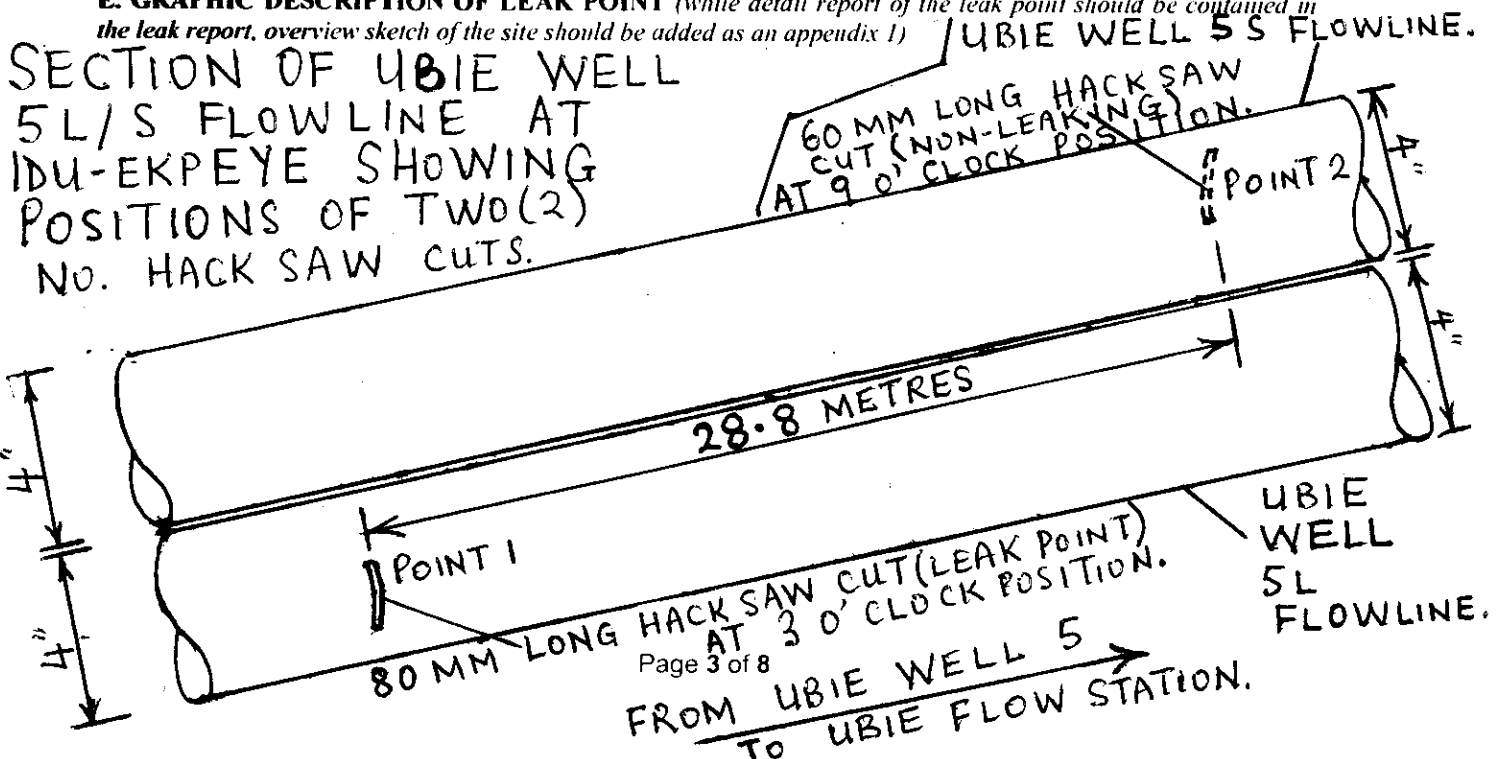
**E. GRAPHIC DESCRIPTION OF LEAK POINT** (while detail report of the leak point should be contained in the leak report, overview sketch of the site should be added as an appendix 1)

Additional observations around the spill point: UPON EXCAVATION AROUND THE LEAK POINT ON THE SECOND DAY OF JOINT INVESTIGATION VISIT (J.I.V), THE JOINT INVESTIGATION TEAM OBSERVED TWO FLOWLINES (5L AND 5S). LEAK WAS CONFIRMED FROM A HACK SAW CUT ON 5L. ON EXCAVATING APPROXIMATELY 28.8 METRES AWAY FROM THE LEAK POINT, ANOTHER HACK SAW CUT (NON-LEAKING) WAS OBSERVED ON 5S.

| <input type="checkbox"/> Drilled hole | <input checked="" type="checkbox"/> Hack saw cut | <input type="checkbox"/> Tear (_____). |
