JOINT INVESTIGATION REPORT

INCIDENT NO: 1559109 JIV report S/N: Nº 0000124

1. Spill incident Number: 1559109 2. Type of incident* OIL SPILL
3. Name of Location 28" BOMU - BONNY PIPELINE
4. Name of nearest community BODO-CITY 5. State: RIVERS 6. LGA GOKANA
7. Type of Production facility/Installation OIL PIPELINE
8. Asset owner/District THE SHELL PETROLEUM DEVELOPMENT COMPANY OF NIGERIA LIMITED / PIPELINE

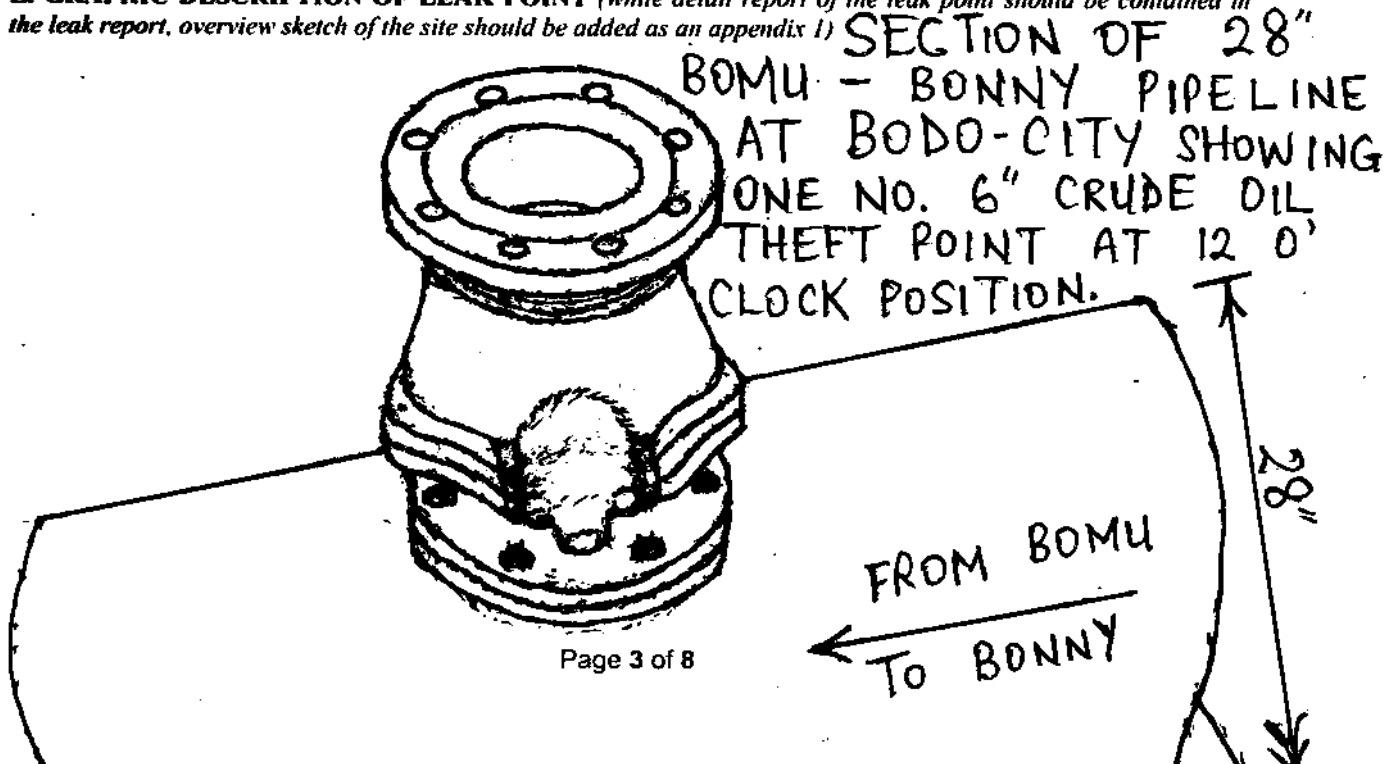
E. GRAPHIC DESCRIPTION OF LEAK POINT (while detail report of the leak point should be contained in the leak report, overview sketch of the site should be added as an appendix 1)

Additional observations around the spill point: ON ARRIVAL AT SITE, THE JOINT INVESTIGATION TEAM OBSERVED A DITCH EXCAVATED AROUND THE INCIDENT POINT BY UNKNOWN PERSON(S). ALTHOUGH THE OBSERVED INCIDENT POINT (A CRUDE OIL THEFT POINT) WAS CONFIRMED NON-LEAKING, SOME SPILL IMPACT WAS NOTICED WITHIN AND OUTSIDE THE DITCH SUSPECTED TO BE DUE TO CRUDE OIL THEFT ACTIVITIES.

MAPPING OF SPILL IMPACT WITHIN EXCAVATED DITCH AROUND INCIDENT POINT WAS DONE USING ABSORBENT MATERIALS AFTER WHICH REPAIR WAS TEMPORARILY DONE BY BLIND-FLANGING THE CRUDE OIL THEFT POINT.
