JOINT INVESTIGATION REPORT

INCIDENT NO: 1556750 JIV report S/N: Nº 0000091

1. Spill incident Number: 1556750 2. Type of incident* OIL SPILL
3. Name of Location 16" NUN-RIVER - KOLA-CREEK PIPELINE
4. Name of nearest community OPORDOMA 5. State: BAYELSA 6. LGA SOUTHERN IJAW
7. Type of Production facility/Installation OIL PIPELINE
8. Asset owner/District THE SHELL PETROLEUM DEVELOPMENT COMPANY OF NIG LTD

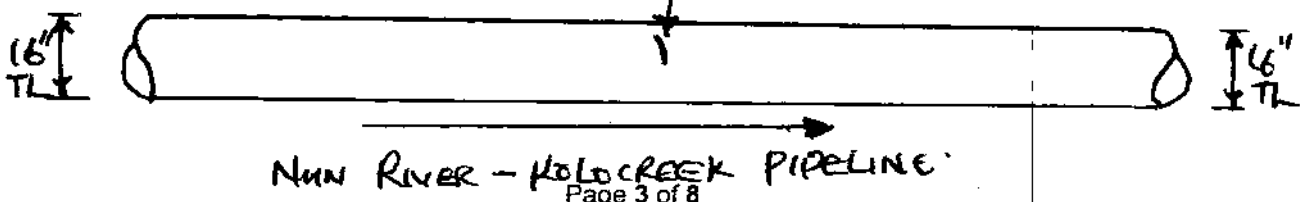
SECTION VIEW OF 16" NUN RIVER - KOLOCREEK PIPELINE AT OPOROMO
SHOWING:- HACK SAW CUT FROM 1⁰ CLOCK TO 3⁰ CLOCK.

LEAK DUE TO 150mm LENGTH OF CUT WITH
EFFECTIVE OF 50mm CUT FROM 1⁰ CLOCK TO
3⁰ CLOCK POSITION ON 16" NUN RIVER - KOLOCREEK
PIPELINE.

NON RECOVERABLE AND REPAIR WORK INITIATED AND COMPLETED
