JOINT INVESTIGATION REPORT

INCIDENT NO: 1669981 JIV report S/N: N° 0000171

1. Spill incident Number: 1669981 2. Type of incident* OIL SPILL
3. Name of Location 16" ZARAMA - GBARAN CPF BULKLINE
4. Name of nearest community OKOTIAMA 5. State: BAYELSA 6. LGA TENAGOA
7. Type of Production facility/Installation OIL BULKLINE
8. Asset owner/District SPDC / LAND 2.

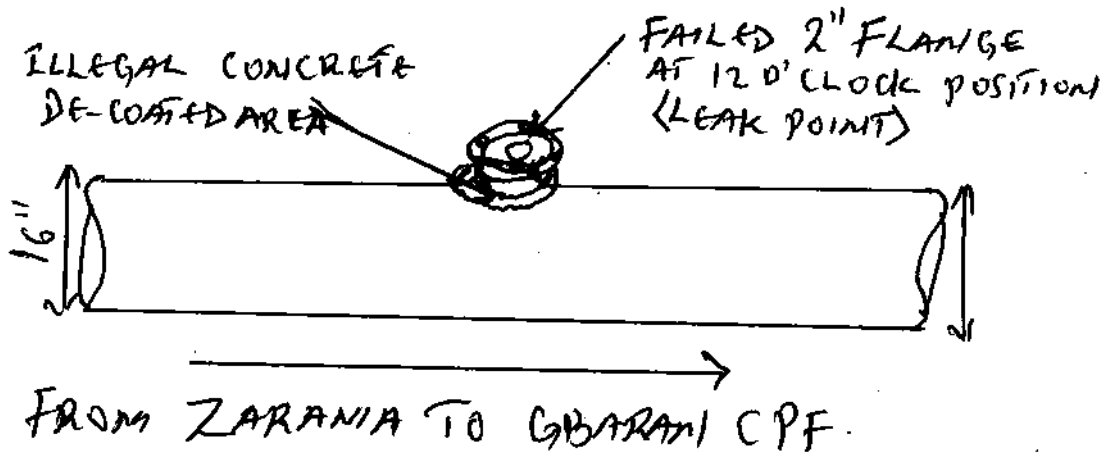
E. GRAPHIC DESCRIPTION OF LEAK POINT (while detail report of the leak point should be contained in the leak report, overview sketch of the site should be added as an appendix 1)

| <input checked="" type="checkbox"/> Failed Weld-on illegal hot tap valve | <input type="checkbox"/> Failed Clamp, | <input type="checkbox"/> Missing Pipeline/Flowline |
| <input checked="" type="checkbox"/> Crude oil theft (illegal bunkering) point, | <input type="checkbox"/> Saver-pit over flow | <input type="checkbox"/> Third party tampering with Clamp |

SECTION OF 16" ZARANIA - GBARANI CPE BULLG LINE AT OKOTIAMA SHOWING POSITION OF CRUDE OIL THEFT POINT AT 12 O'CLOCK POSITION

REPAIR WORK PLANNED.

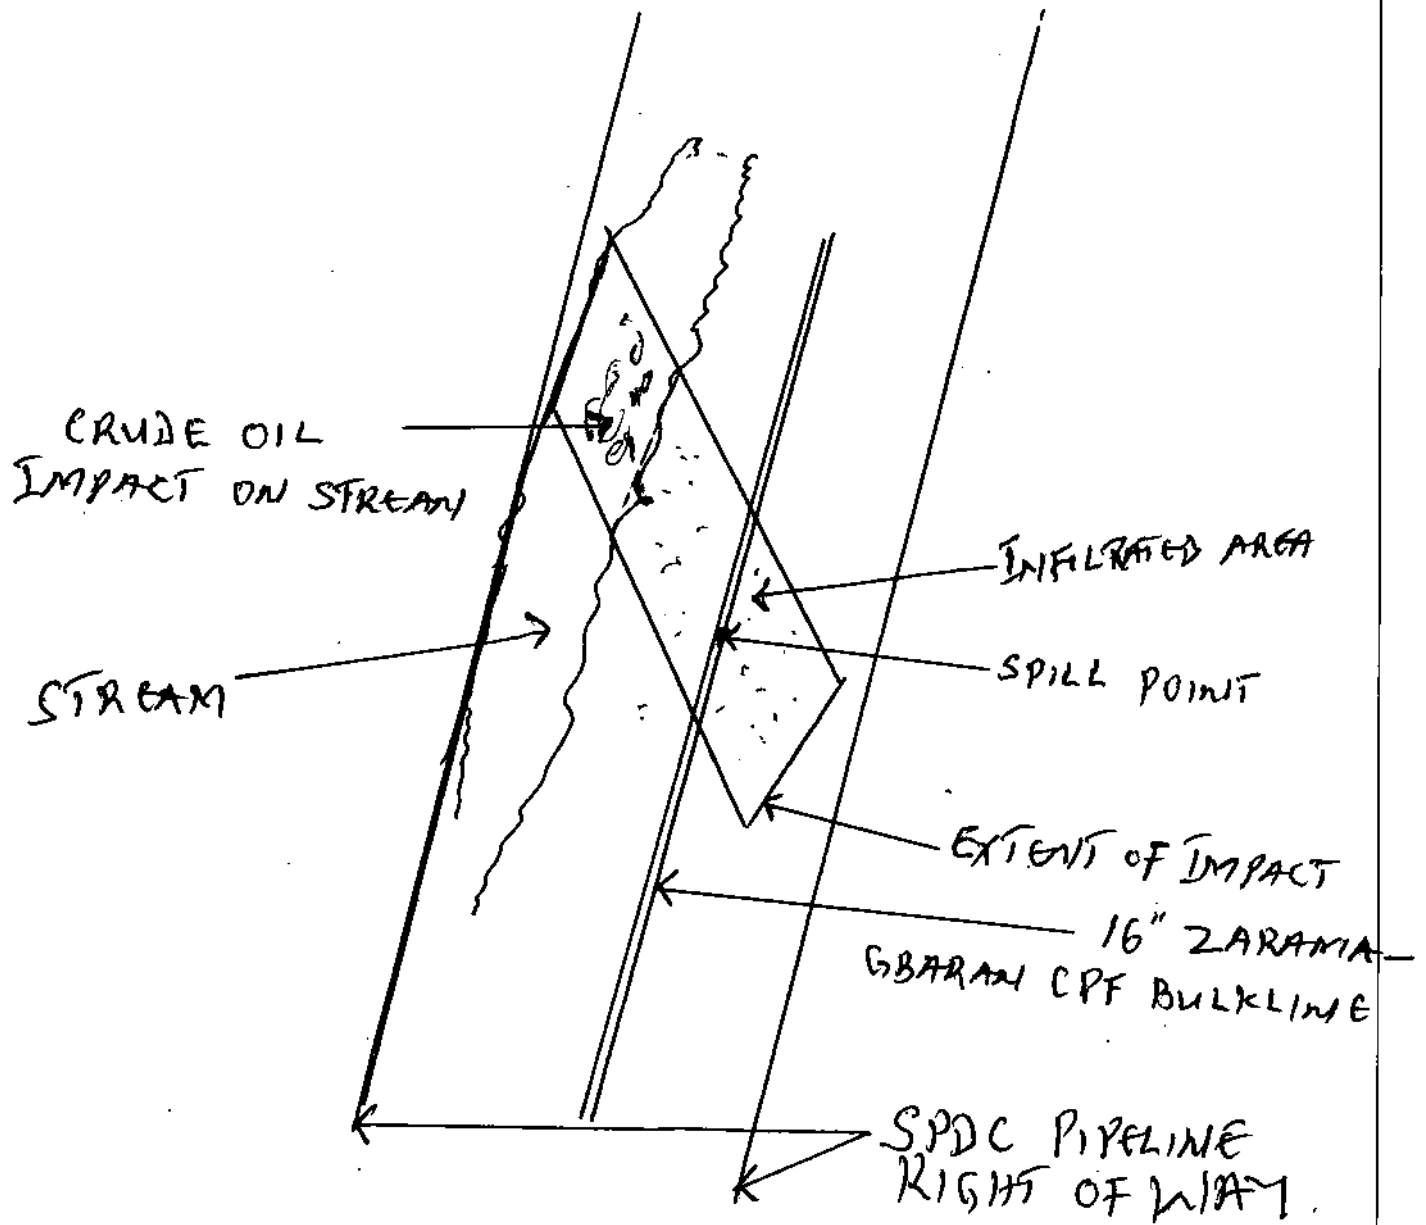
f. Appendix I: Overview sketch of the site

Location: 16" ZARAMA - GBARAN CPF BULKLINE AT OKOTIMATA
