JOINT INVESTIGATION REPORT

INCIDENT NO: 1673879 JIV report S/N: Nº 0000178

1. Spill incident Number: 1673879 2. Type of incident* OIL SPILL
3. Name of Location AHIA WELL 3 S FLOWLINE
4. Name of nearest community EGBEDA 5. State: RIVERS 6. LGA EMOHUA
7. Type of Production facility/Installation OIL FLOWLINE
8. Asset owner/District THE SHELL PETROLEUM DEVELOPMENT COMPANY OF NIGERIA LIMITED / LAND 2

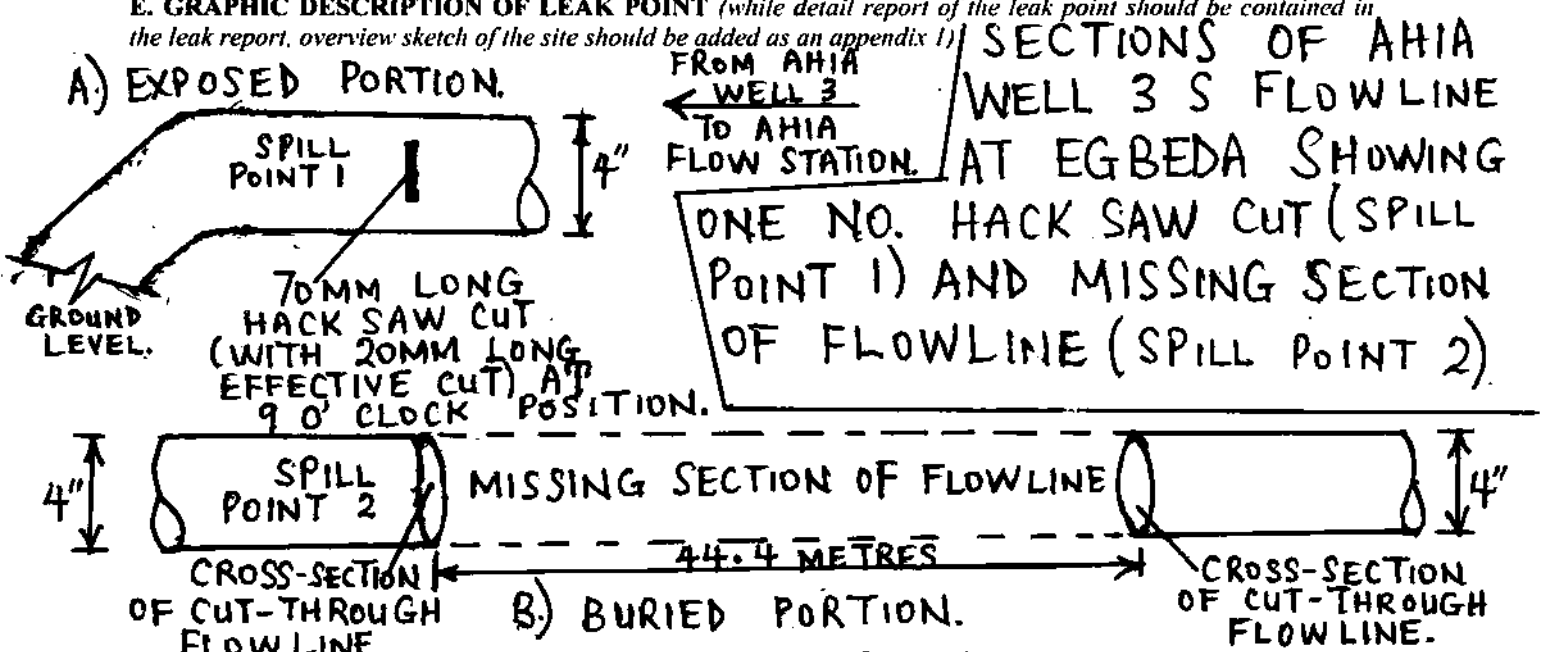
E. GRAPHIC DESCRIPTION OF LEAK POINT (while detail report of the leak point should be contained in the leak report, overview sketch of the site should be added as an appendix 1)

Additional observations around the spill point: SPILL IMPACT WAS OBSERVED FROM THE WELL 3 S FLOWLINE (ADJACENT TO THE WELL 3 L FLOWLINE) AT TWO LOCATIONS: ONE FROM A HACK SAW CUT ON THE EXPOSED FLOWLINE SECTION WITHIN THE WELL HEAD VICINITY, AND THE OTHER FROM A MISSING SECTION OF THE BURIED PORTION OF THE FLOWLINE WHICH HAD BEEN REMOVED BY UNKNOWN PERSON(S).

| <input type="checkbox"/> Drilled hole | <input checked="" type="checkbox"/> Hack saw cut | <input type="checkbox"/> Tear (_____). |
| <input type="checkbox"/> Failed Weld-on illegal hot tap valve | <input type="checkbox"/> Failed Clamp, | <input checked="" type="checkbox"/> Missing Pipeline/Flowline |

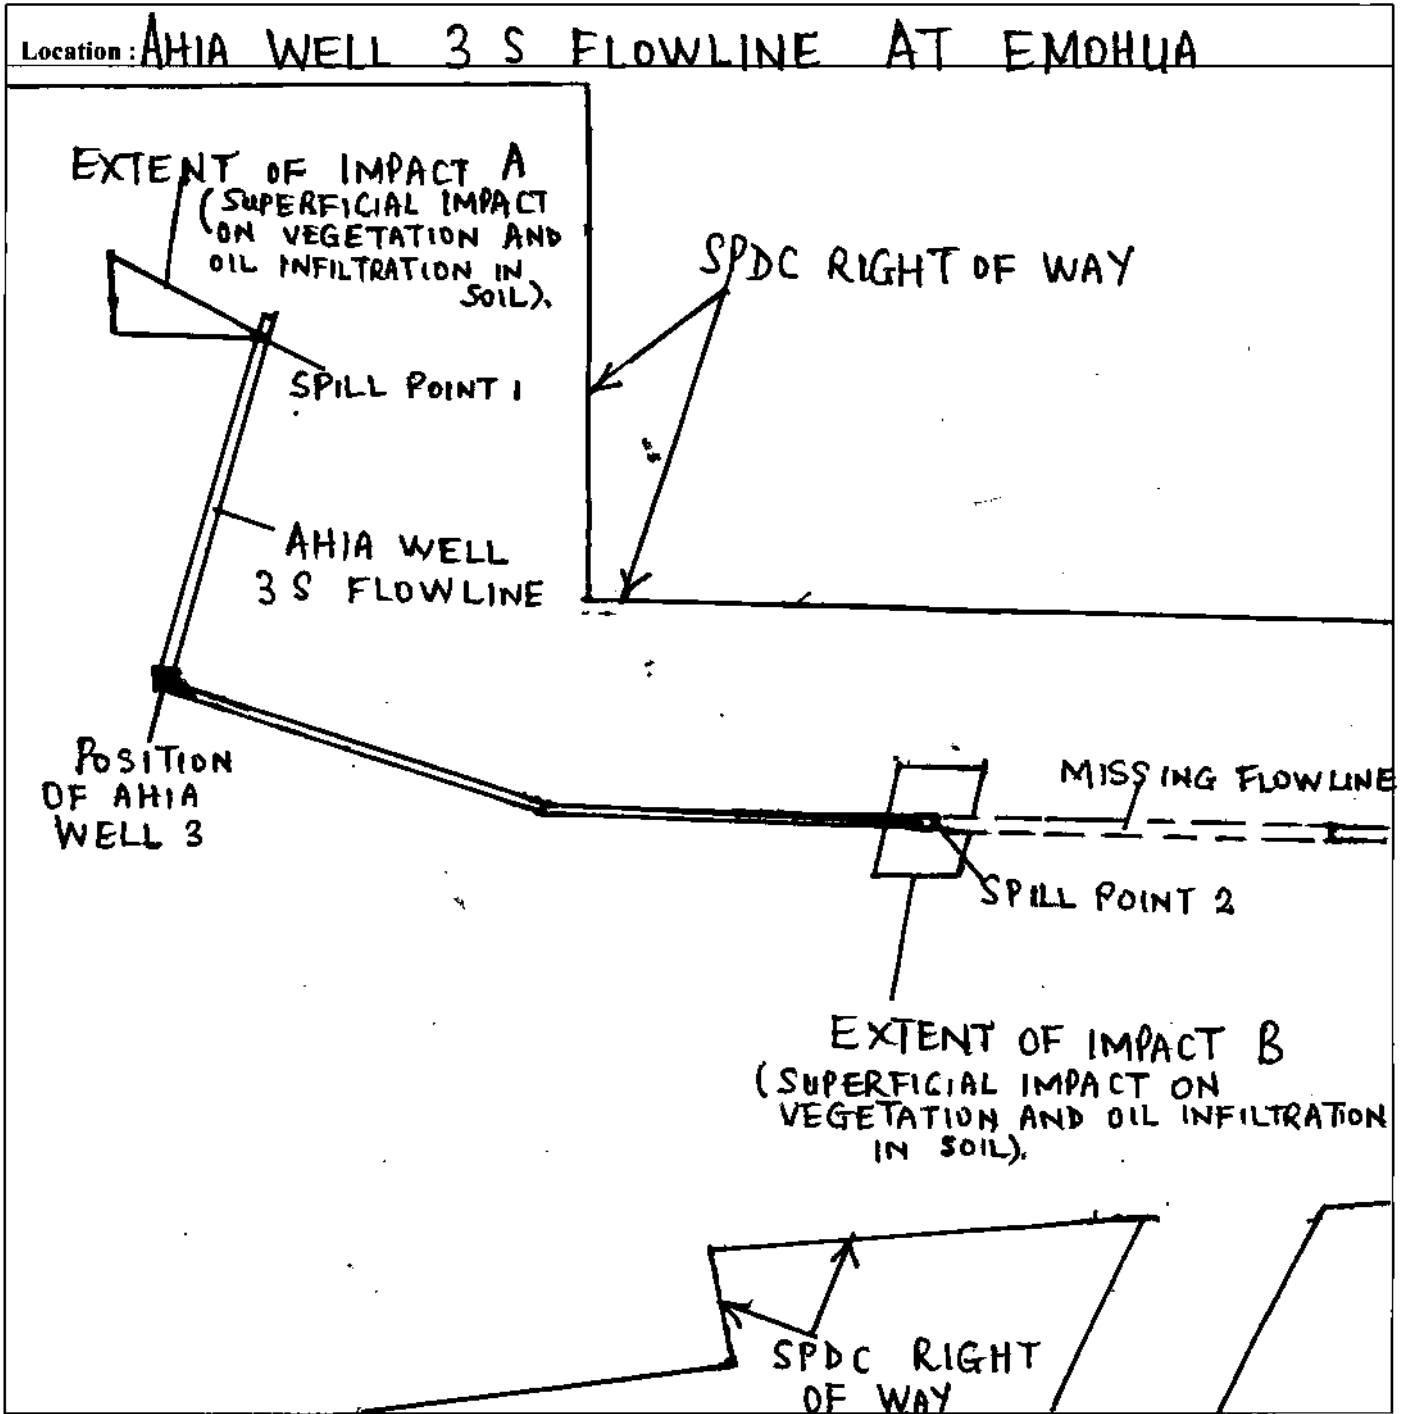
f. Appendix 1: Overview sketch of the site

- Total calculated area of impact 0.0040HA } A - 0.0015HA
B - 0.0025HA
- Impact within R.O.W YES
- Impact outside R.O.W NO
