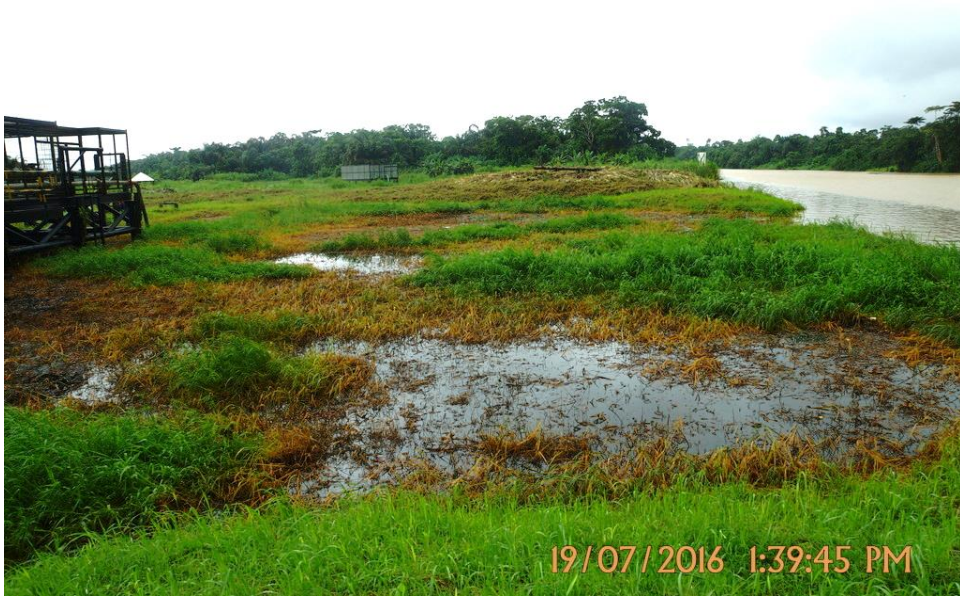
Overview: Part of spill impact on 16" Tunu-Brass Creek Pipeline Riser at Peretorugbene. Picture was taken during Joint Investigation of 19th July 2016.

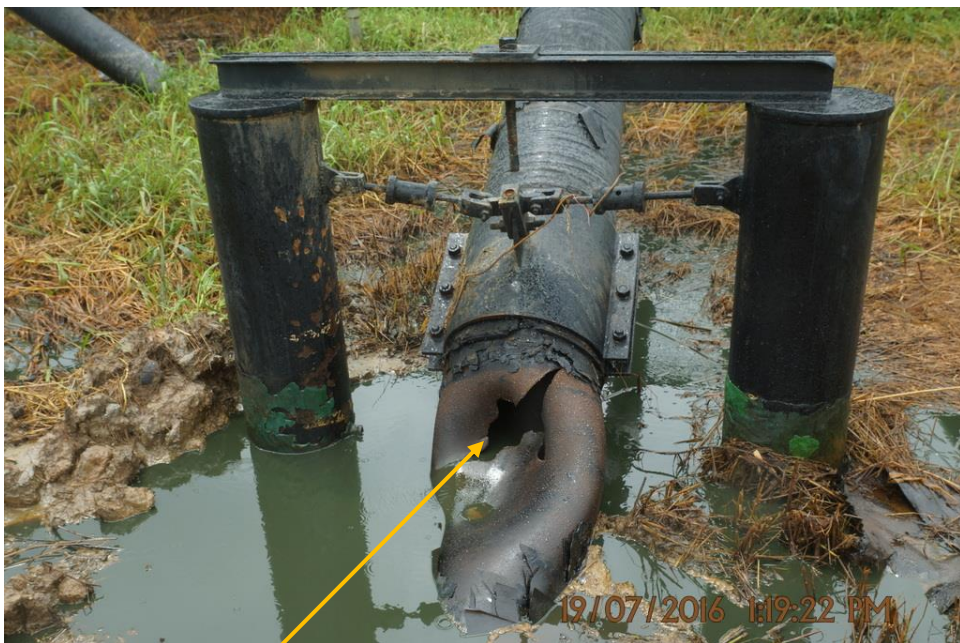
Close-up: Inward Dent/Tear on 16" Tunu-Brass Creek Pipeline Riser at Peretorugbene. Picture was taken during Joint Investigation of 19th July 2016.
