JOINT INVESTIGATION REPORT

INCIDENT NO: 1658680 JIV report S/N: Nº 0000125

1. Spill incident Number: 1658680 2. Type of incident* OIL SPILL / SUSPECTED EXPLOSION
3. Name of Location 18" ASSA - RUMUEKPE PIPELINE
4. Name of nearest community OCHIA 5. State: IMO 6. LGA OHAIJ/EGBEMA
7. Type of Production facility/Installation OIL PIPELINE
8. Asset owner/District THE SHELL PETROLEUM DEVELOPMENT COMPANY OF NIGERIA LIMITED / PIPELINE

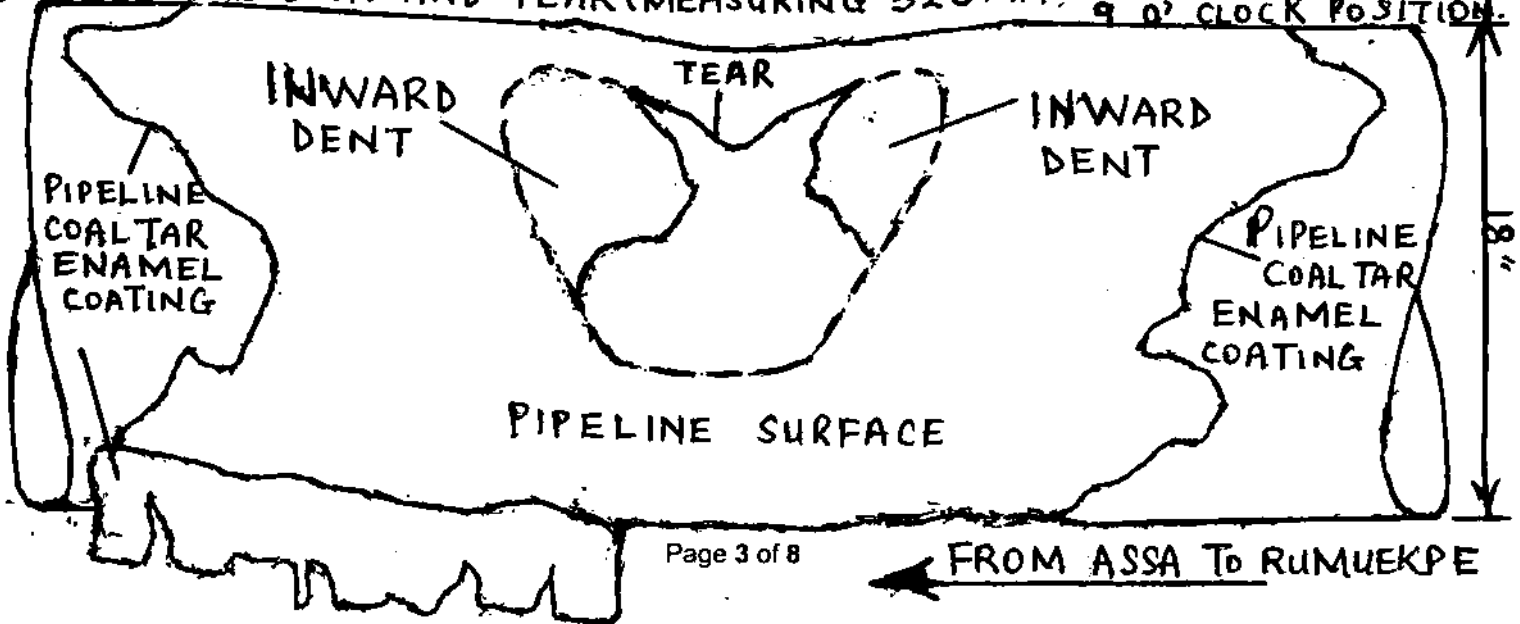
Additional observations around the spill point: ON ARRIVAL AT SITE, THE JOINT INVESTIGATION TEAM OBSERVED A DITCH SUSPECTED TO HAVE BEEN EXCAVATED AROUND THE SPILL POINT BY UNKNOWN PERSON(S). ON COMPLETE EXPOSURE, IN THE COURSE OF J.I.V, THE SPILL POINT WAS CONFIRMED TO BE A TEAR WITH SURROUNDING INWARD DENT SUSPECTED TO BE DUE TO THE USE OF EXPLOSIVE MATERIAL(S) ON THE PIPELINE BY UNKNOWN PERSON(S). A SECTION OF THE PIPELINE COAL TAR ENAMEL COATING WAS OBSERVED IMPACTED.

SECTION OF 18" ASSA - RUMUEKPE PIPELINE AT DCHIA SHOWING BOTH INWARD BENT AND TEAR (MEASURING 320MM X 240MM) FROM 2 TO 9 O' CLOCK POSITION.

i. Joint investigation of the incident site found that there is no residual impact after the initial response and JIT therefore recommend that the site be closed out <input type="checkbox"/>
ii. Investigation of the incident site showed that there is residual impact on site requiring further works <input checked="" type="checkbox"/>
