JOINT INVESTIGATION REPORT

INCIDENT NO: 1663168 JIV report S/N: Nº 0000194

1. Spill incident Number: 1663168 2. Type of incident* OIL SPILL
3. Name of Location 20" KOLOCREEK - RUMIUEKPE PIPELINE RISER
4. Name of nearest community AMINIGBOKO 5. State: RIVERS 6. LGA ATHEDA WEST
7. Type of Production facility/Installation OIL PIPELINE
8. Asset owner/District THE SHELL PETROLEUM DEVELOPMENT COMPANY OF NIGERIA LIMITED

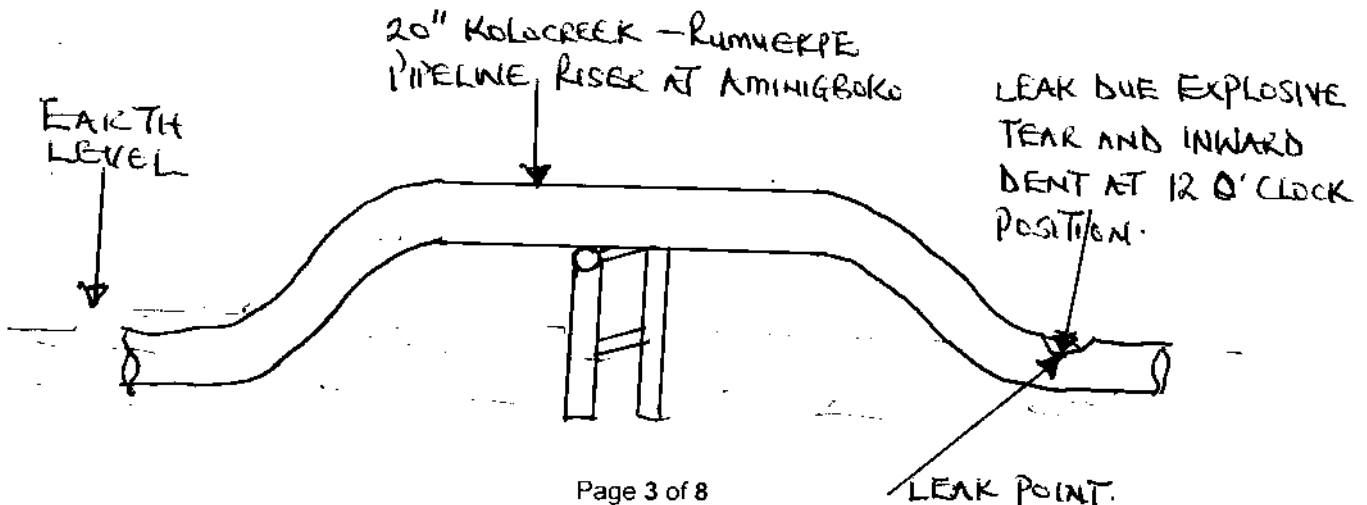
Additional observations around the spill point: THE JOINT INVESTIGATION TEAM OBSERVED AN INWARD DENT AND A TEAR DUE TO EXPLOSIVE AT 12 O'CLOCK POSITION BY UNKNOWN PERSON(S).

| <input type="checkbox"/> Drilled hole | <input type="checkbox"/> Hack saw cut | <input checked="" type="checkbox"/> Tear (<u>EXPLOSIVE TEAR</u>). |
| <input type="checkbox"/> Complete Rupture | <input checked="" type="checkbox"/> Inward dent. | <input type="checkbox"/> Well head tampering |

SECTION OF 20" KOLACREEK - RUMUKEPE PIPELINE RISER AT AMINIGBOKO SHOWING A TEAR DUE TO EXPLOSIVE AT 12 O'CLOCK POSITION BY UNKNOWN PERSON(S)

RECOVERY WORK AND REPAIR BY SECTIONAL REPLACEMENT
ONGOING
