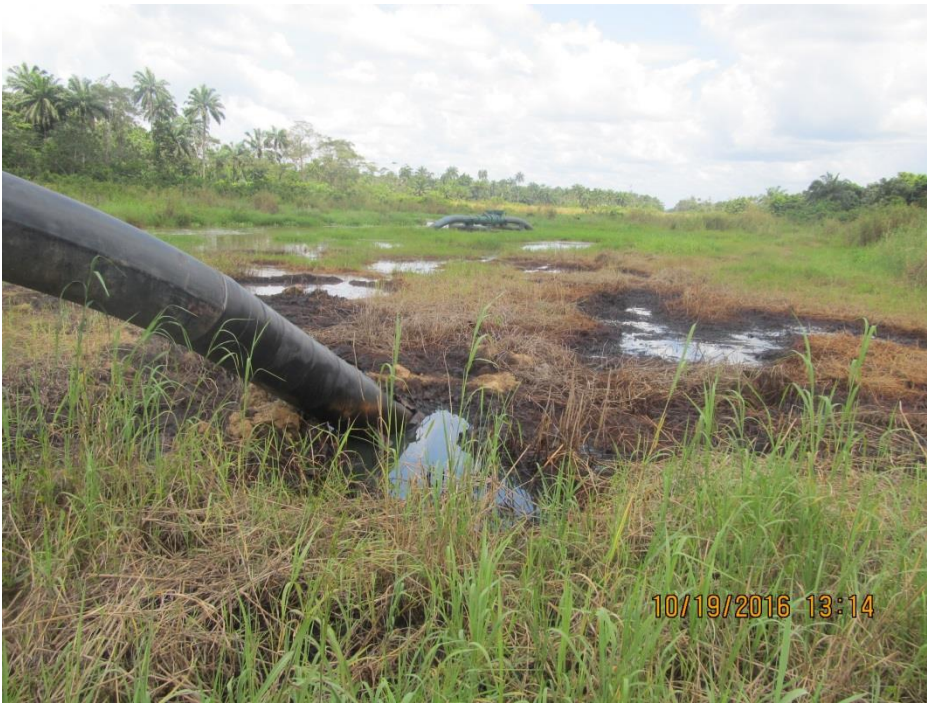
Overview: Part of spill impact on 20" Kolocreek-Rumuekpe Pipeline Riser at Aminigboko. Picture was taken during Joint Investigation of 19th October 2016.

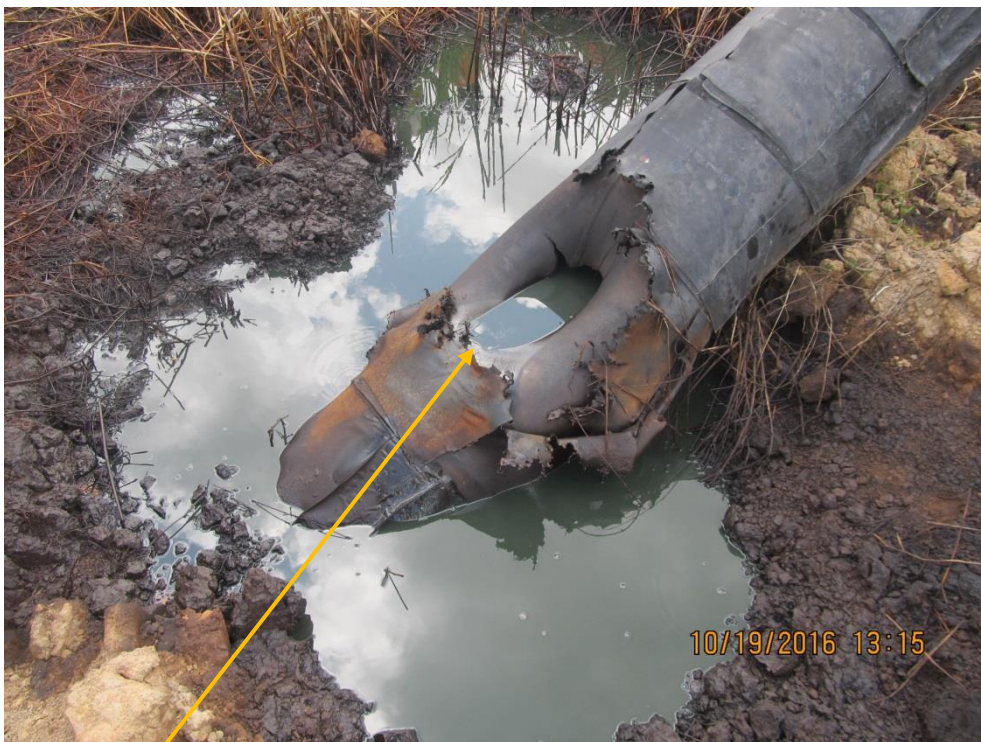
Close-up: Inward dent, explosive tear on 20" Kolocreek-Rumuekpe Pipeline Riser at Aminigboko. Picture was taken during Joint Investigation of 19th October 2016.
