# JOINT INVESTIGATION REPORT

INCIDENT NO: 1628084 JIV report S/N: Nº 0000301

1. Spill incident Number: 1628084 2. Type of incident\* OIL SPILL  
3. Name of Location 20" OTUMARA - ESCRAVOS PIPELINE  
4. Name of nearest community OGIDIGBEN 5. State: DELTA 6. LGA WARRI SOUTH-WEST  
7. Type of Production facility/Installation OIL PIPELINE  
8. Asset owner/District THE SHELL PETROLEUM DEVELOPMENT COMPANY OF

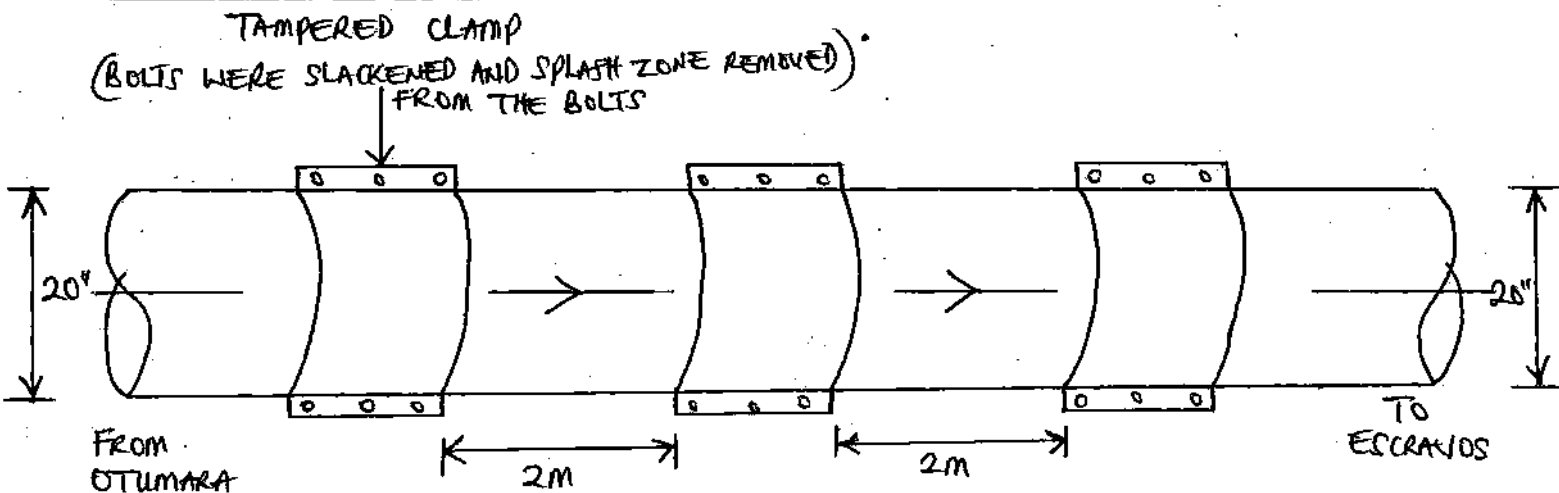
Additional observations around the spill point: ON EXCAVATION, THE JOINT INVESTIGATION TEAM OBSERVED THAT ONE OF THE CLAMPS INSTALLED ON THE 20" OTUMARA - ESCRAVOS PIPELINE HAS BEEN TAMPERED WITH, BY UNKNOWN PERSONS.

SECTION OF 20" OTUMARA - ESCRAVOS PIPELINE AT OGIDIBEN AXIS  
SHOWING POSITION OF TAMPERED CLAMP
