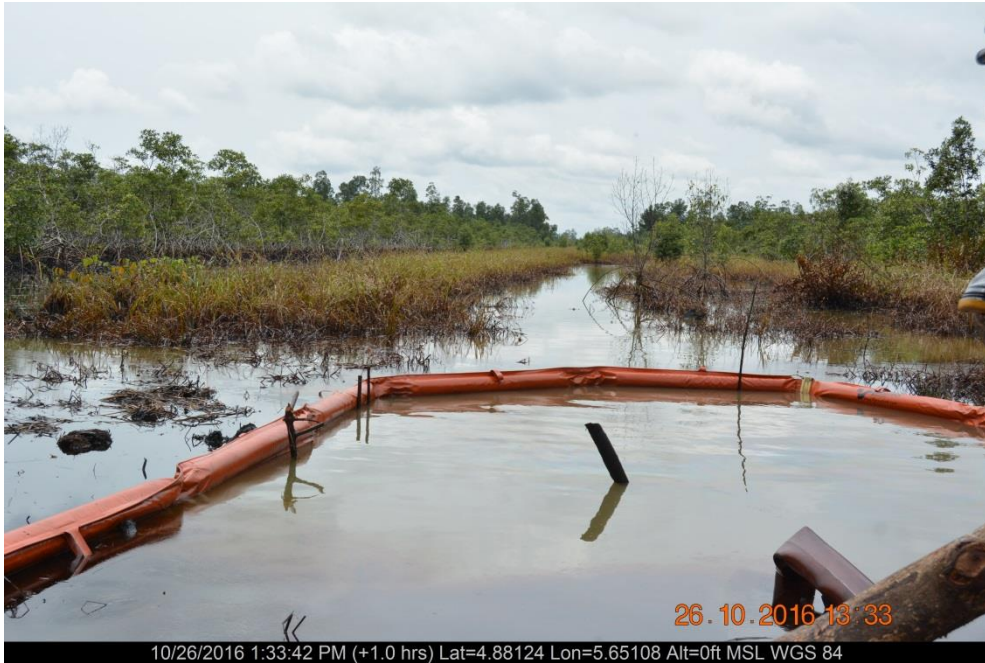
**Overview:** Part of spill impact on 6" Kanbo Wells 7S and 9T Flowlines at Agbidiama. Picture was taken during Joint Investigation of 26<sup>th</sup> October 2016.

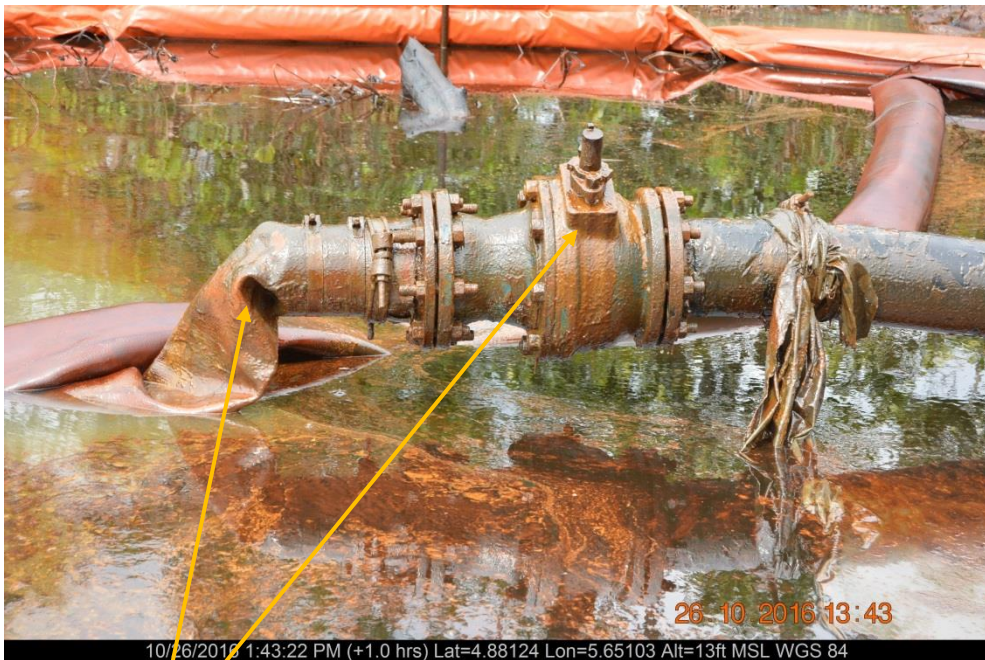
**Close-up:** Illegally attached flexible hose and 6" valve on 6" Kanbo Well 7S Flowline at Agbidiama. Picture was taken during Joint Investigation of 26<sup>th</sup> October 2016.

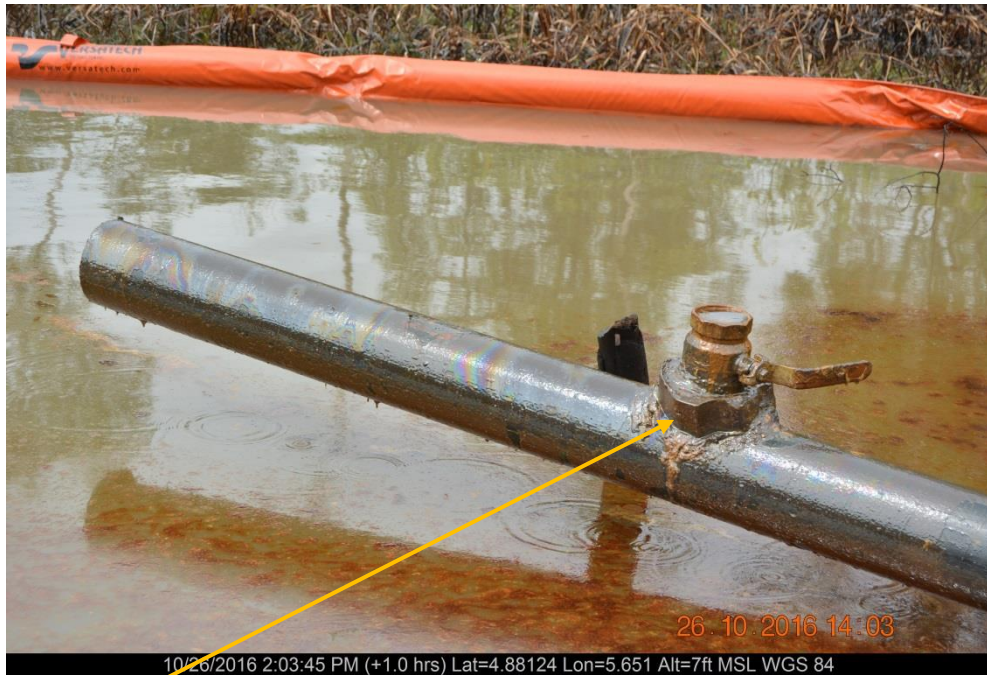
**Close-up: Illegally attached 3" valve on 6" Kanbo Well 9T Flowline at Agbidiama. Picture was taken during Joint Investigation of 26<sup>th</sup> October 2016.**
