# JOINT INVESTIGATION REPORT

INCIDENT NO: 1995090 JIV report S/N: 0905

1. Spill incident Number: 1995090 2. Type of incident\* OIL SPILL  
3. Name of Location 12" IMO RIVER - OGALE PIPELINE  
4. Name of nearest community UZUAKU 5. State: ABIA 6. LGA UKWA-WEST  
7. Type of Production facility/Installation OIL PIPELINE  
8. Asset owner/District SPDC / PIPELINE

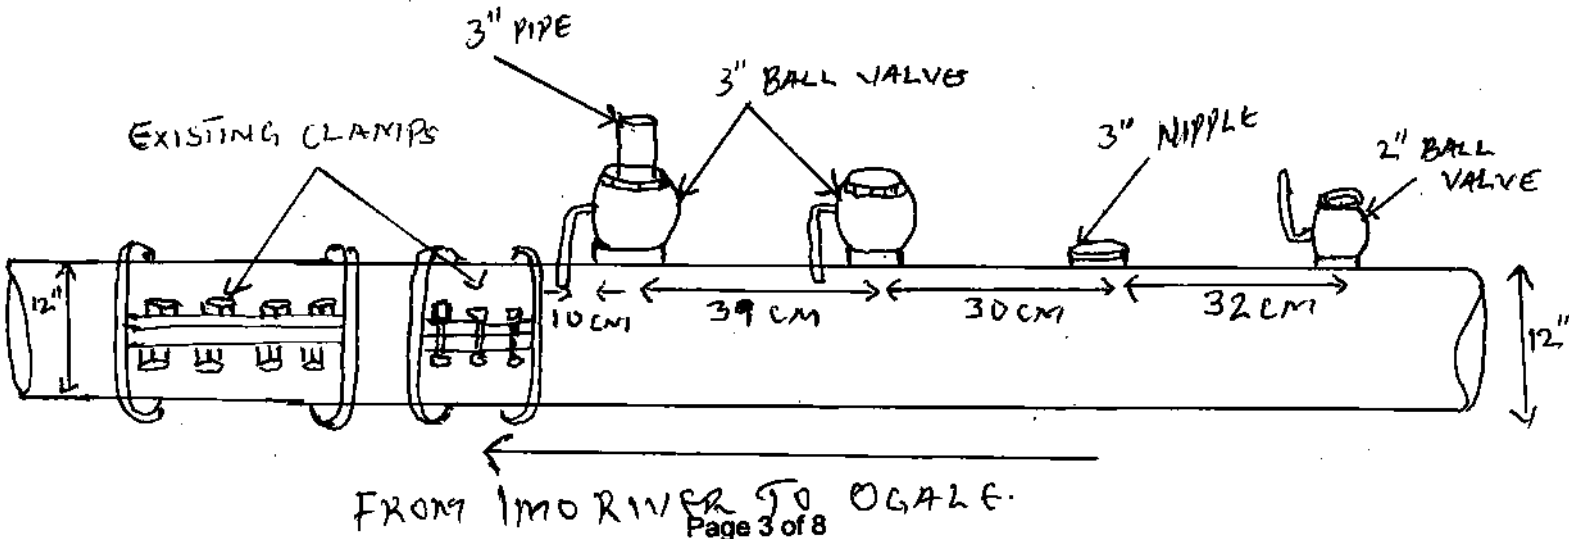
**E. GRAPHIC DESCRIPTION OF LEAK POINT** *(While detail report of the leak point should be contained in the leak report, overview sketch of the site should be added as an appendix.)*

| <input checked="" type="checkbox"/> Failed Weld-on illegal hot tap valve | <input type="checkbox"/> Failed Clamp, | <input type="checkbox"/> Missing Pipeline/Flowline |
| <input checked="" type="checkbox"/> Crude oil theft (illegal bunkering) point, | <input type="checkbox"/> Saver-pit over flow | <input type="checkbox"/> Third party tampering with Clamp |

SECTIONAL 12" IMORIVER - OGALE PIPELINE AT UZUAKU SHOWING POSITIONS OF CRUDE OIL THERM POINTS AT 12 O'CLOCK POSITION.

OIL SPILL RECOVERY AND REPAIR ACTIVITIES ARE ONGOING.

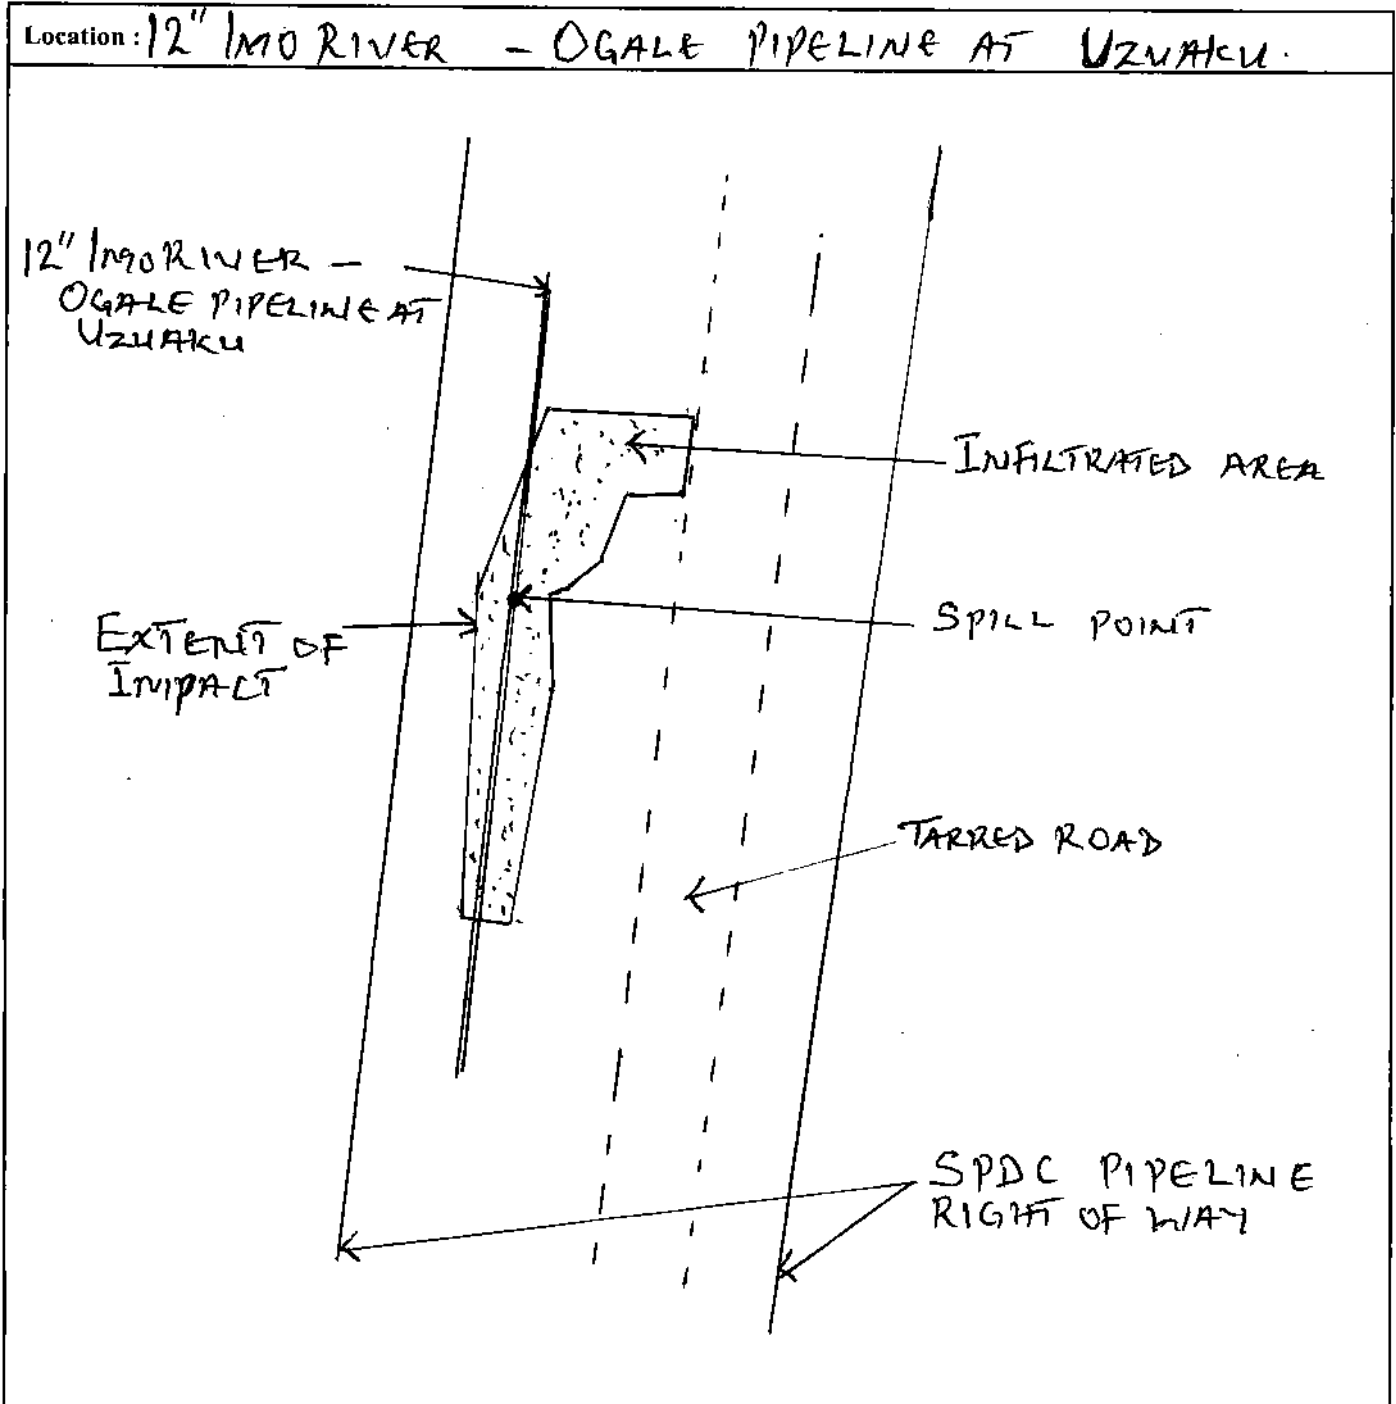
f. Appendix 1: Overview sketch of the site

THE SPILL POINT WAS OBSERVED WITHIN THE VICINITY OF A TARRED ROAD. SAND BAGS WERE ALSO OBSERVED.
