JOINT INVESTIGATION REPORT

INCIDENT NO: 1806684 JIV report S/N: N^o 0000236

1. Spill incident Number: 1806684 2. Type of incident* Oil Spill
3. Name of Location 8" MININTIA - RUMUEKPE BULKLINE
IMHABA/IMDQU/
4. Name of nearest community ELELEALIMINI 5. State: RIVERS 6. LGA EMDHUA
7. Type of Production facility/Installation FLOWLINE
8. Asset owner/District THE SHELL PETROLEUM DEVELOPMENT COMPANY OF NIGERIA LTD (SPDC)

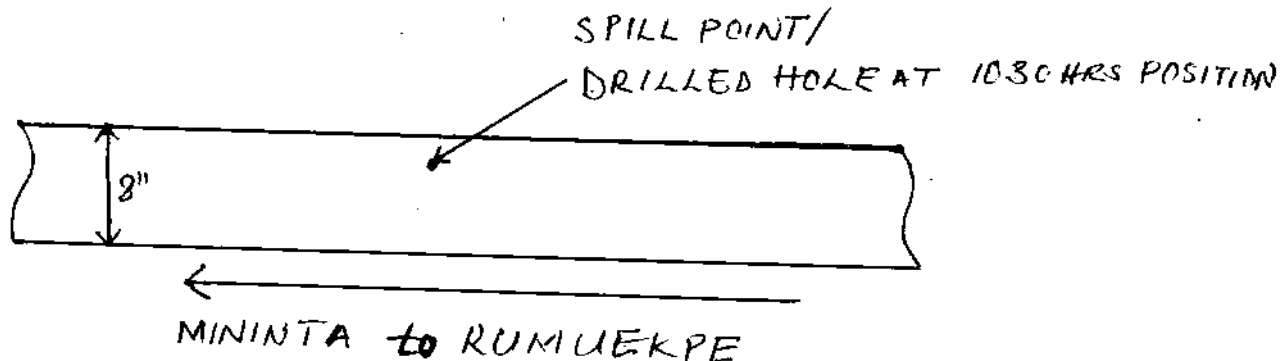
Additional observations around the spill point: THE JOINT INVESTIGATION TEAM SAW A DRILLED HOLE AT 1030 O'CLOCK POSITION.

E. GRAPHIC DESCRIPTION OF LEAK POINT (while detail report of the leak point should be contained in the leak report, overview sketch of the site should be added as an appendix 1) A SECTION OF 8" MININTA - RUMUEKPE BULKLINE AT ELELE ALIMINI/IHUABA/IMOGU SHOWING A DRILLED HOLE AT 1030 POSITION BY UNKNOWN PERSONS.

SECTIONAL REPLACEMENT
