JOINT INVESTIGATION REPORT

INCIDENT NO: 1786885 JIV report S/N: Nº 0000245

1. Spill incident Number: 1786885 2. Type of incident* OIL SPILL
3. Name of Location 4" OBELE - IBAA (DELIVERY LINE) PIPELINE
4. Name of nearest community IBAA 5. State: RIVERS 6. LGA EMOTUA
7. Type of Production facility/Installation OIL PIPELINE
8. Asset owner/District THE SHELL PETROLEUM DEVELOPMENT COMPANY OF NIGERIA LIMITED

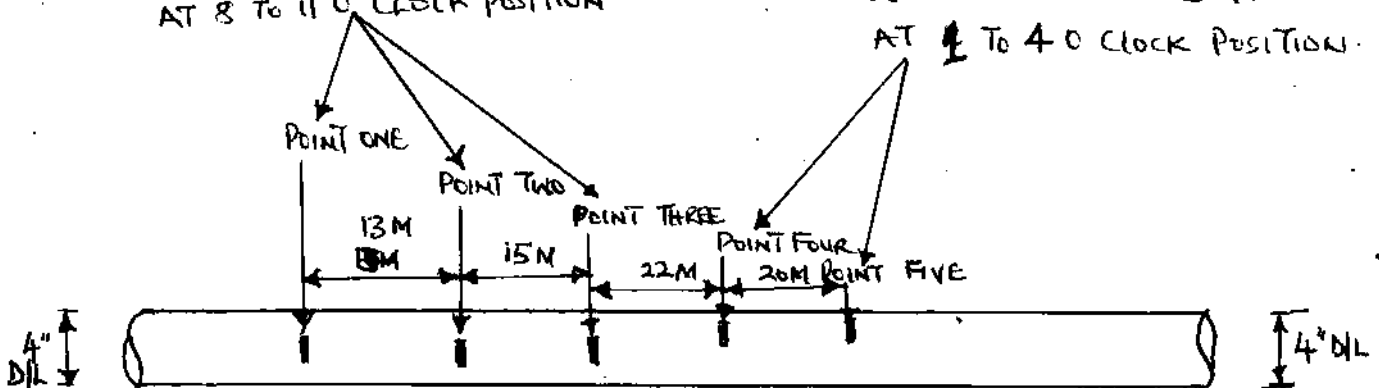
SECTIONAL VIEW OF 4" OBELE - 18AA (DELIVERY LINE) PIPELINE AT 18AA

SHOWING MULTIPLE HACK-SAW CUT ON THE DELIVERY LINE

60mm LENGTH OF CUTS
AT 8 TO 11 O'CLOCK POSITION.

60mm LENGTH OF CUTS
AT 1 TO 4 O'CLOCK POSITION.

REPAIR WORK ONGOING.
