Overview: Part of spill impact on 12" Imo River - Ogale Pipeline Right of Way at Komkom. Picture was taken during Joint Investigation of 12th July 2017.

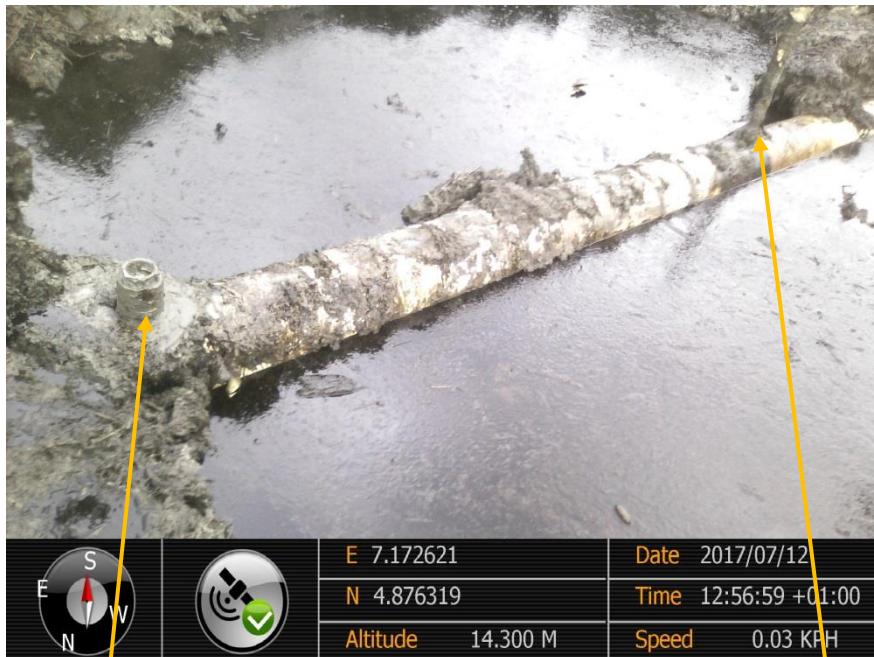
Close-up: Leaking illegal fitting on 12" Imo River-Ogale Pipeline at Komkom. Non-leaking fitting subject to another Joint Investigation Visit.
