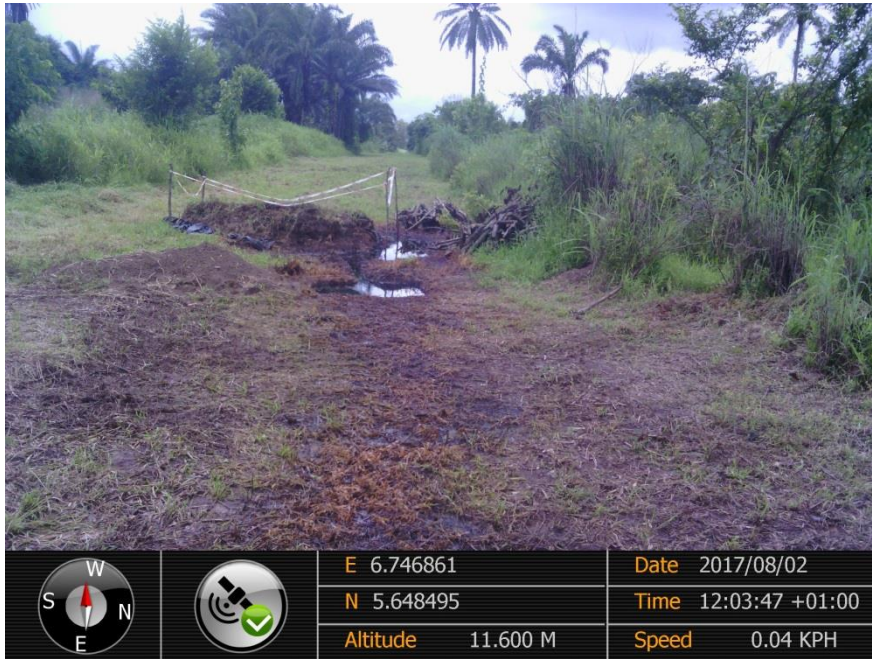
Overview: Part of spill impact on 12" Oguta-Egbema Pipeline Right of Way at Oguta. Picture was taken during Joint Investigation of 2nd August 2017.

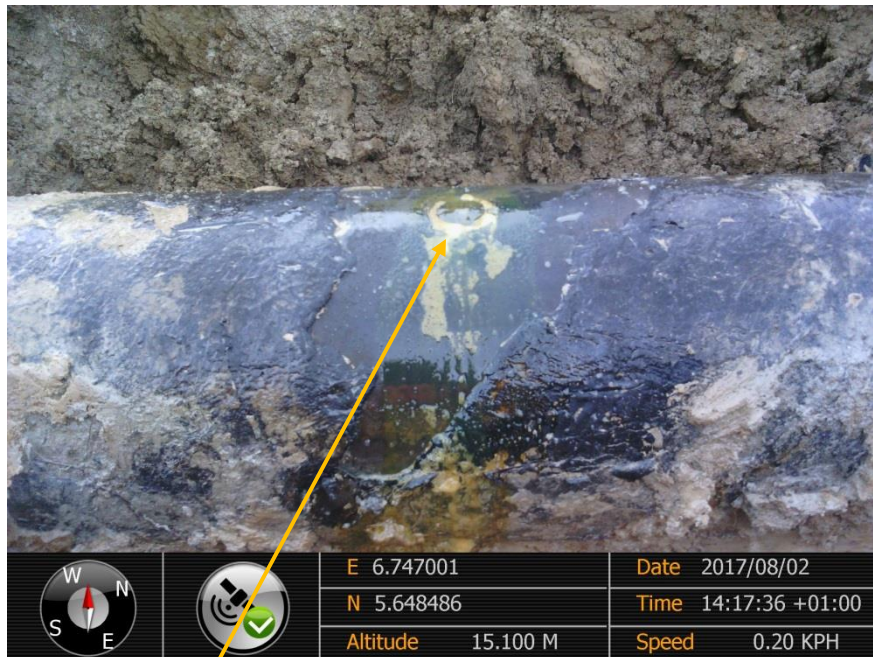
Close-up: Attempted Drilled Hole on 12" Oguta-Egbema Pipeline at Oguta. Picture was taken during Joint Investigation of 2nd August 2017.
