JOINT INVESTIGATION REPORT

INCIDENT NO: 1970513 JIV report S/N: 0948

1. Spill incident Number: 1970513 2. Type of incident* OIL SPILL
3. Name of Location: 8" SAGHARA TIE-IN AT SAGHARA MANIFOLD
4. Name of nearest community UGBODEGUNGUN State: DELTA 6. LGA WARRI SOUTH-WEST
7. Type of Production facility/Installation MANIFOLD
8. Asset owner/District THE SHELL PETROLEUM DEVELOPMENT COMPANY
B. INCIDENT INFORMATION: OF NIGERIA LIMITED / PIPELINE

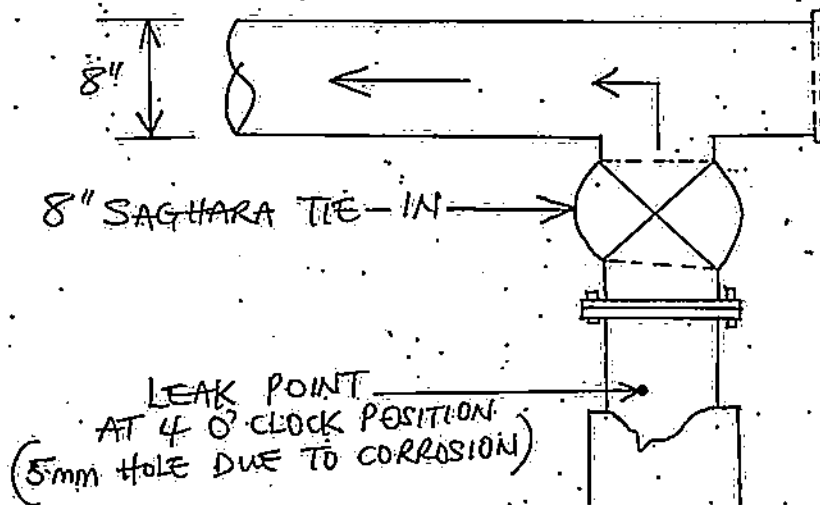
Additional observations around the spill point: DURING ASSESSMENT OF THE LEAK POINT, THE JOINT INVESTIGATION TEAM OBSERVED A 5MM HOLE (DUE TO CORROSION) AT 4 O' CLOCK POSITION ON THE 8" SAGHARA TIE-IN AT SAGHARA MANIFOLD.

| <input checked="" type="checkbox"/> Corrosion (<u>5MM HOLE</u>) | <input type="checkbox"/> Others(specify) _____ | |

E. GRAPHIC DESCRIPTION OF LEAK POINT (While detail report of the leak point should be contained in the leak report, overview sketch of the site should be added as an appendix I)
SECTION OF 8" SAGHARA TIE-IN AT SAGHARA MANIFOLD IN UGBOEGUNGUN SHOWING POSITION OF 5mm HOLE (DUE TO CORROSION) AT 4 O' CLOCK
