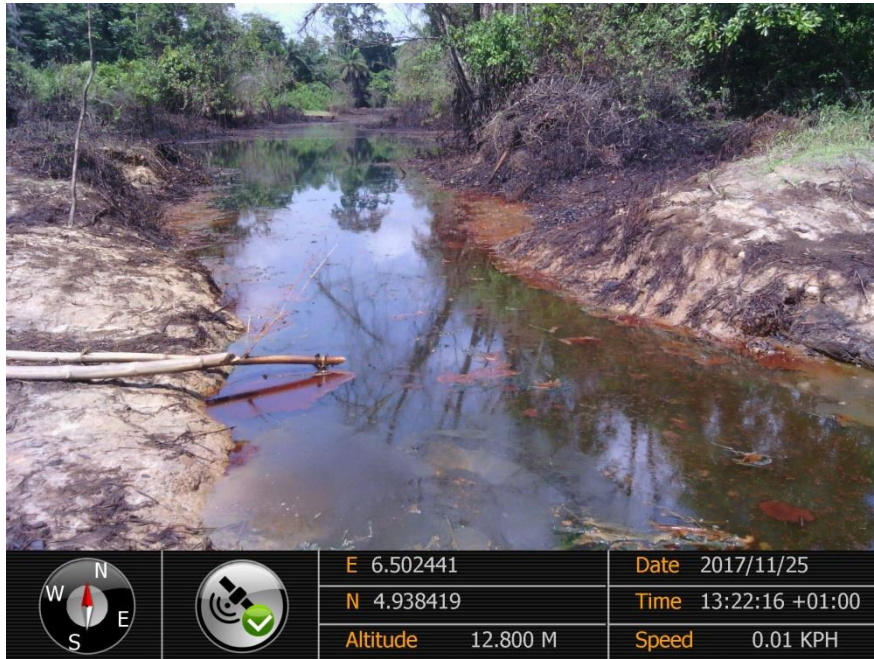
Overview: Part of spill impact on 20" Kolocreek-Rumuekpe Pipeline Right of Way at Odau_Ozochi Picture was taken during Joint Investigation of 25th November 2017.

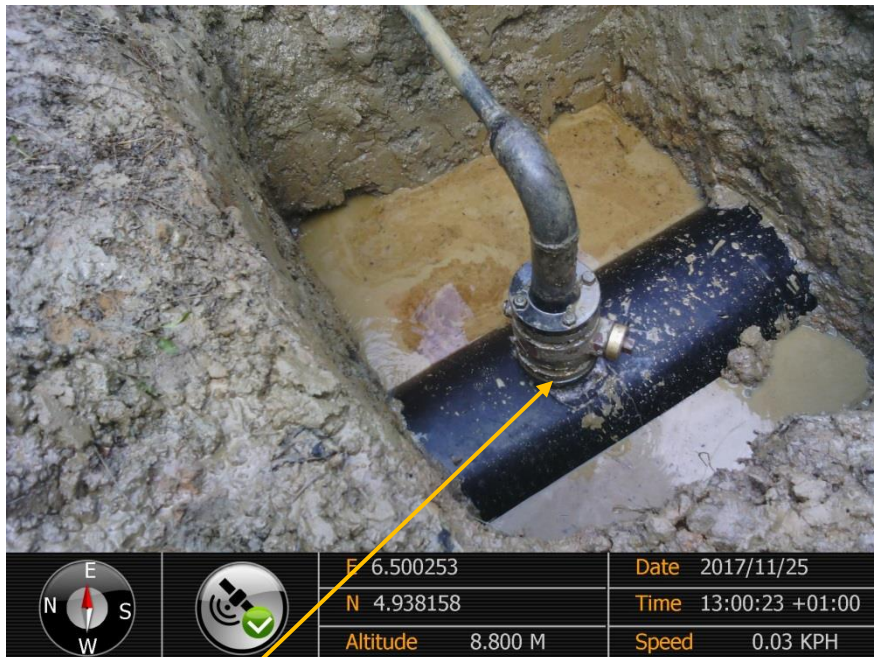
Close-up: Illegal fitting on 20" Kolocreek-Rumuekpe Pipeline at Odau_Ozochi. Picture was taken during Joint Investigation of 25th November 2017.
