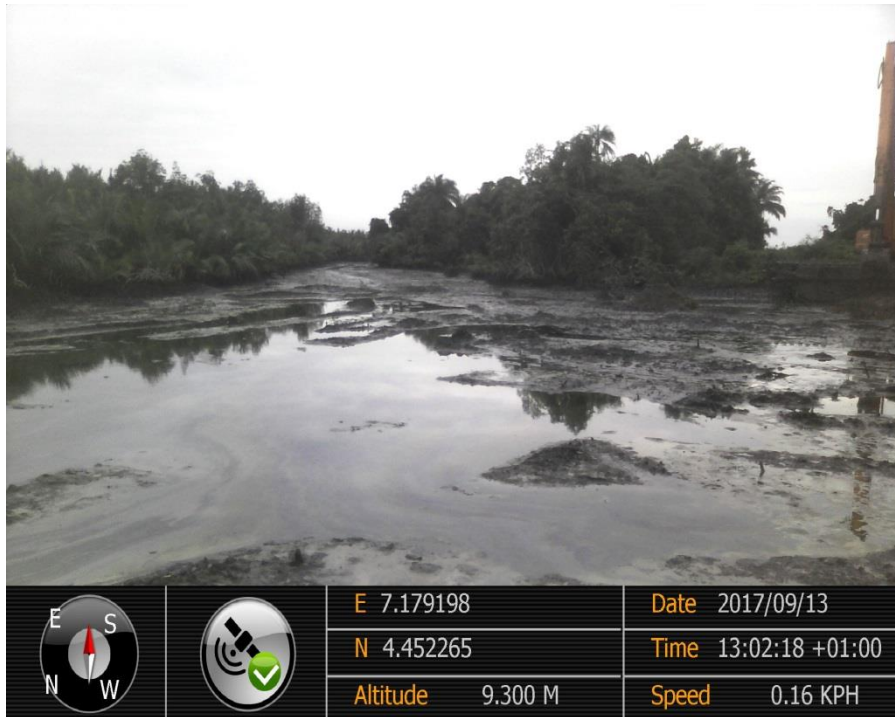
Overview: Part of spill impact on 28" Bomu-Bonny Pipeline Right of Way at Ogbonga Forest Oloma. Picture was taken during Joint Investigation of 13th September 2017.

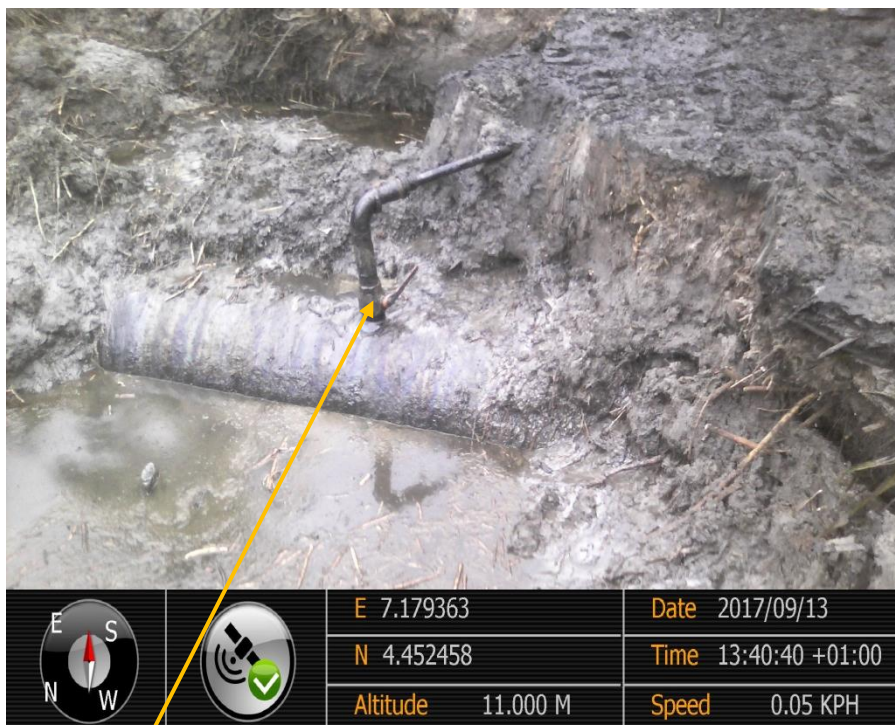
Close-up: Non leaking illegal fitting on 28" Bomu-Bonny Pipeline at Ogbonga Forest Oloma. Picture was taken during Joint Investigation of 13th September 2017.

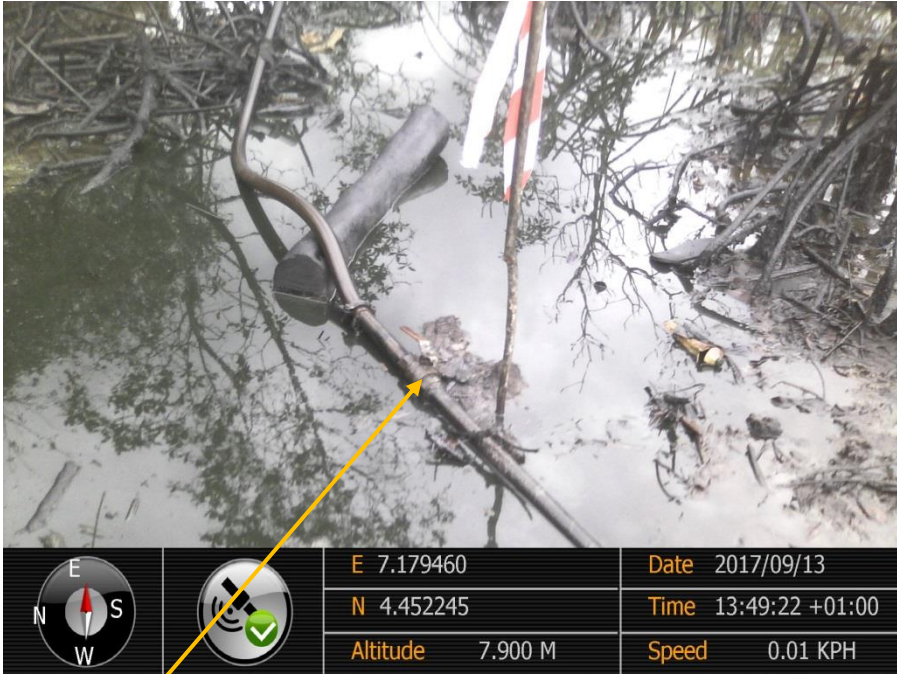
Close-up: Illegal pipe and failed 2" ball valve hose connection on 28" Bomu-Bonny Trans Niger Pipeline at Ogbonga Forest Oloma. Picture was taken during Joint Investigation of 13th September 2017.

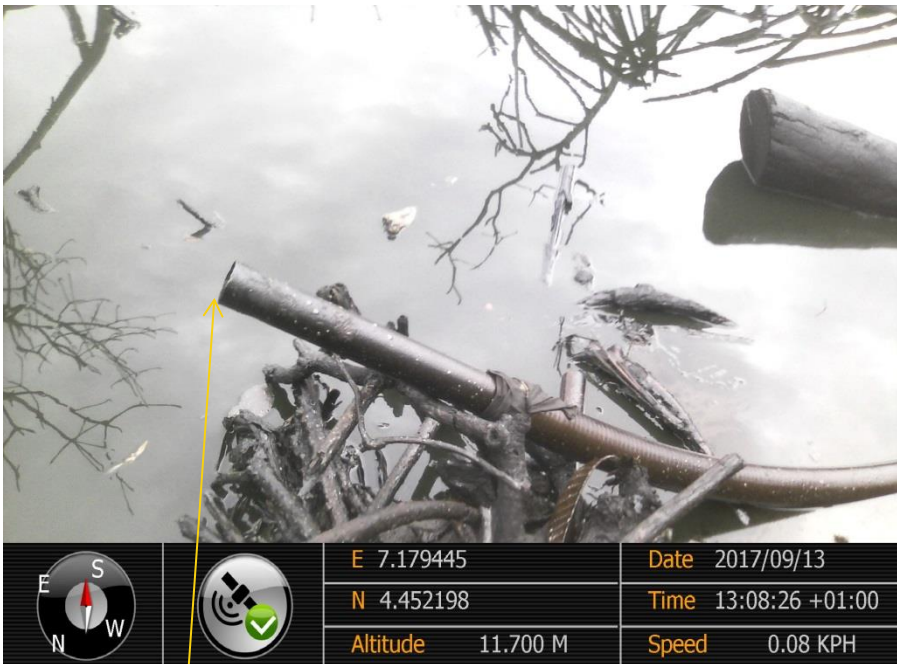
Close-up: Leak point on 28" Bomu-Bonny Pipeline at Ogbonga Forest Oloma. Picture was taken during Joint Investigation of 13th September 2017.
