JOINT INVESTIGATION REPORT

INCIDENT NO: 1932501 JIV report S/N: 0925

1. Spill incident Number: 1932501 2. Type of incident* OIL SPILL
3. Name of Location SOKU WELL 22 WELL HEAD
4. Name of nearest community SOKU 5. State: RIVERS 6. LGA AKUKU-TORU
7. Type of Production facility/Installation WELL HEAD
8. Asset owner/District SPDC / SWAMP EAST

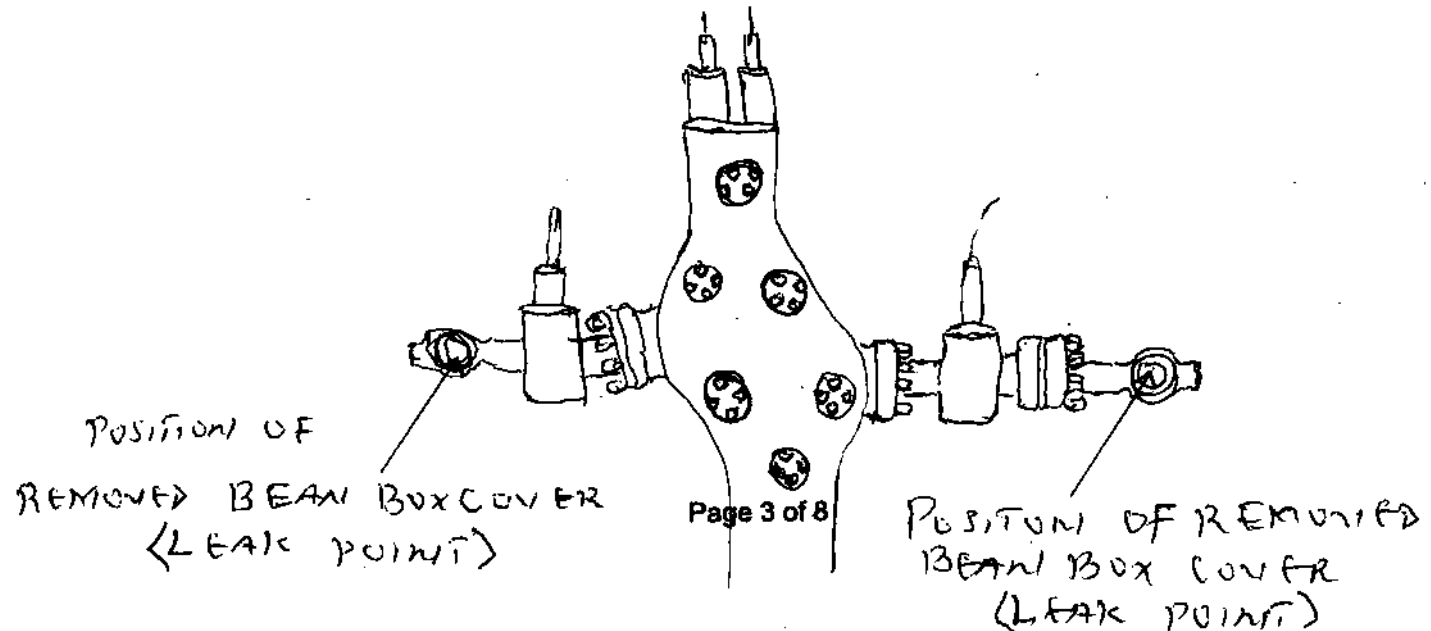
ON ARRIVAL AT SITE, THE JOINT INVESTIGATION TEAM OBSERVED OIL STAINS ON THE SOKU WELL 22 CHRISTMAS TREE. ALSO BEAM BOX COVERS WERE OBSERVED REMOVED BY UNKNOWN PERSON(S)

SECTION OF SOKU WELL 22 WELL HEAD AT SOKU SHOWING POSITION OF BEAM BOX COVERS (LEAK POINTS)

ONE BEANI BOX COVER WAS REPLACED
