JOINT INVESTIGATION REPORT

INCIDENT NO: 2142070 JIV report S/N: 0021

- 1. Spill incident Number: 2142070 2. Type of incident*: OIL SPILL
- 3. Name of Location: 12th IMO RIVER - OGARE PIPELINE
- 4. Name of nearest community: OGARE 5. State: RIVERS 6. LGA: FLEME
- 7. Type of Production facility/Installation: OIL PIPELINE
- 8. Asset owner/District: THE SHELL PETROLEUM DEVELOPMENT COMPANY OF NIGERIA LIMITED (SPDC) / PIPELINE

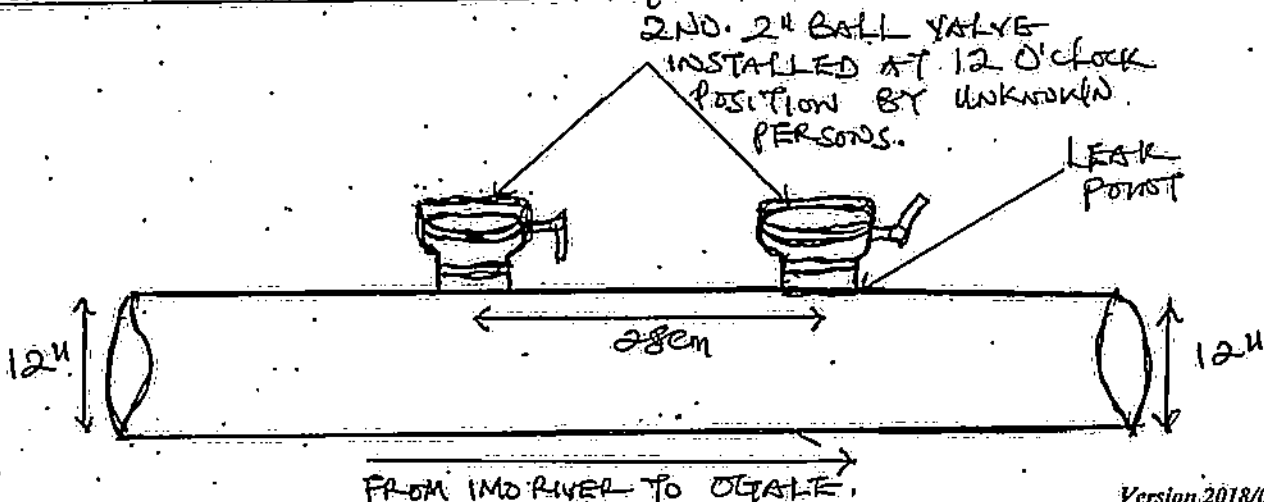
E. GRAPHIC DESCRIPTION OF LEAK POINT (while detailed report of the leak point should be contained in the leak report, overview sketch of the site should be added as an appendix 1)

Additional observations around the spill point: SAND BAGS CONCREALING CRUDE OIL TIGHT POINT WERE OBSERVED.

| <input checked="" type="checkbox"/> Crude oil theft (illegal bunkering) point | <input type="checkbox"/> Saver-pit over flow | <input type="checkbox"/> Third party tampering with Clamp |

SECTION OF 12" IMD RIVER - OGAGE PIPELINE AT OGAGE SHOWING POSITIONS OF CRABS ON THREE POINTS.
