JOINT INVESTIGATION REPORT

INCIDENT NO: 2139644 JIV report S/N: 0035

1. Spill incident Number: 2139644 2. Type of incident* OIL SPILL
3. Name of Location 12" IMO RIVER - OGALE PIPELINE
(OWAZA)
4. Name of nearest community UMUOLOLO 5. State: ABIA 6. LGA UKWA WEST
7. Type of Production facility/Installation OIL PIPELINE
8. Asset owner/District THE SHELL PETROLEUM DEVELOPMENT COMPANY OF NIGERIA
LTD (SPDC) / PIPELINE

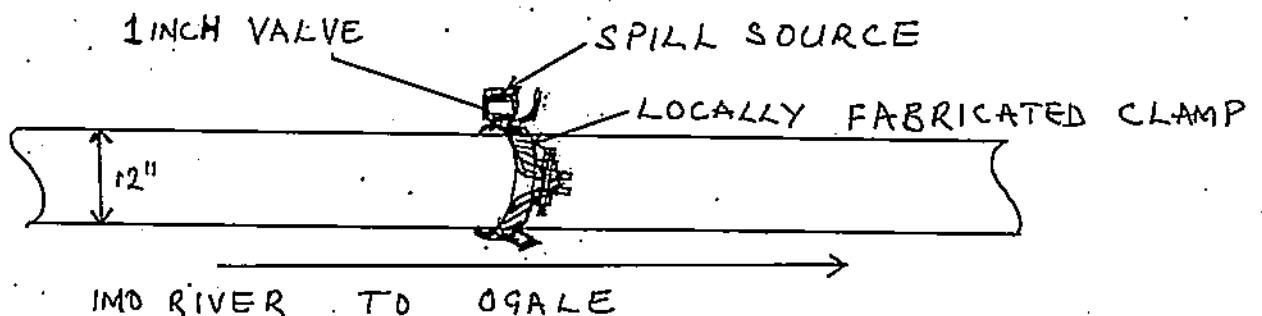
E. GRAPHIC DESCRIPTION OF LEAK POINT (while detailed report of the leak point should be contained in the leak report, overview sketch of the site should be added as an appendix 1)

Additional observations around the spill point: THE TEAM SAW A ONE INCH (1inch) VALVE INSTALLED AT 12 O'CLOCK POSITION BY UNKNOWN PERSONS.

| <input checked="" type="checkbox"/> Crude oil theft (illegal bunkering) point | <input type="checkbox"/> Saver-pit over flow | <input type="checkbox"/> Third party tampering with Clamp |

A SECTION OF 12" IMD RIVER - OGALE PIPELINE SHOWING 1" VALVE CRUDE THEFT POINT INSTALLED AT 12 O'CLOCK POSITION BY UNKNOWN PERSON AT UMUDLOLO

LEAK REPAIR
