JOINT INVESTIGATION REPORT

INCIDENT NO: 2005045 JIV report S/N: 0990

1. Spill incident Number: 2005045 2. Type of incident* OK SPILL
3. Name of Location 4" GBARAN WELL 12T FLOWLINE
4. Name of nearest community ONOPA 5. State: BAYELSA 6. LGA YENAGOA
7. Type of Production facility/Installation FLOWLINE
8. Asset owner/District THE SHELL PETROLEUM DEVELOPMENT COMPANY OF NIGERIA LTD (SPDC)/CENTRAL HUB

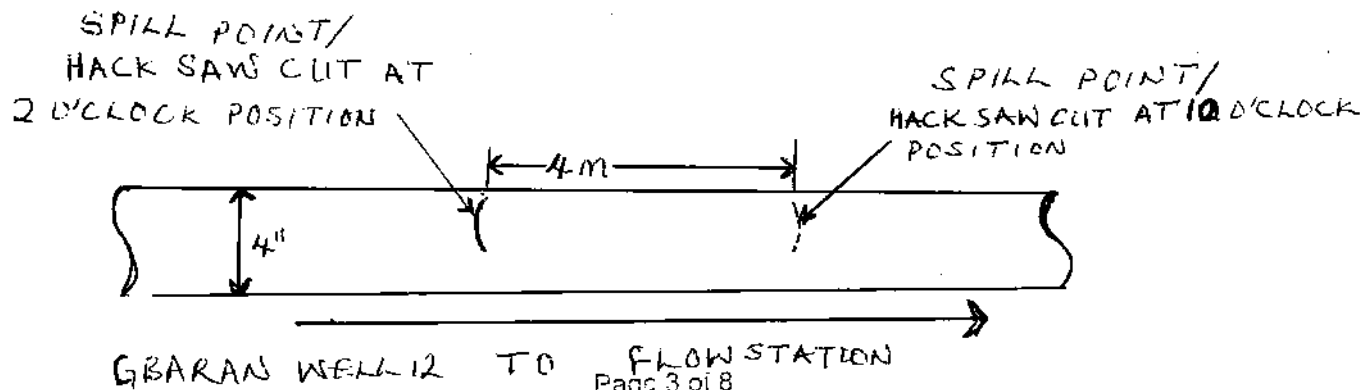
Additional observations around the spill point: THE JOINT INVESTIGATION TEAM SAW HACK SAW CUTS AT 10'O'CLOCK POSITION AND AT 2 O'CLOCK POSITION

E. GRAPHIC DESCRIPTION OF LEAK POINT (While detail report of the leak point should be contained in the leak report, overview sketch of the site should be added as an appendix I) A SECTION OF 4" GBARAN WELL 12T FLOWLINE AT ONOPA SHOWING 2 NOS HACK SAW CUTS, 4 METERS APART AT 2 O'CLOCK AND 10 O'CLOCK POSITIONS RESPECTIVELY, DONE BY UNKNOWN PERSONS
