JOINT INVESTIGATION REPORT

INCIDENT NO: 2121145 JIV report S/N: 0014

1. Spill incident Number: 2121145 2. Type of incident* OIL SPILL
3. Name of Location: 24" BOMU - BONNY PIPELINE
4. Name of nearest community MOGHO 5. State: RIVERS 6. LGA GOKANA
7. Type of Production facility/Installation OIL PIPELINE
8. Asset owner/District THE SHELL PETROLEUM DEVELOPMENT COMPANY OF NIGERIA LIMITED / PIPELINES

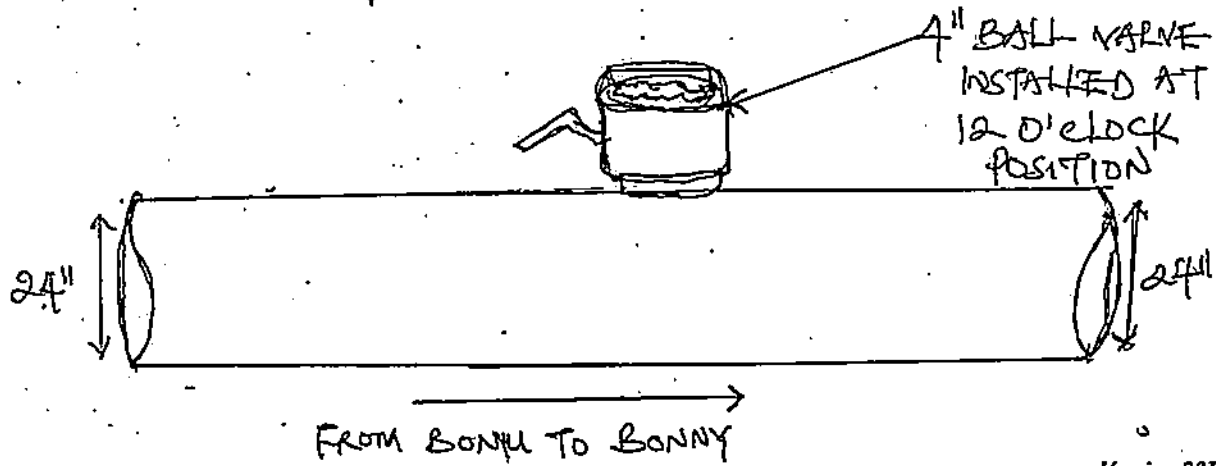
Additional observations around the spill point: THE JOINT INVESTIGATION TEAM OBSERVED A 4" BALL VALVE INSTALLED AT 12 O'CLOCK POSITION.

SECTION OF 24" BOMU-BONNY PIPELINE AT MOGHO STOPPING POSITION OF CRUDE OIL TIEFF POINT.
