JOINT INVESTIGATION REPORT

INCIDENT NO: 2121195 JIV report S/N: 0012

1. Spill incident Number: 2121195 2. Type of incident*: CRUDE OIL SPILL
3. Name of Location 12" IMO RIVER TO SCALE PIPELINE
UMUOLOLO-ETI-TI 2020
4. Name of nearest community: UMUOLOLO-ETI-TI 2020 5. State: ABIA 6. LGA UKWA-WEST
7. Type of Production facility/Installation OIL PIPELINE
8. Asset owner/District THE SHELL PETROLEUM DEVELOPMENT COMPANY
OF NIGERIA LIMITED / PIPELINE

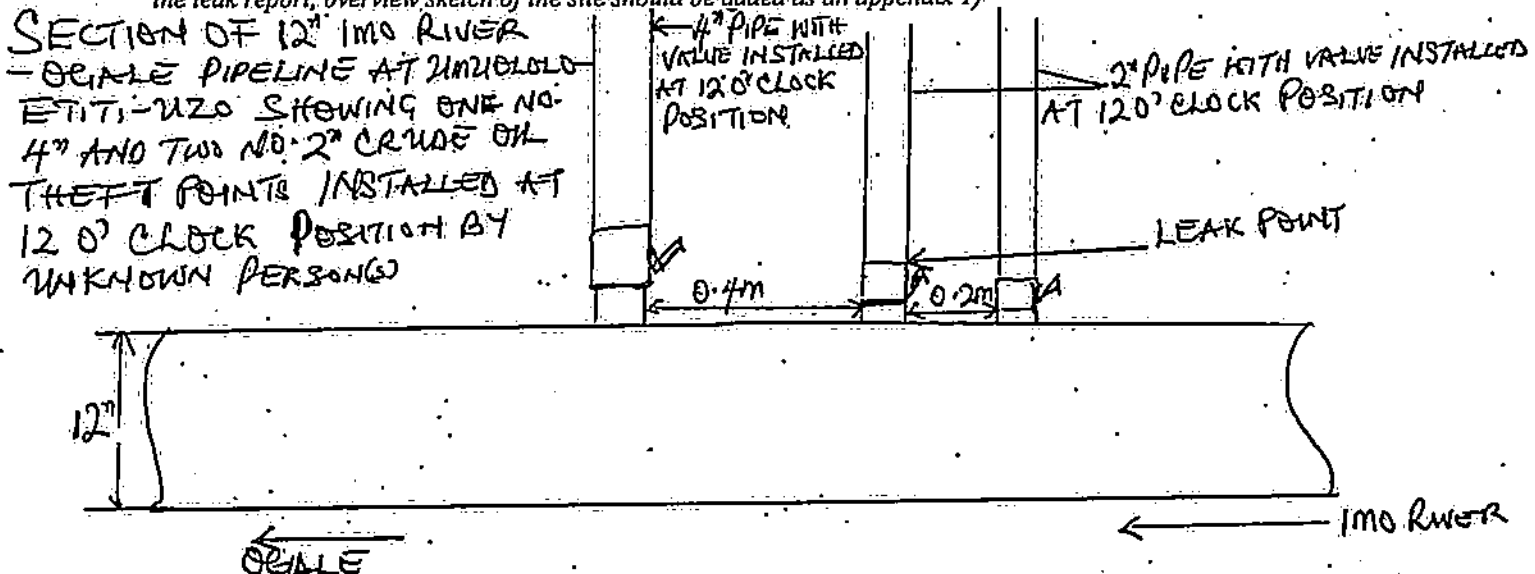
E. GRAPHIC DESCRIPTION OF LEAK POINT (while detailed report of the leak point should be contained in the leak report, overview sketch of the site should be added as an appendix 1)

Additional observations around the spill point: THE JOINT INVESTIGATION TEAM OBSERVED THAT THERE WAS A PIPE-WRENCH LEFT IN THE POOL OF CRUDE OIL AT THE SPILL POINT AREA BY UNKNOWN PERSON(S).

| <input checked="" type="checkbox"/> Crude oil theft (illegal bunkering) point | <input type="checkbox"/> Saver-pit over flow | <input type="checkbox"/> Third party tampering with Clamp |

REPAIR WAS INITIATED AND WILL CONTINUE THE NEXT DAY BY CRAMPING AND RECOVERY WAS ONGOING.

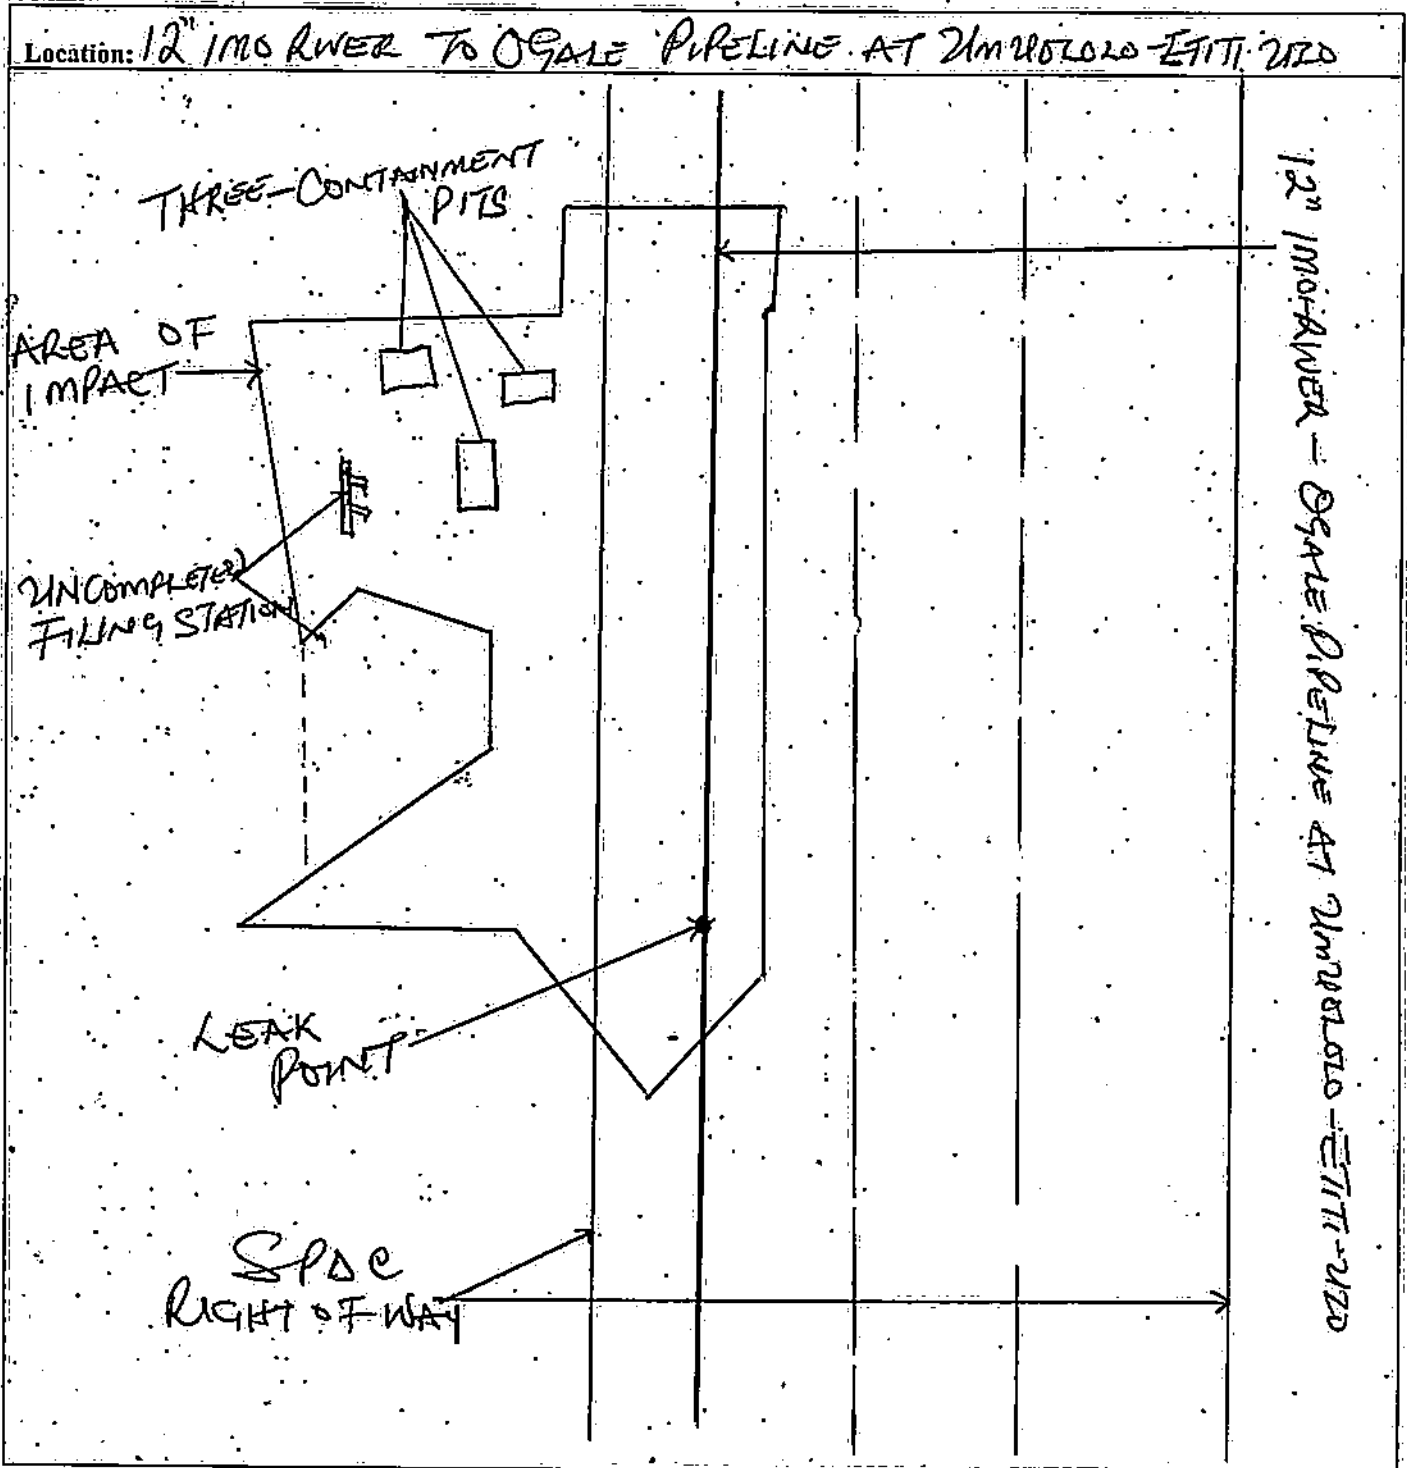
f. Appendix 1: Overview sketch of the site

- Total calculated area of impact 0.08 Ha
- Impact within R.O.W YES
- Impact outside R.O.W YES
