JOINT INVESTIGATION REPORT

INCIDENT NO: 2120415 JIV report S/N: 0024

1. Spill incident Number: 2120415 2. Type of incident* OIL SPILL
3. Name of Location 20" RUMUOKPE - NKPOKU (TRUNKLINE) PIPELINE
4. Name of nearest community IBAA 5. State: RIVERS 6. LGA EMOHUA
7. Type of Production facility/Installation OIL PIPELINE
8. Asset owner/District THE SHELL PETROLEUM DEVELOPMENT COMPANY OF NIGERIA LIMITED PIPELINE

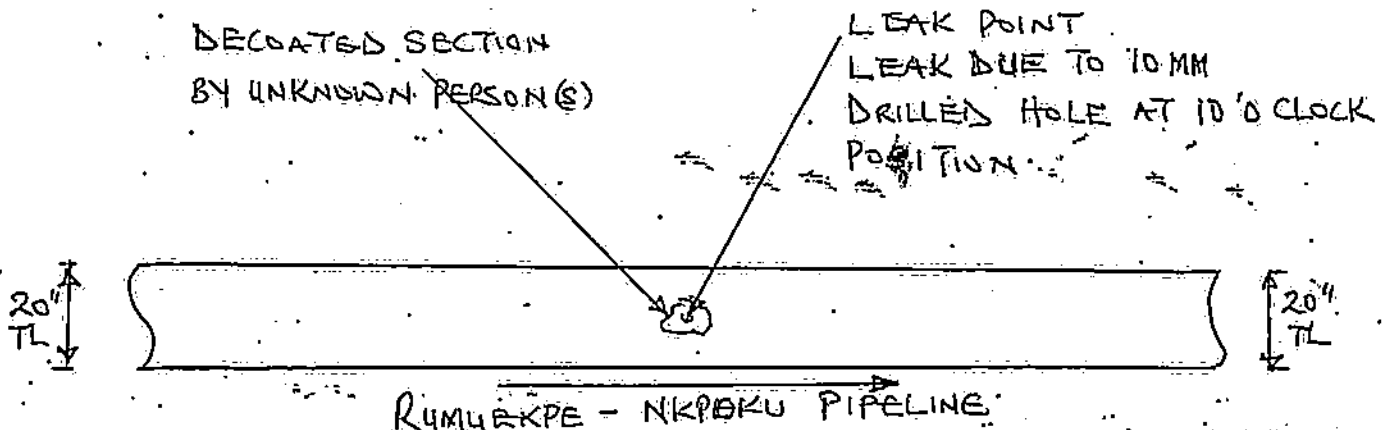
| <input checked="" type="checkbox"/> Drilled hole | <input type="checkbox"/> Hack saw cut | <input type="checkbox"/> Tear (_____) |

SECTIONAL VIEW OF 20" RUMUEKPE - NKPOKU (TRUNKLINE) PIPELINE AT IBAA SHOWING:- LEAK DUE TO 10MM DRILLED HOLE

REPAIR WORK BY CLAMPING COMPLETED
