# JOINT INVESTIGATION REPORT

INCIDENT NO: 2107841 JIV report S/N: 1098

1. Spill incident Number: 2107841 2. Type of incident\* OIL SPILL  
3. Name of Location 14" ORORDIA - RUMUEKPE PIPELINE  
4. Name of nearest community AKARA - MINI 5. State: RIVERS 6. LGA AHOADA WEST  
7. Type of Production facility/Installation OIL PIPELINE  
8. Asset owner/District THE SHELL PETROLEUM DEVELOPMENT COMPANY OF NIGERIA LTD (SPDC) / PIPELINE

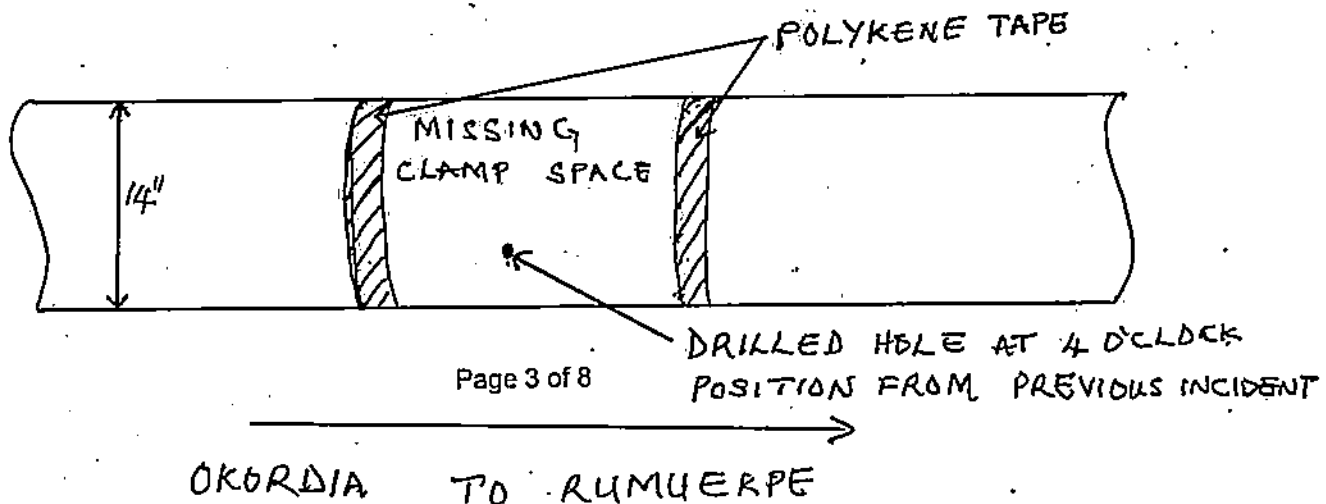
Additional observations around the spill point: THE JOINT INVESTIGATION TEAM SAW EVIDENCE OF MISSING CLAMP, FROM PREVIOUS INCIDENT OF DRILLED HOLE AT 4 O'CLOCK POSITION.

**E. GRAPHIC DESCRIPTION OF LEAK POINT** (While detail report of the leak point should be contained in the leak report, overview sketch of the site should be added as an appendix I) A SECTION OF 14" OKORDIA - RUMUEKPE PIPELINE AT AKARA-MINI SHOWING EVIDENCE

OF MISSING CLAMP FROM PREVIOUS DRILLED HOLE INCIDENT, REMOVED BY UNKNOWN PERSON(S)

LEAK REPAIR
