JOINT INVESTIGATION REPORT

INCIDENT NO: 2201312 JIV report S/N: 0173

1. Spill incident Number: 2201312 2. Type of incident: OIL SPILL (CRUDE OIL THEFT POINT)
3. Name of Location: 20" KOLD CREEK - RUMUEKPE PIPELINE
4. Name of nearest community: DKOMA-1 5. State: RIVERS 6. LGA: AKHADA EAST
7. Type of Production facility/Installation: OIL PIPELINE
8. Asset owner/District: THE SHELL PETROLEUM DEVELOPMENT COMPANY OF NIGERIA LIMITED/PIPELINE

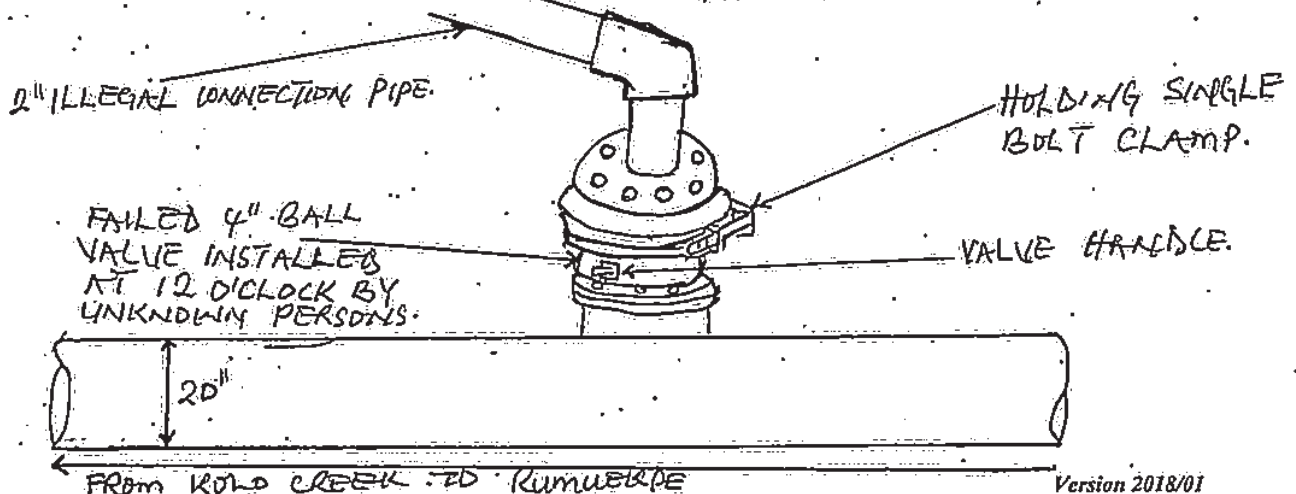
Additional observations around the spill point: THE JOINT INVESTIGATION TEAM OBSERVED A FAILED 4" BALL VALVE SUPPORT WITH CONCRETE SUPPORT AT 12 O'CLOCK POSITION BY UNKNOWN PERSON(S).

| <input checked="" type="checkbox"/> Failed Weld-on illegal hot tap valve | <input type="checkbox"/> Failed Clamp | <input type="checkbox"/> Missing Pipeline/Flowline |
| <input checked="" type="checkbox"/> Crude oil theft (illegal bunkering) point | <input type="checkbox"/> Saver-pit over flow | <input type="checkbox"/> Third party tampering with Clamp |

E. GRAPHIC DESCRIPTION OF LEAK POINT (while detailed report of the leak point should be contained in the leak report, overview sketch of the site should be added as an appendix 1) A SECTION OF 20" KOLE CREEK - KUMBERPE PIPELINE AT OKMA-1 SHOWING FAILED 4" BALL VALVE INSTALLED AT 12 O'CLOCK POSITION BY UNKNOWN PERSON(S).

REPAIR BY CLAMPING ONGOING.
