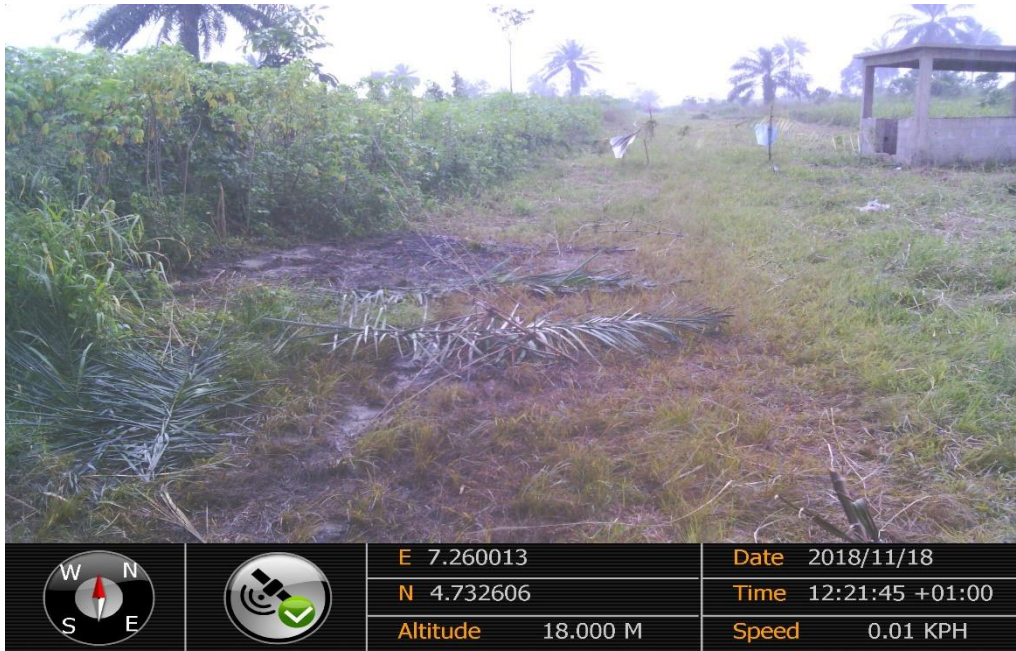
**Overview:** Part of spill impact on 24" Nkpoku - Bomu Pipeline Right of Way at Bara-alue .  
 Picture was taken during Joint Investigation of 18<sup>th</sup> November 2018.

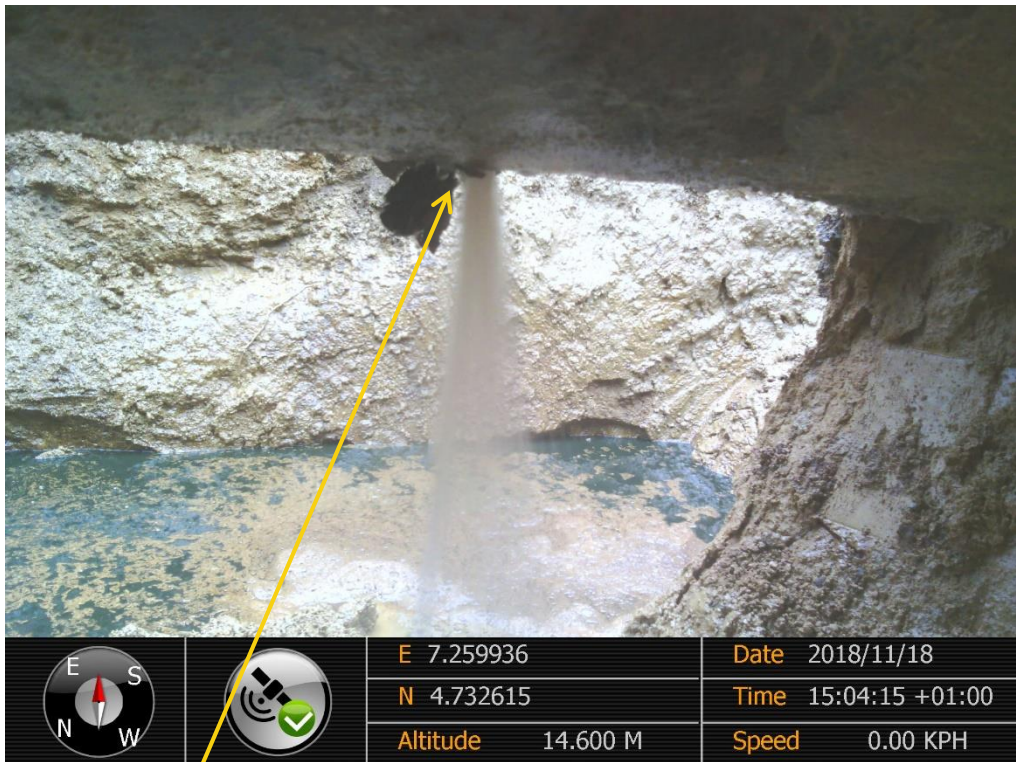
**Close-up:** Internal Corrosion on 24" Nkpoku - Bomu Pipeline at Bara-alue Picture was taken during Joint Investigation of 18<sup>th</sup> November 2018.
