JOINT INVESTIGATION REPORT

INCIDENT NO: 2215450 JIV report S/N: 0178

1. Spill incident Number: 2215450 2. Type of incident*: OIL SPILL/FIRE
3. Name of Location: 24" NKPOKU - BOMU PIPELINE
4. Name of nearest community: EGBALOR 5. State: RIVERS 6. LGA: ELEME
7. Type of Production facility/Installation: OIL PIPELINE
8. Asset owner/District: THE SHELL PETROLEUM DEVELOPMENT COMPANY OF NIGERIA LTD (SPDC)/PIPELINE

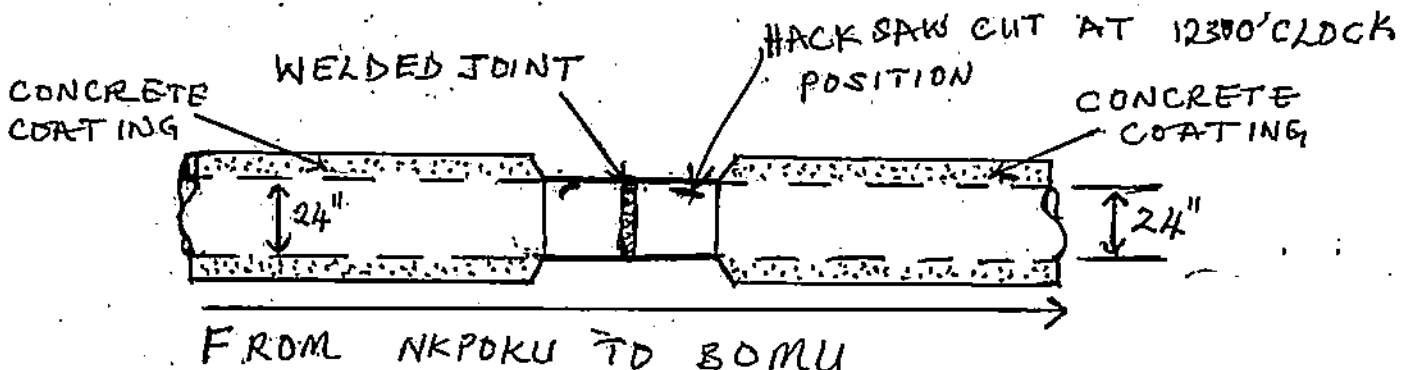
Additional observations around the spill point: THE JIV SAW THAT THE SPILL SITE WAS BURNT.

E. GRAPHIC DESCRIPTION OF LEAK POINT (while detailed report of the leak point should be contained in the leak report, overview sketch of the site should be added as an appendix 1) **A SECTION OF 24" NKPOKU - BOMU PIPELINE AT EGBALOR SHOWING HACK SAW CUT AT 1230 O'CLOCK POSITION BY UNKNOWN PERSONS.**

REPAIR BY CLAMPING

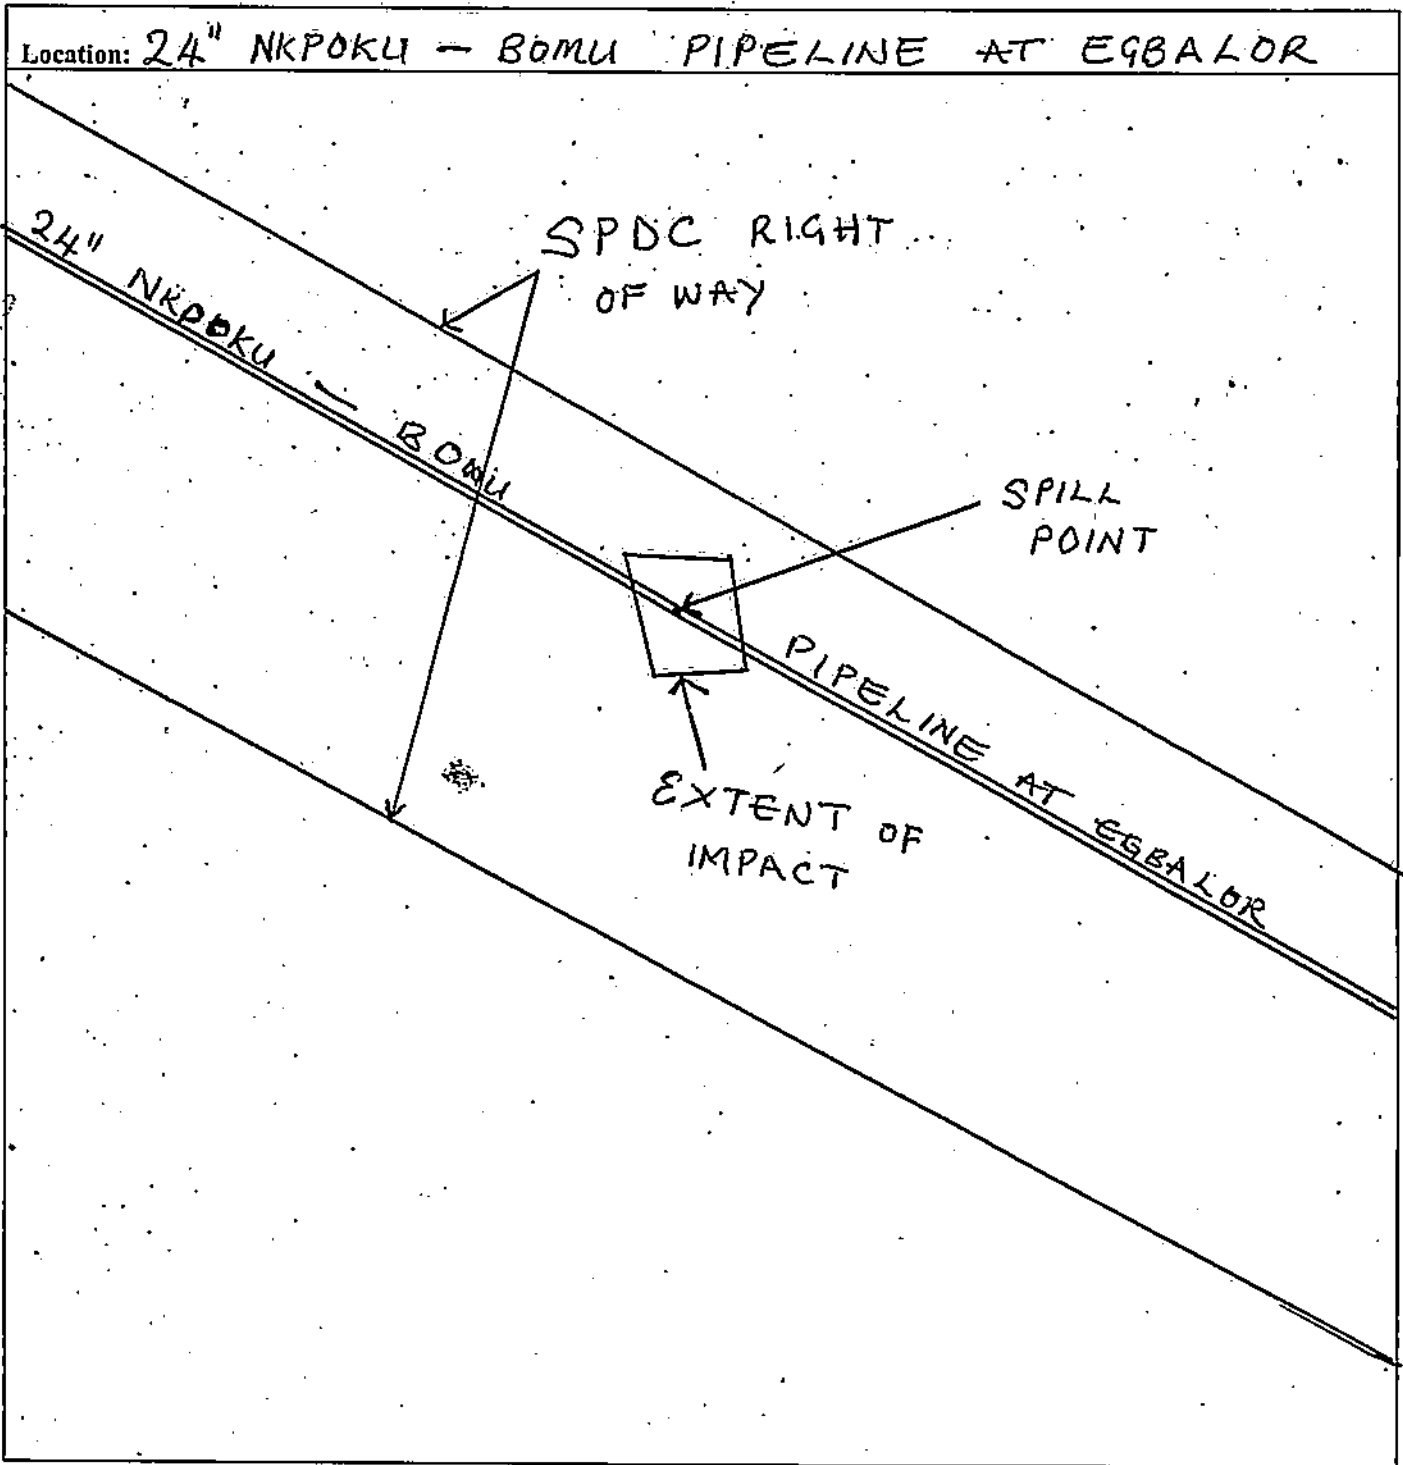
f. Appendix 1: Overview sketch of the site

- Total calculated area of impact 0.000816 ha
- Impact within R.O.W YES
- Impact outside R.O.W NO
