JOINT INVESTIGATION REPORT

INCIDENT NO: 2178768 JIV report S/N: 0164

A. GENERAL INFORMATION:

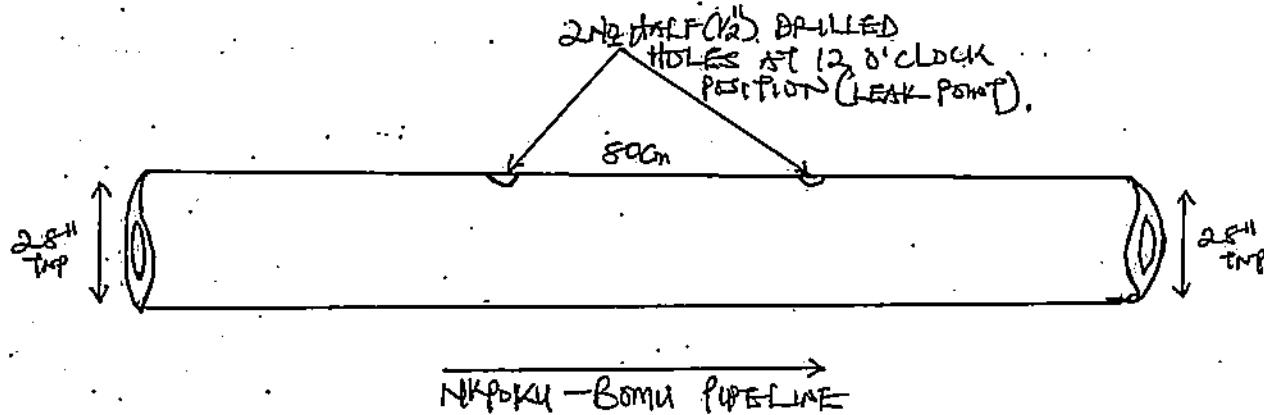
E. GRAPHIC DESCRIPTION OF LEAK POINT (while detailed report of the leak point should be contained in the leak report, overview sketch of the site should be added as an appendix 1) SECTIONAL VIEW OF 28" NKOKU-BOMU PIPELINE AT GID SHOWING 2ND OR HALF (1/2") WITH DRILLED HOLES OF 80CM APART AT 12 O'CLOCK POSITION BY UNKNOWN PERSON(S).

REPAIR AND RESPONSE ACTIVITIES
