JOINT INVESTIGATION REPORT

INCIDENT NO: 2160271 JIV report S/N: 0094

1. Spill incident Number: 2160271 2. Type of incident*: OIL SPILL
3. Name of Location: INTD. RIVER: WELL: 59T. FLOWLINE
4. Name of nearest community: IGIRIUKWU 5. State: ABIA 6. LGA: UKINA WEST
7. Type of Production facility/Installation: FLOWLINE
8. Asset owner/District: THE SHELL PETROLEUM DEVELOPMENT COMPANY OF NIGERIA LIMITED

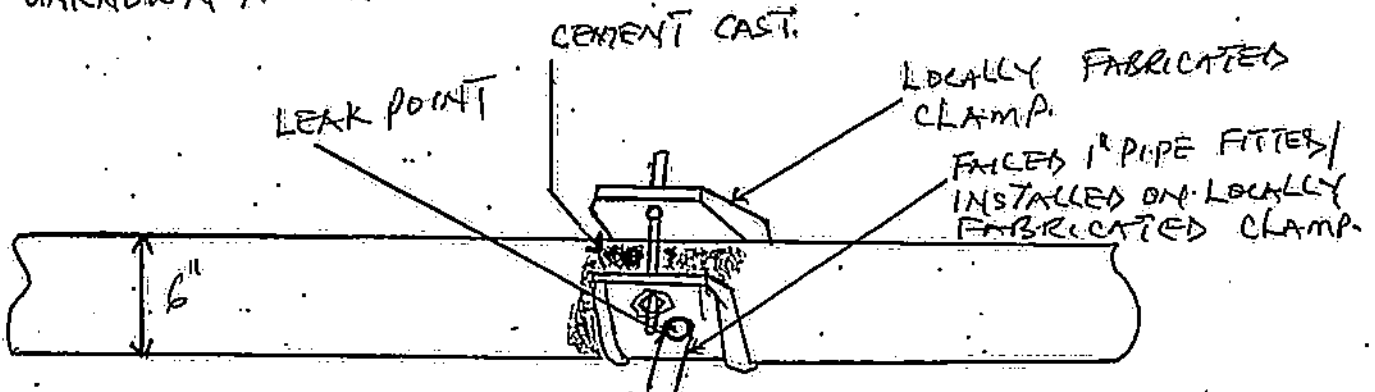
Additional observations around the spill point: THE JOINT INVESTIGATION TEAM OBSERVED FAILED 1" ILLEGAL CONNECTION PIPE INSTALLED ON A LOCALLY FABRICATED CLAMP AT 9 O'CLOCK POSITION WITH CEMENT CAST SUPPORTING THE CLAMP

E. GRAPHIC DESCRIPTION OF LEAK POINT (while detailed report of the leak point should be contained in the leak report, overview sketch of the site should be added as an appendix 1) A SECTION OF IMB RIVER WELL 59T FLOWLINE AT GIRIUKWU DWAZA SHOWING A FAILED 1" ILLEGAL CONNECTION AT 9 O'CLOCK POSITION BY UNKNOWN PERSONS.

← FROM IMB RIVER WELL 59 TO IMB RIVER FLOW STATION.
