JOINT INVESTIGATION REPORT

INCIDENT NO: 2156111 JIV report S/N: 0090

1. Spill incident Number: 2156111 2. Type of incident*: OIL SPILL
3. Name of Location: 6th IMO RIVER 2 - IMO RIVER 1 BULKLINE (IMO - RIVER 2 WELL
4. Name of nearest community: UMUABEDOKWARA (CODAGWA) 5. State: RIVERS 6. LGA: ETCETE (UMUABEDOKWARA) SIL FLK AT ODAGWA
7. Type of Production facility/Installation: OIL BULKLINE
8. Asset owner/District: THE SHELL PETROLEUM DEVELOPMENT COMPANY OF NIGERIA
LAND EAST HUB

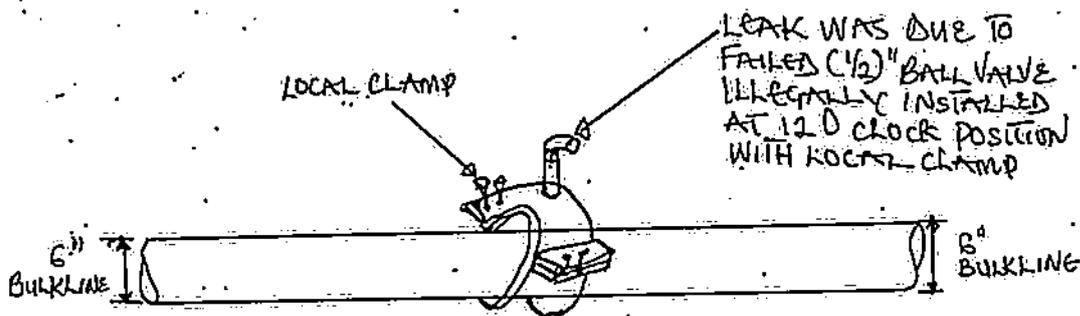
E. GRAPHIC DESCRIPTION OF LEAK POINT (while detailed report of the leak point should be contained in the leak report, overview sketch of the site should be added as an appendix 1)

| <input checked="" type="checkbox"/> Failed Weld-on/illegal hot tap valve | <input type="checkbox"/> Failed Clamp | <input type="checkbox"/> Missing Pipeline/Flowline |
| <input checked="" type="checkbox"/> Crude oil theft (illegal bunkering) point | <input type="checkbox"/> Saver-pit over flow | <input type="checkbox"/> Third party tampering with Clamp |

SECTIONAL VIEW OF 6" IMO RIVER 2 - IMO RIVER 1 BULKLINE AT UNWADEOKWARA
SHOWING FAIL (1/2)" BALL VALVE ILLEGALLY INSTALLED
AT 12 O'CLOCK POSITION WITH LOCAL CLAMP
