JOINT INVESTIGATION REPORT

INCIDENT NO: 2325957 JIV report S/N:0285

1. Spill incident Number: 2325957 2. Type of incident*: OIL SPILL
3. Name of Location 18" ASSA - RUMUEKPE PIPELINE
4. Name of nearest community ELELE-ALIMINI 5. State: RIVERS 6. LGA EMDHUA
7. Type of Production facility/Installation OIL PIPELINE
8. Asset owner/District THE SHELL PETROLEUM DEVELOPMENT COMPANY OF NIGERIA LIMITED / PIPELINE

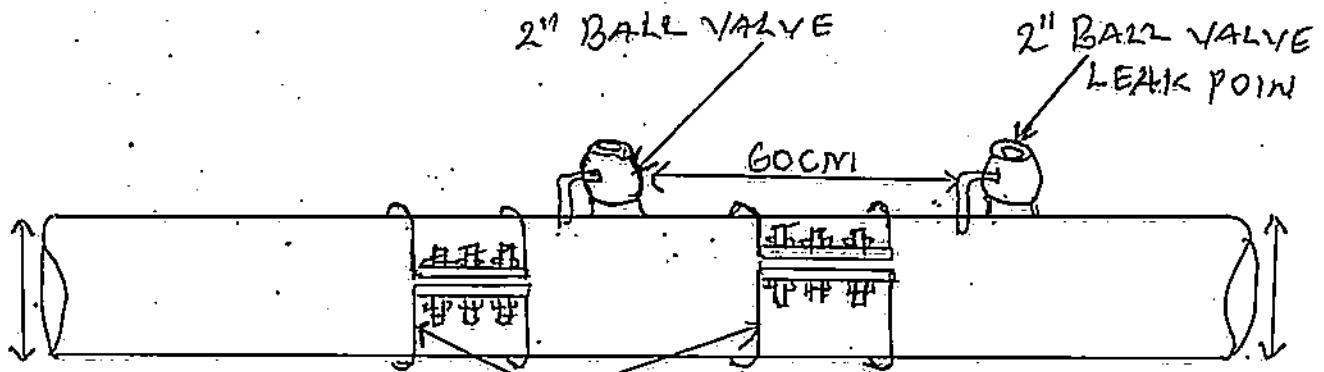
| <input checked="" type="checkbox"/> Failed Weld-on illegal hot tap valve | <input type="checkbox"/> Failed Clamp | <input type="checkbox"/> Missing Pipeline/Flowline |
| <input checked="" type="checkbox"/> Crude oil theft (illegal bunkering) point | <input type="checkbox"/> Saver-pit over flow | <input type="checkbox"/> Third party tampering with Clamp |

SECTION OF 18" ASSA - RUMUKEPE PIPELINE AT GLELE-ALINGIWI SHOWING CRUDE OIL THER POINTS AT 12 O'CLOCK POSITION.

EXISTING CLAMPS (PREVIOUSLY REPAIRED POINT)

FROM ASSA TO RUMUKEPE →

REPAIR WORK ACTIVITY ONGOING
