JOINT INVESTIGATION REPORT

INCIDENT NO: 2332755 JIV report S/N: 0119

1. Spill incident Number: 2332755 2. Type of incident*: OIL SPILL
3. Name of Location: 12" IMO RIVER 2 - OGALE PIPELINE
4. Name of nearest community: KOMKOM 5. State: RIVERS 6. LGA: OYIGBO
7. Type of Production facility/Installation: OIL PIPELINE
8. Asset owner/District: THE SHELL PETROLEUM DEVELOPMENT COMPANY OF NIGERIA LIMITED / PIPELINE

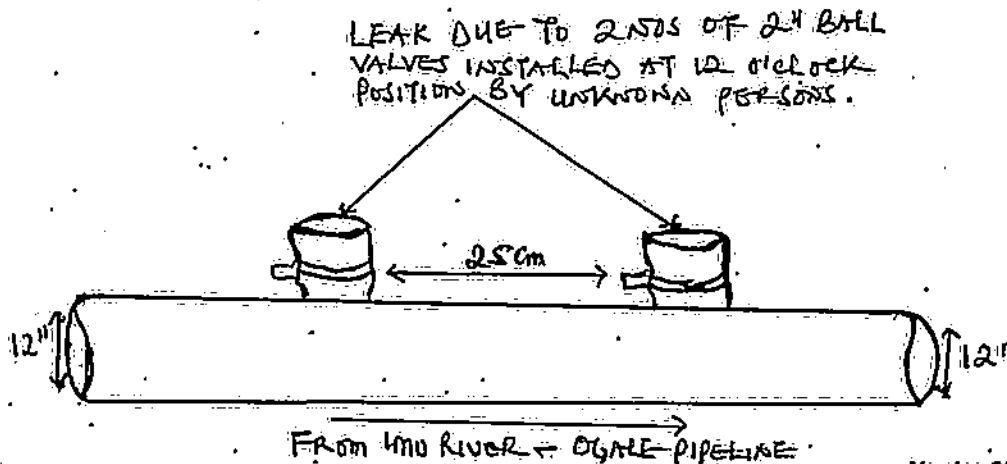
| <input checked="" type="checkbox"/> Crude oil theft (illegal bunkering) point | <input type="checkbox"/> Saver-pit over flow | <input type="checkbox"/> Third party tampering with Clamp |

- Third party interference (Sabotage ; crude theft ; Line theft ; Accidental 3rd party damage
 Operational Mystery spills Others(specify) _____

E. GRAPHIC DESCRIPTION OF LEAK POINT (while detailed report of the leak point should be contained in the leak report, overview sketch of the site should be added as an appendix 1). A SECTION OF 12" IUGR 2-OGALE PIPELINE AT KOKKOM SHOWING 2 NOS OF 2" BALL VALVES INSTALLED AT 12 O'CLOCK POSITION BY UNKNOWN PERSON(S).

REPAIR ACTIVITIES ONGOING
