# JOINT INVESTIGATION REPORT

INCIDENT NO: 233 4244 JIV report S/N: 0264

1. Spill incident Number: 233 4244 2. Type of incident\*: OIL SPILL  
3. Name of Location: 12" IMO RIVER - OGARE PIPELINE  
4. Name of nearest community KOMKOM 5. State: RIVERS 6. LGA OYIGBO  
7. Type of Production facility/Installation OIL PIPELINE  
8. Asset owner/District THE SHELL PETROLEUM DEVELOPMENT COMPANY OF NIGERIA LIMITED (SPDC) / PIPELINE

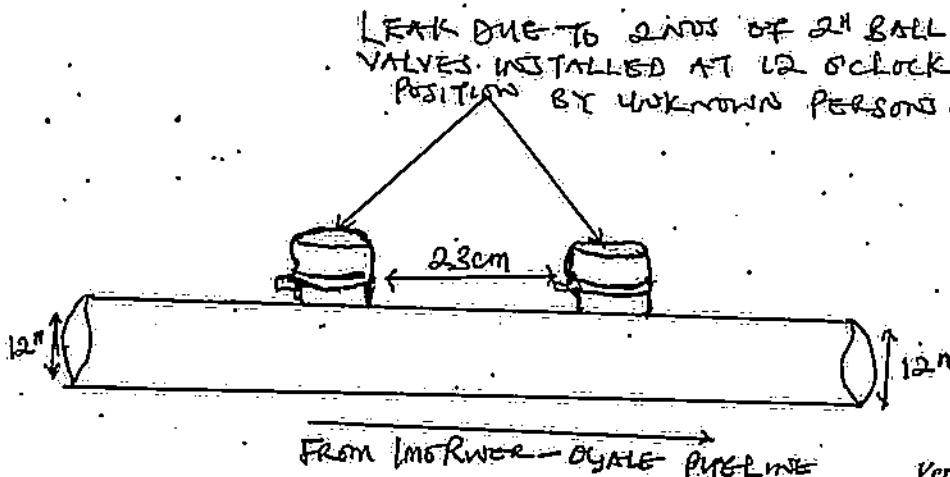
E. GRAPHIC DESCRIPTION OF LEAK POINT (while detailed report of the leak point should be contained in the leak report, overview sketch of the site should be added as an appendix 1) A SECTION OF 12" IMO RIVER - OYALE PIPELINE AT KOKKOM SHOWING A 2 NOS OF 2" BALL VALVES INSTALLED AT 12 O'CLOCK POSITION BY UNKNOWN PERSONS.

REPAIR ACTIVITIES ONGOING
