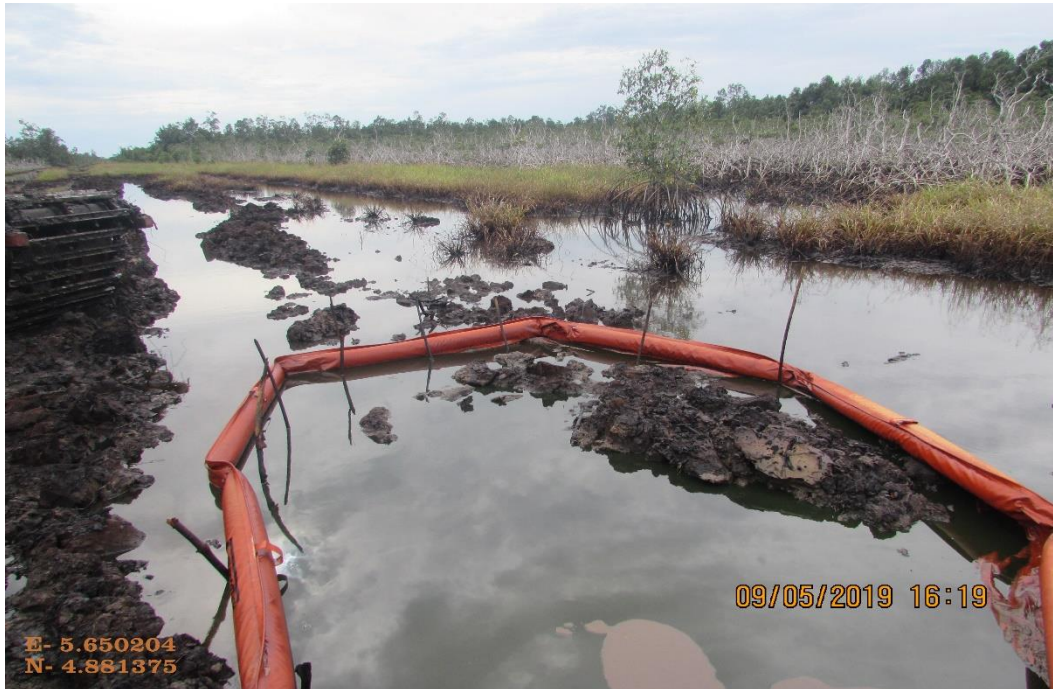
Overview: Part of spill impact on 6'' Tunu Kanbo Well 7L Flowline at Egbemo-Analabiri-agbidiana. Picture was taken during Joint Investigation of 9th May 2019.

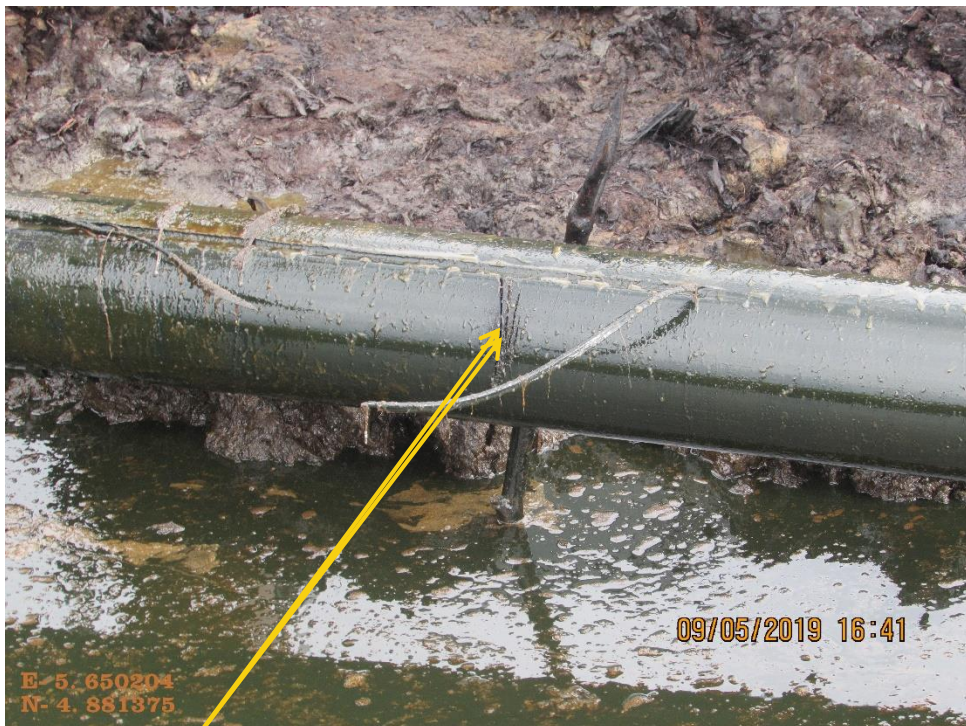
Close-up: Hack Saw Cuts on 6'' Tunu Kanbo Well 7L Flowline at Egbemo-Analabiri-agbidiana. Picture was taken during Joint Investigation of 9th May 2019.
