JOINT INVESTIGATION REPORT

INCIDENT NO: 2417404 JIV report S/N: 1030094

1. Fountain Incident Number: 2417404 2. Type of incident* OIL SPILL
3. Name of Location 12" INDI RIVER 2 - OGALE PIPELINE
4. Name of nearest community OKOHIA 5. State: ABIA 6. LGA UKWA-WEST
7. Type of Production facility/Installation OIL PIPELINE
8. Asset owner/District THE SHELL PETROLEUM DEVELOPMENT COMPANY OF NIGERIA LIMITED PIPELINE

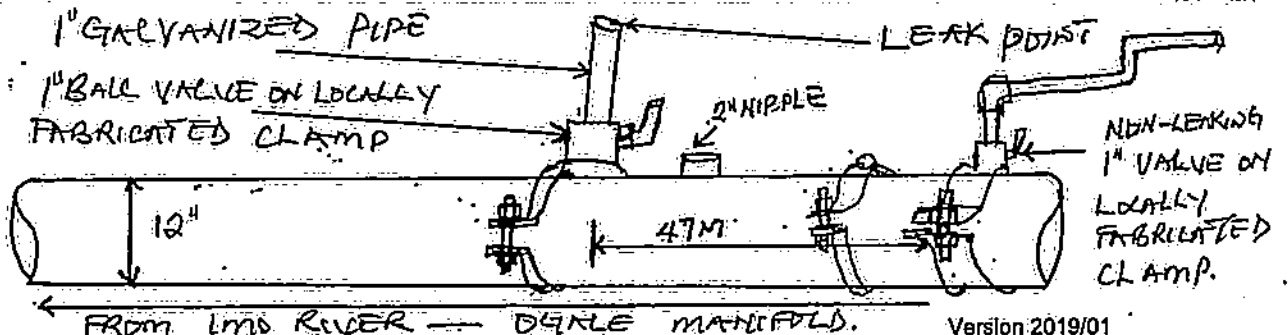
Additional observations around the spill point: THE JOINT INVESTIGATION TEAM OBSERVED CRUDE OIL LEAK FROM THE ILLEGAL CONNECTION LINE - OUT, EARLIER REPORTED AS NON LEAKING ILLEGAL CONNECTION (INCIDENT NO 2250799).

E. GRAPHIC DESCRIPTION OF LEAK POINT (while detail report of the leak point should be contained in the leak report, overview sketch of the site should be added as an appendix 1). A SECTION OF 12" IMB RIVER 2 - OSCALE PIPELINE AT OKOHA SHOWING 1" VALVE INSTALLED AT 12 O'CLK POSITION BY UNKNOWN PERSONS.

REPAIR BY CLAMPING AND CRUISE OIL RECOVERY
ARE ONGOING.

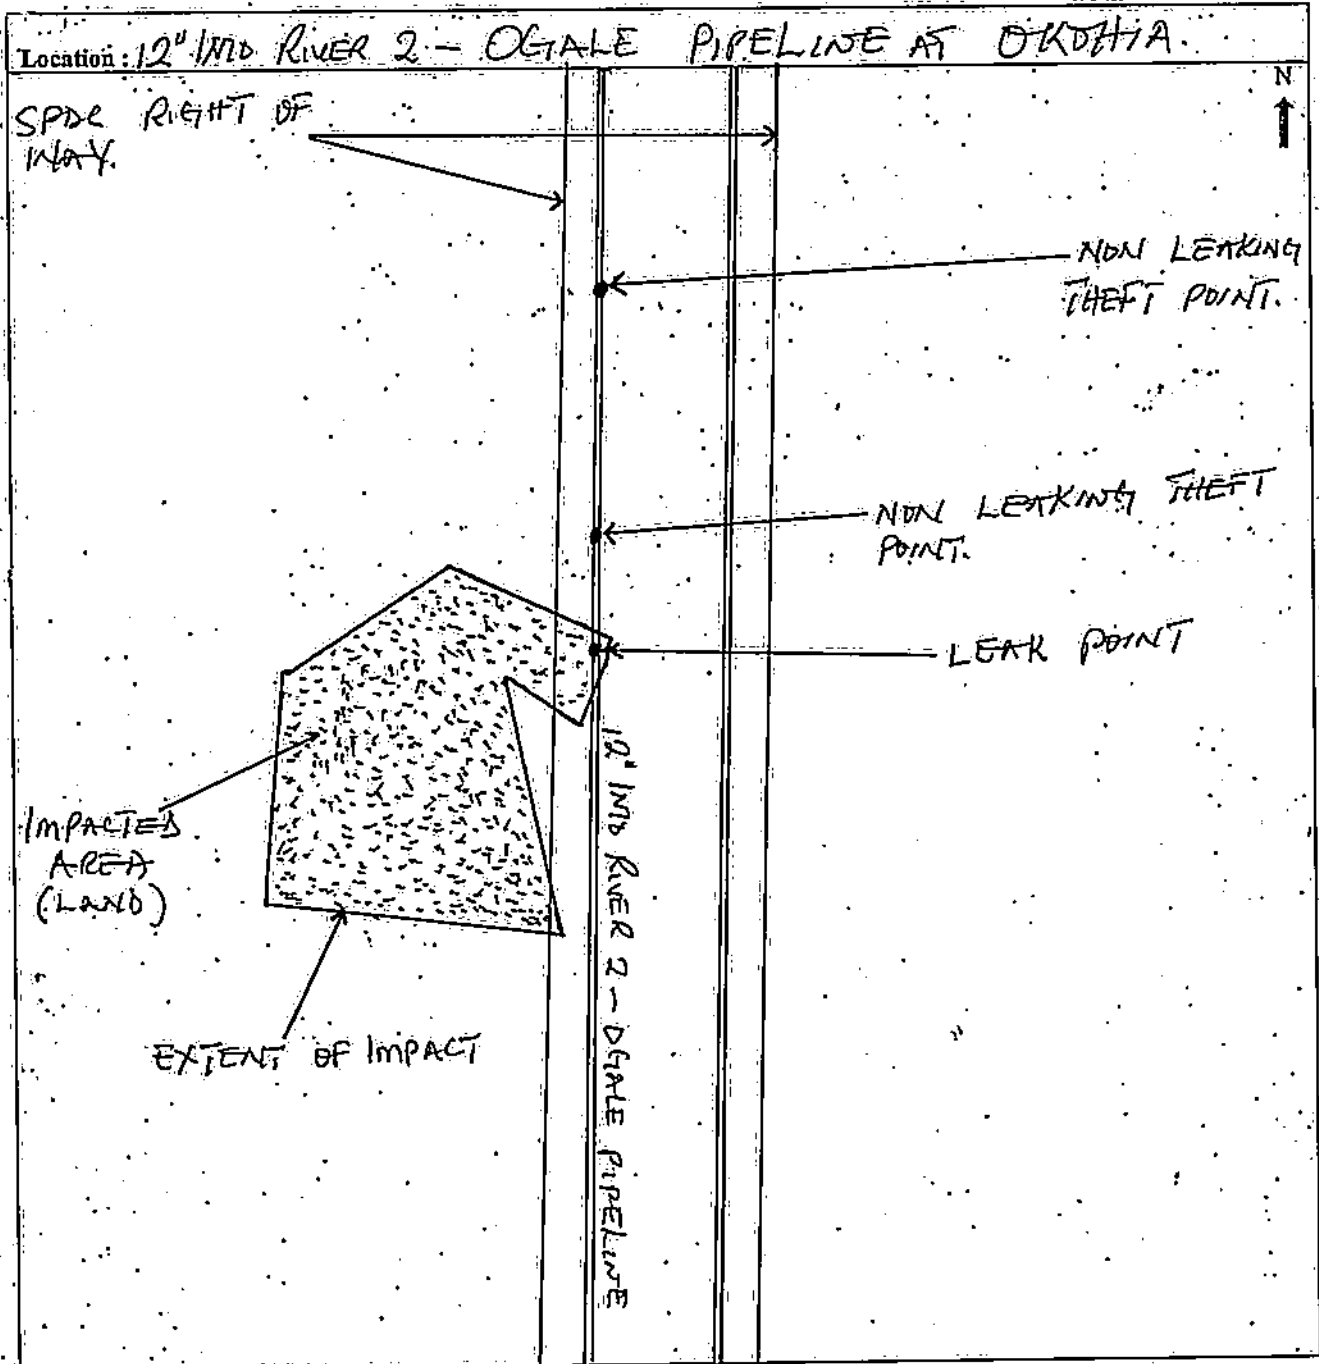
f. Appendix 1: Overview sketch of the site

- Total calculated area of impact: 0.0309 HA
- Impact within SPDC R.O.W.: YES
- Impact outside SPDC R.O.W.: YES
