JOINT INVESTIGATION REPORT

INCIDENT NO: 2434228 JIV report S/N: 1030122

1. Fountain Incident Number: 2434228 2. Type of incident* OIL SPILL
3. Name of Location 8" UMUECHEM- AKPOKU DELIVERY LINE
4. Name of nearest community RUKPOKWU 5. State: RIVERS 6. LGA OBIO AKPOR
7. Type of Production facility/Installation OIL PIPELINE
8. Asset owner/District THE SHELL PETROLEUM DEVELOPMENT COMPANY OF NIGERIA LIMITED / PIPELINE

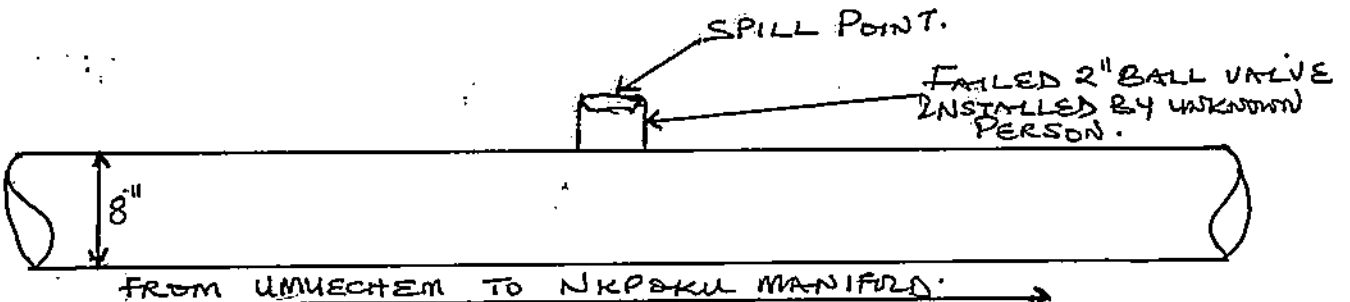
E. GRAPHIC DESCRIPTION OF LEAK POINT (while detail report of the leak point should be contained in the leak report, overview sketch of the site should be added as an appendix) A SECTION of 8" UMUECHEM-NKPOKU DELIVERY LINE AT RUKPOKU SHOWING A NO 2" BALL VALVE INSTALLED AT 12 O'CLOCK POSITION BY UNKNOWN PERSONS.

REPAIR BY CLAMPING ON GOING
