JOINT INVESTIGATION REPORT

INCIDENT NO: 2435984 JIV report S/N: 1030129

1. Fountain Incident Number: 2435984 2. Type of incident* OIL SPILL
3. Name of Location 20" KOLD CREEK - KIMUEKPE PIPELINE
4. Name of nearest community ODAU (Km 9) 5. State: RIVERS 6. LGA ABUJA/ODUAL
7. Type of Production facility/Installation: OIL PIPELINE
8. Asset owner/District THE SHELL PETROLEUM DEVELOPMENT COMPANY OF NIGERIA LIMITED/PIPELINE

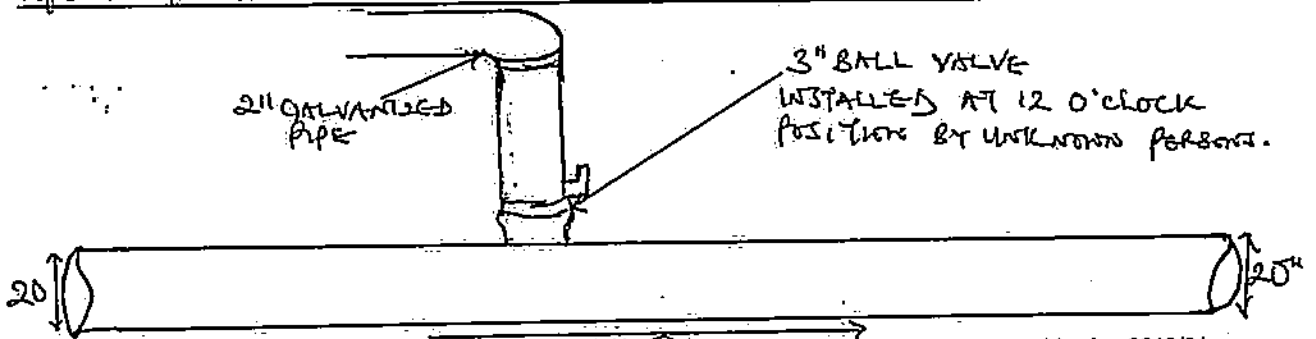
Additional observations around the spill point: THE SPILL POINT IS THE SAME LOCATION WHERE A PREVIOUS INCIDENTS OF ILLEGAL CONNECTION WITH PRESENCE OF OIL IN A PIT DUG BY UNKNOWN PERSON(S) WAS REPORTED (INCIDENT NO 2424272 AND 2424281).

| <input checked="" type="checkbox"/> Failed Weld-on illegal hot tap valve | <input type="checkbox"/> Failed Clamp, | <input type="checkbox"/> Missing Pipeline/Flowline |
| <input checked="" type="checkbox"/> Crude oil theft (illegal bunkering) point, | <input type="checkbox"/> Saver-pit over flow | <input type="checkbox"/> Third party tampering with Clamp |

E. GRAPHIC DESCRIPTION OF LEAK POINT (while detail report of the leak point should be contained in the leak report, overview sketch of the site should be added as an appendix 1) A SECTION OF 20" KOLOREEK - RUMUEKPE PIPELINE AT ODAUCKIN 9) SHOWING A 3" BALL VALVE AND A 2" GALVANIZED PIPE INSTALLED AT 12 O'CLOCK POSITION BY UNKNOWN PERSONS

RECOVERY OF SPILLED CRUISE OIL AND REPAIR WORK ONGOING

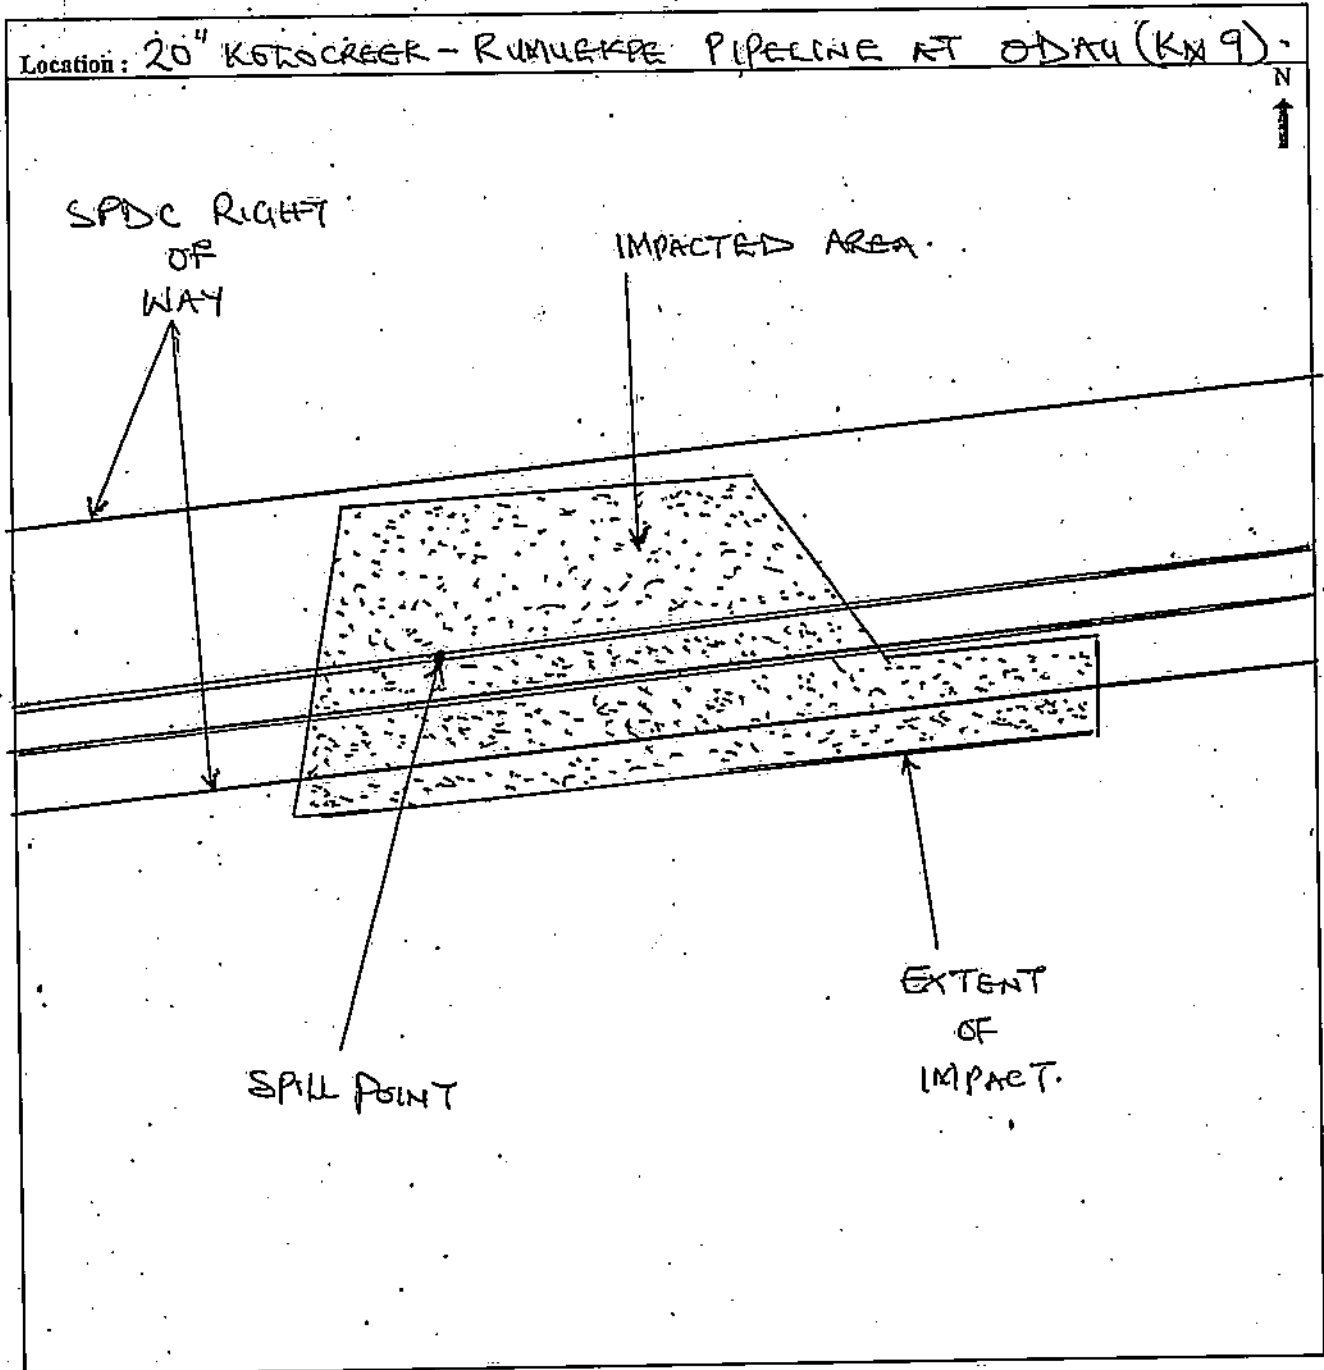
f. Appendix d: Overview sketch of the site

- Total calculated area of impact 0.113774 HA
- Impact within SPDC R.O.W. YES
- Impact outside SPDC R.O.W. YES
