JOINT INVESTIGATION REPORT

INCIDENT NO: 2522653 JIV report S/N: 1030208

1. Fountain Incident Number: 2522653 2. Type of incident*: OIL SPILL
3. Name of Location 8" NKALI - IMO RIVER 2 DELIVERY LINE
4. Name of nearest community NKALI 5. State: RIVERS 6. LGA ETCHE
7. Type of Production facility/Installation PIPELINE
8. Asset owner/District THE SHELL PETROLEUM DEVELOPMENT COMPANY OF NIGERIA LIMITED (SPDC)

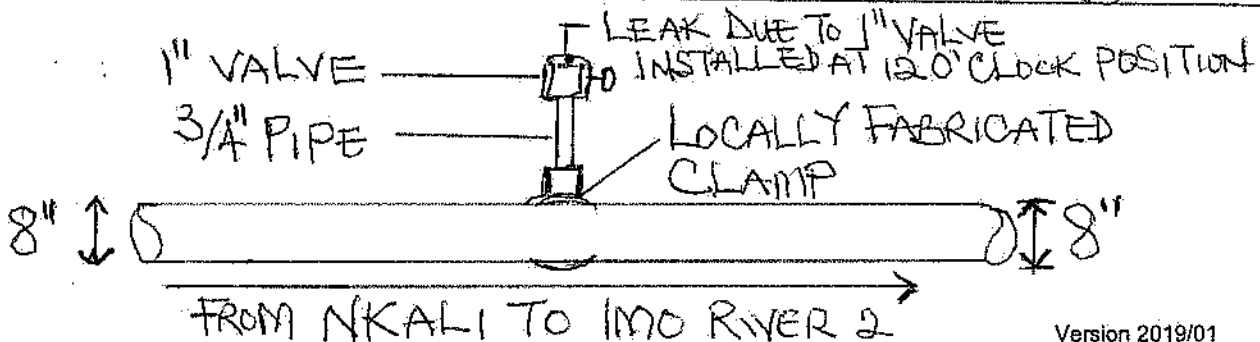
| <input checked="" type="checkbox"/> Crude oil theft (illegal bunkering) point, | <input type="checkbox"/> Saver-pit over flow | <input type="checkbox"/> Third party tampering with Clamp |

E. GRAPHIC DESCRIPTION OF LEAK POINT (while detail report of the leak point should be contained in the leak report, overview sketch of the site should be added as an appendix 1) A SECTION OF 8" NKALI TO IMO RIVER 2 DELIVERY LINE AT NKALI SHOWING 1" VALVE INSTALLED AT 12 O'CLOCK POSITION BY UNKNOWN PERSON(S).

CLAMPING ONGOING
