JOINT INVESTIGATION REPORT

INCIDENT NO: 2529690 JIV report S/N: 1030184

1. Fountain Incident Number: 2529690 2. Type of incident* OIL SPILL
3. Name of Location: 12" IMORIVERI-OGALE PIPELINE
4. Name of nearest community Umuololos, State: ABIA, LGA UKWA WEST
7. Type of Production facility/Installation OIL PIPELINE
8. Asset owner/District THE SHELL PETROLEUM DEVELOPMENT COMPANY OF NIGERIA LIMITED (SPDC)/PIPELINE

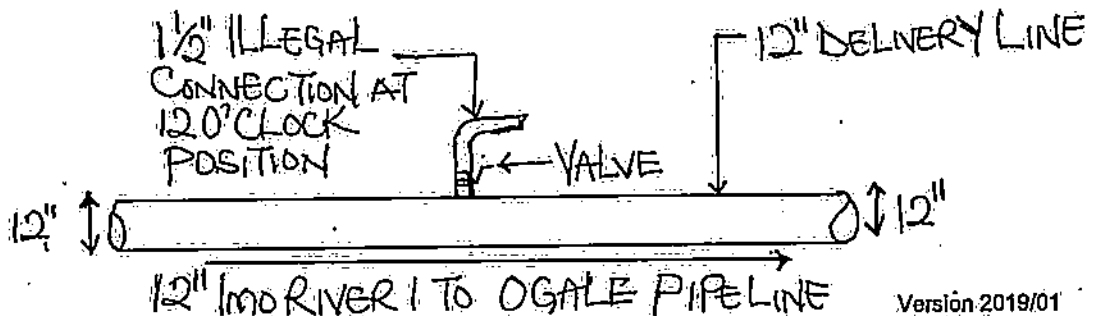
| <input checked="" type="checkbox"/> Crude oil theft (illegal bunkering) point, | <input type="checkbox"/> Saver-pit over flow | <input type="checkbox"/> Third party tampering with Clamp |

E. GRAPHIC DESCRIPTION OF LEAK POINT (while detail report of the leak point should be contained in the leak report, overview sketch of the site should be added as an appendix 1) A SECTION OF 12" MO RIVER 1 - OGALE PIPELINE AT UMUDOLO SHOWING 1/2" PIPE CONNECTED AT 12 O'CLOCK POSITION BY UNKNOWN PERSON(S).

CLAMPING ONGOING / RECOVERY COMPLETED
