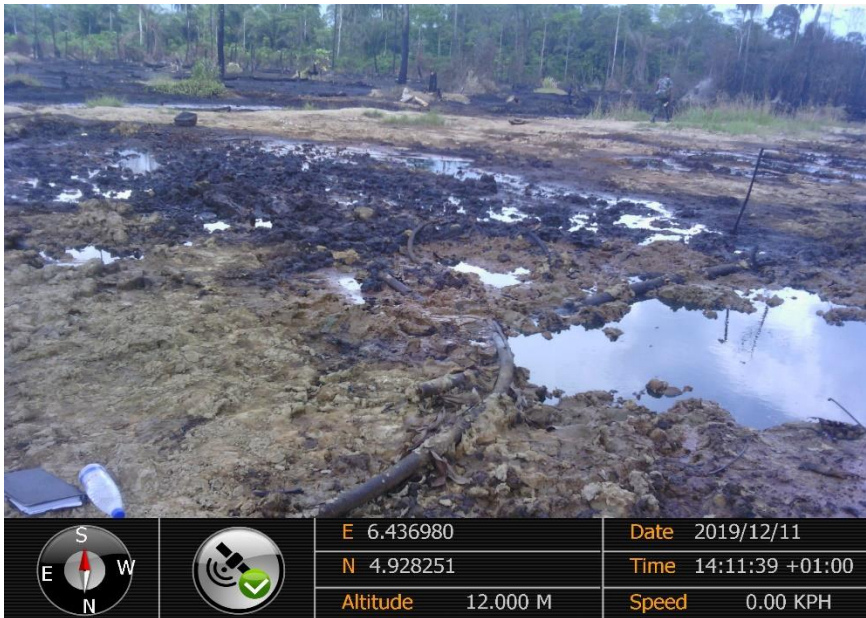
**Overview:** Part of spill impact on 20'' Kolocreek – Rumuekpe Pipeline Right of Way at Odau-KP9. Picture was taken during Joint Investigation of 11<sup>th</sup> December 2019.

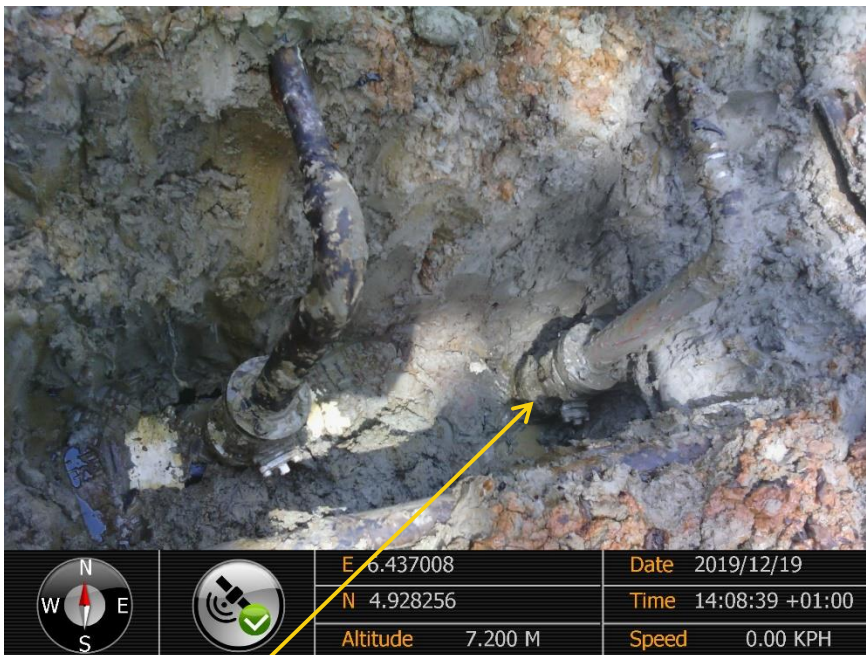
**Close-up:** Leaking Illegal Fitting on 20'' Kolocreek – Rumuekpe Pipeline at Odau-KP9. Picture was taken during Joint Investigation of 19<sup>th</sup> December 2019
