# JOINT INVESTIGATION REPORT

INCIDENT NO: 2530938 JIV report S/N: 1030191

1. Fountain Incident Number: 2530938 2. Type of incident\* OIL SPILL  
 3. Name of Location 12" IMO RIVER 2 PIPELINE AT UMUOLOLO  
 4. Name of nearest community UMUOLOLO 5. State: ABIA 6. LGA UKWA WEST  
 7. Type of Production facility/Installation OIL PIPELINE  
 8. Asset owner/District: THE SHELL PETROLEUM DEVELOPMENT COMPANY OF NIGERIA LIMITED (SPDC) (PIPELINE)

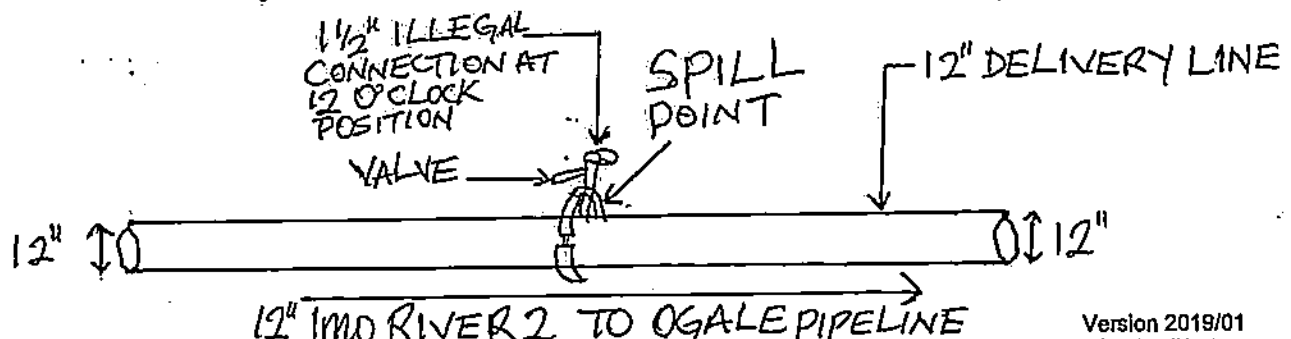
Additional observations around the spill point: JOINT INVESTIGATION TEAM OBSERVED THAT LEAK IS FROM A PREVIOUSLY REPORTED NON-LEAKING ILLEGAL CONNECTION/THEFT LINE. (REF ID- 2500035)

**E. GRAPHIC DESCRIPTION OF LEAK POINT** (while detail report of the leak point should be contained in the leak report, overview sketch of the site should be added as an appendix 1) A SECTION OF 12" IMO RIVER 2 - OGALE PIPELINE AT UMILOLOD SHOWING 1 1/2" PIPE CONNECTED AT 12 O'CLOCK POSITION BY UNKNOWN PERSON(S).

REPAIR BY CLAMPING
