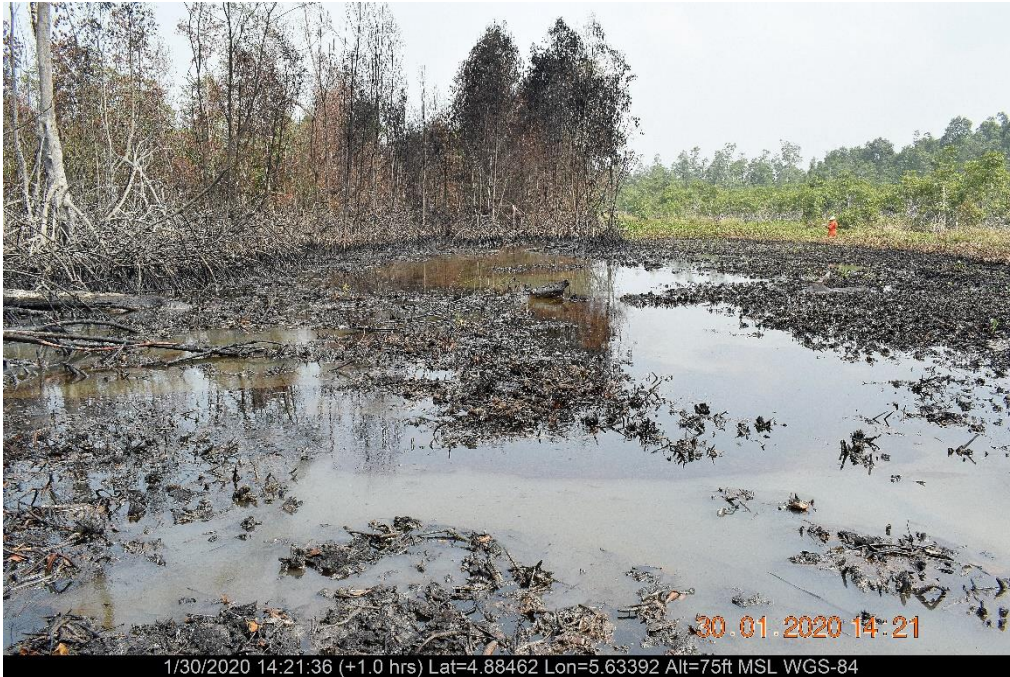
**Overview:** Part of spill impact on 6'' Tunu 3T Flowline at Egbemo Angalabiri Agbidiama. Picture was taken during Joint Investigation of 30<sup>th</sup> January 2020.

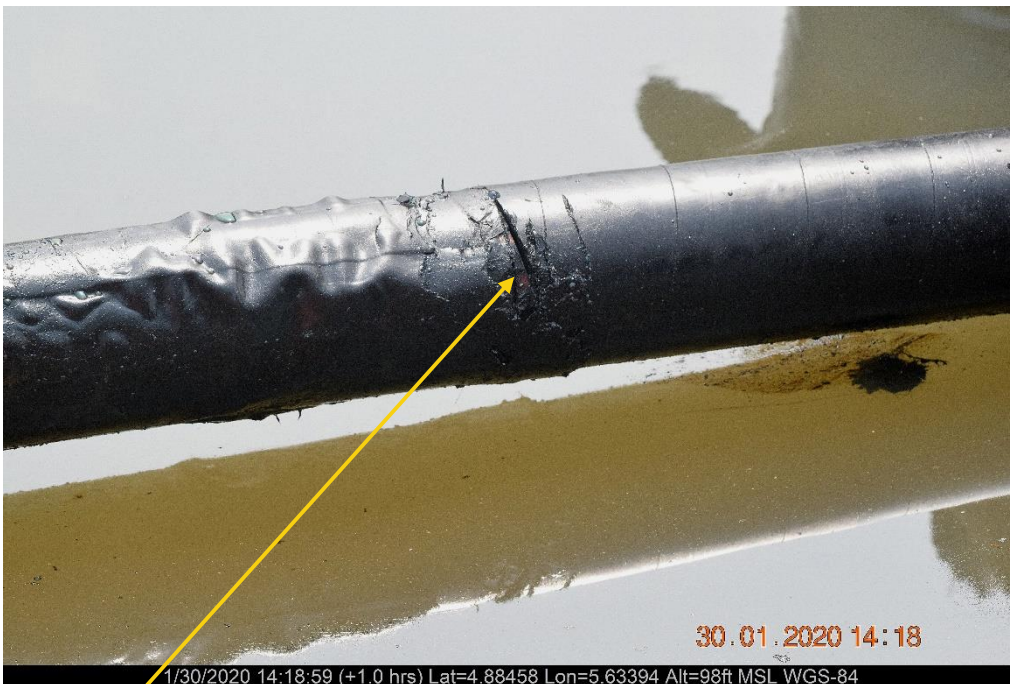
**Close-up:** Hacksaw Cut on 6'' Tunu 3T Flowline at Egbemo Angalabiri Agbidiama. Picture was taken during Joint Investigation of 30<sup>th</sup> January 2020.
