JOINT INVESTIGATION REPORT

INCIDENT NO: 2260413 JIV report S/N: 0180

1. Spill incident Number: 2260413 2. Type of incident*: OIL SPILL
3. Name of Location 6th IMO RIVER 2 - IMO RIVER 1 BULKLINE
4. Name of nearest community ODAGWA 5. State: RIVERS 6. LGA ETITE
7. Type of Production facility/Installation OIL PIPELINE
8. Asset owner/District THE STEEL PETROLEUM DEVELOPMENT COMPANY OF NIGERIA LIMITED | LAND EAST

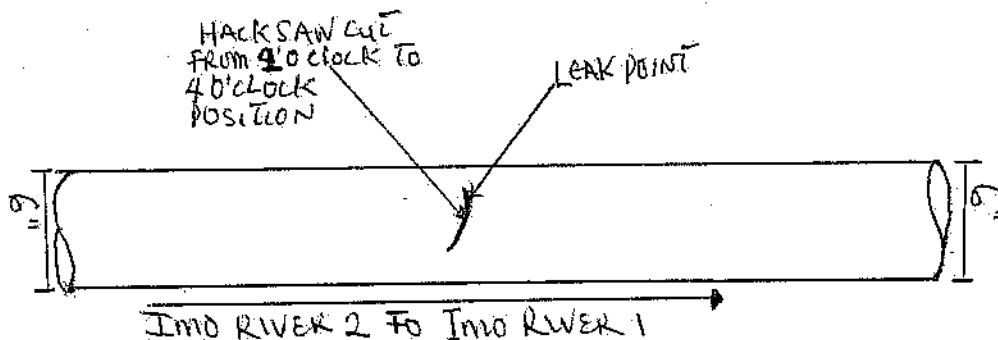
E. GRAPHIC DESCRIPTION OF LEAK POINT (while detailed report of the leak point should be contained in the leak report, overview sketch of the site should be added as an appendix 1)

A SECTION OF 6" Imo River 2 - Imo River 1 BULKLING AT ODAQWA SHOWING HACKSAW CUT FROM 2'O'CLOCK TO 4'O'CLOCK POSITION BY UNKNOWN PERSON(S).
