JOINT INVESTIGATION REPORT

INCIDENT NO: 22.49212 JIV report S/N: 0205

1. Spill incident Number: 2249212 2. Type of incident*: OIL SPILL (CRUDE OIL THEFT ADJANT)
 3. Name of Location 24" NKPOKU - BOMU PIPELINE
 4. Name of nearest community EGBALOR 5. State: RIVERS 6. LGA ELEME
 7. Type of Production facility/Installation OIL PIPELINE
 8. Asset owner/District THE SHELL PETROLEUM DEVELOPMENT COMPANY OF NIGERIA LIMITED / PIPELINE.

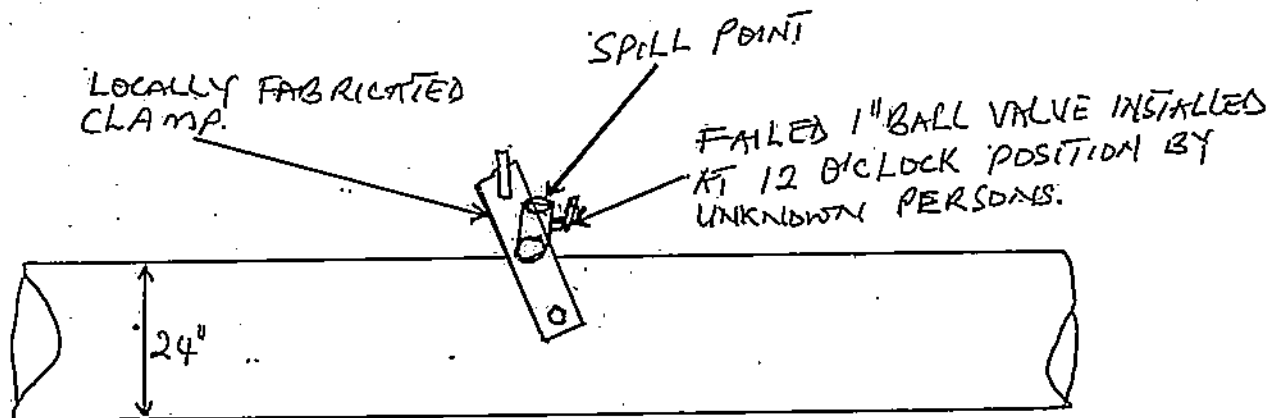
Additional observations around the spill point: THE JOINT INVESTIGATION TEAM BURNT SOIL WITHIN THE SPILL POINT AREA AND A LOCALLY FABRICATED CLAMP WITH 1" BALL VALVE (FAILED) INSTALLED AT 12 O'CLOCK POSITION BY UNKNOWN PERSONS.

E. GRAPHIC DESCRIPTION OF LEAK POINT (while detailed report of the leak point should be contained in the leak report, overview sketch of the site should be added as an appendix 1) A SECTION OF 24" NKPOKU-BDMU PIPELINE AT EQUALOR SHOWING A LOCALLY FABRICATED CLAMP WITH 1" BALL VALVE INSTALLED AT 12 O'CLOCK POSITION.

REPAIR WORK ONGOING.
